Area: Geraldton	Place Number: 224	Category: 3
Assessment Date: 14/10/1996	Last Revision Date: 25/11/2009	
HCWA Number: 13319	Asset ID: MCH126753

Name:	House
Other Names:	79 Gregory Street
Type of Place:	House
Address:	79 Gregory Street
Suburb:	Beachlands

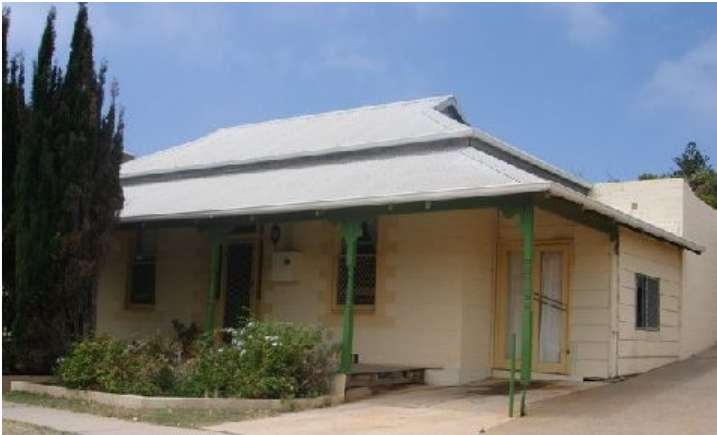
Feature quoining to openings.

Walls:	Concrete Block	Roof:	Corrugated Iron
Condition:	Good	Integrity:	
Original fabric:			
Modifications:	Box awning to front

Set close to the street boundary, this painted concrete block house has a corrugated iron gambrel roof. A separate hipped roof covers a verandah to the front and a fibro enclosed area to the south. The front verandah is supported on turned timber posts which have decorative fretwork brackets. The front facade has contrasting paint treatment which highlights the quoining to the doorway and windows which are timber framed and double hung.

Management Category:	3
Level of Significance:	MODERATE SIGNIFICANCE: Important to the heritage of the locality.
Management Recommendation:	Conservation of the place is recommended. Any proposed change to the place should not unduly impact on the heritage values of the place and should retain significant fabric wherever feasible.

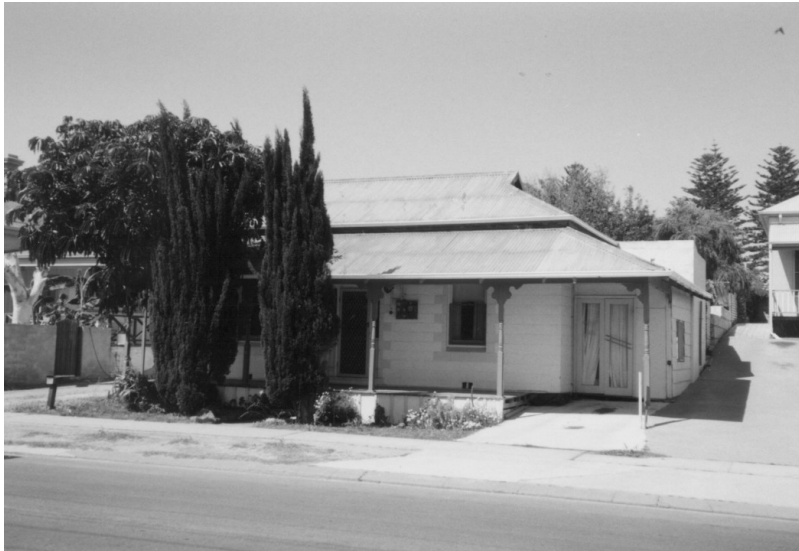
View showing decorative verandah brackets.
