Area: Geraldton	Place Number: 230	Category: 3
Assessment Date: 14/10/1996	Last Revision Date: 25/11/2009	
HCWA Number: 13325	Asset ID: MCH126783

Name:	House
Other Names:	85 Gregory Street
Type of Place:	House
Address:	85 Gregory Street
Suburb:	Beachlands

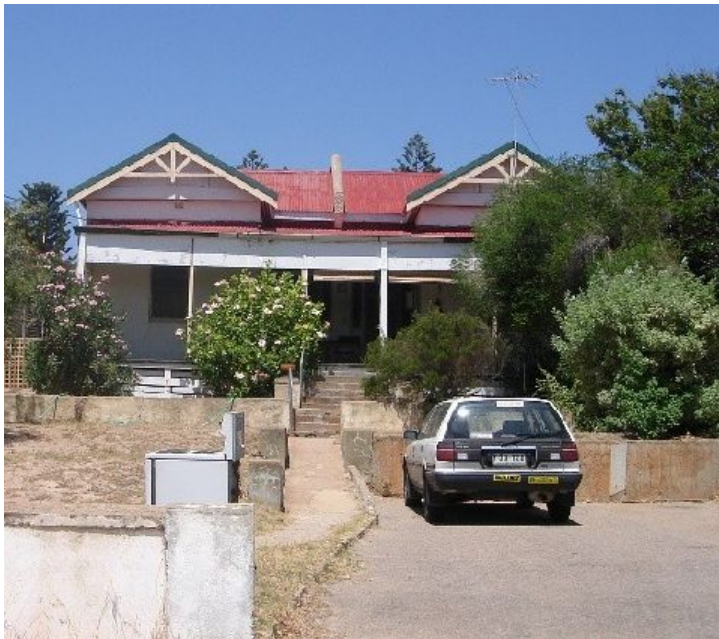
3/01/2008
Rod Milne

House set back from road.

Walls:	Concrete Block	Roof:	Corrugated Iron
Condition:	Fair	Integrity:	
Original fabric:			
Modifications:

These two concrete block semi detached houses are set well back from and above the street. A corrugated iron hipped main roof has a masonry dividing parapet wall and a gable roof to the front (west) elevation of each unit. The gable ends have decorative timber brackets to the barge boards. Below the gables there is a separate verandah roof which is supported on timber posts and has a fibro frieze. There is a low rendered masonry wall to the street boundary. A concrete path from the street with several sets of concrete steps provides access to the front verandah.

Management Category: 3
Level of Significance: MODERATE SIGNIFICANCE: Important to the heritage of the locality.
Management Recommendation: Conservation of the place is recommended. Any proposed change to the place should not unduly impact on the heritage values of the place and should retain significant fabric wherever feasible.

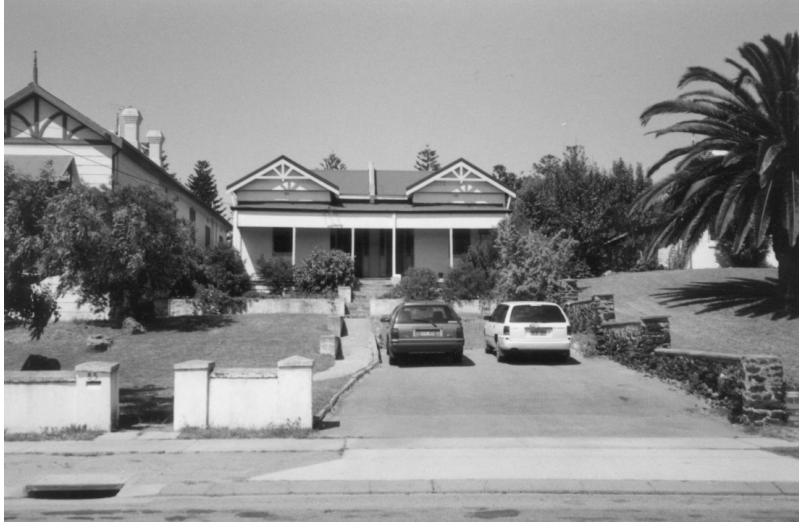
Photo Description:
14/10/1996
Suba & Grundy
Semi-detached pair.
