Area: Geraldton	Place Number: 353	Category: 3
Assessment Date: 24/10/1996	Last Revision Date: 11/03/2010	
HCWA Number: 13745	Asset ID: MCH126856

Name:	House
Other Names:	96-98 Sanford Street
Type of Place:	House
Address:	96-98 Sanford Street
Suburb:	Geraldton

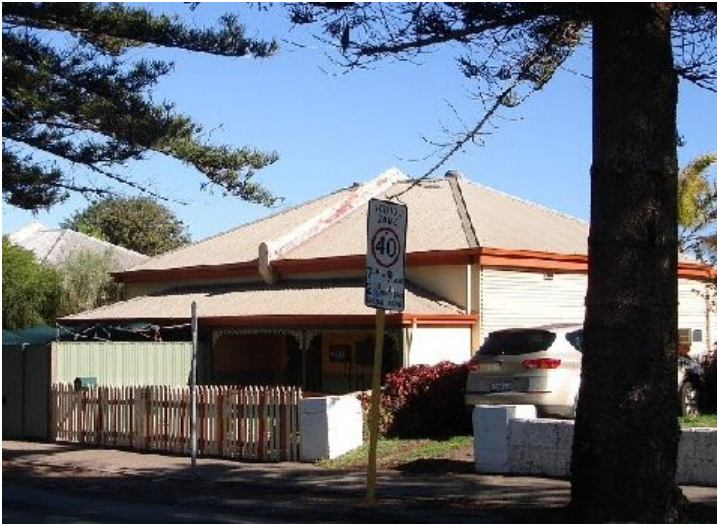
Front facade of the two houses.

This building consists of two small semi detached houses. The hipped corrugated iron roof has a dividing capped parapet wall and a separate hipped verandah roof to the front (south) facade. The place is partly clad with weatherboard, with fibro to the east and south and corrugated iron to the north elevations. The verandah roof is supported on timber posts with a decorative metal frieze to the north. There is a picket fence to the street boundary of number 96 and a tall metal fence to number 98.

Management Category: 3
Level of Significance: MODERATE SIGNIFICANCE: Important to the heritage of the locality.
Management Recommendation: Conservation of the place is recommended. Any proposed change to the place should not unduly impact on the heritage values of the place and should retain significant fabric wherever feasible.

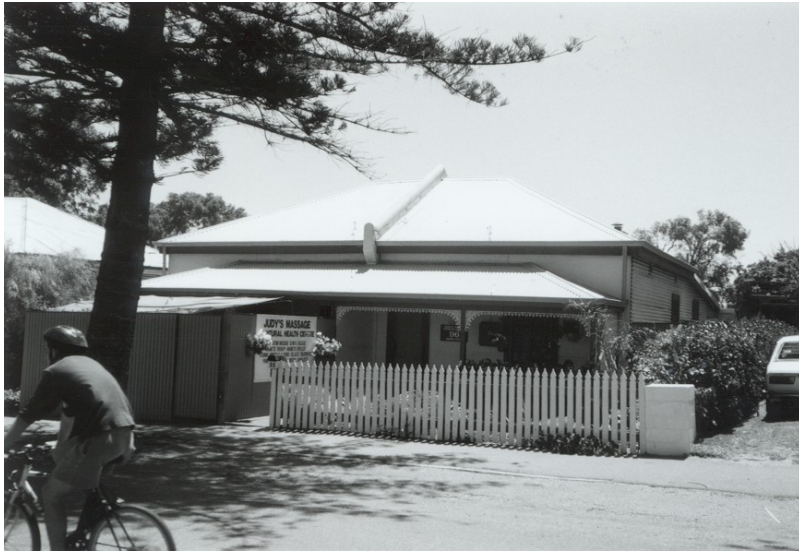
Dividing capped parapet wall separates the 2 houses.
