Area: Geraldton	Place Number: 374	Category: 4
Assessment Date: 24/10/1996	Last Revision Date: 15/03/2010	
HCWA Number: 13768	Asset ID: MCH126580

Name:	House
Other Names:	178 Shenton Street
Type of Place:	House
Address:	178 Shenton Street
Suburb:	Beachlands

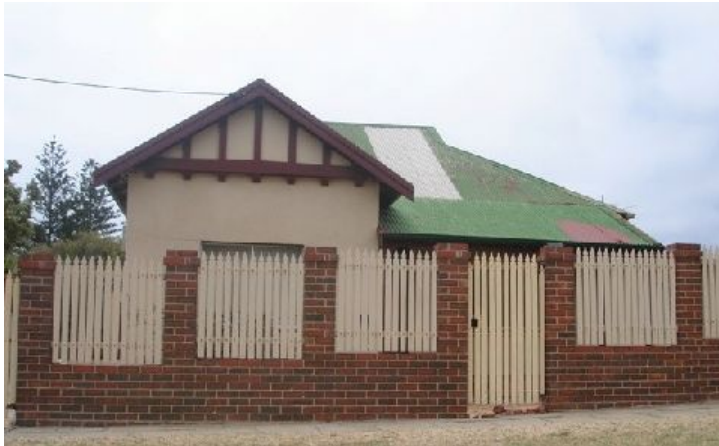
View of front facade.

Walls:	Brick (Rendered)	Roof:	Corrugated Iron
Condition:	Good	Integrity:	
Original fabric:			
Modifications:

This rendered brick house has a gambrel corrugated iron roof with a separate gable to the main room. The gable end is enclosed with fibro with timber battens. The main roof extends to cover a verandah to the side of the gable. Windows have been replaced and are aluminium framed. There is a tall fence with pickets set between brick piers to the street boundary.

Management Category:	4
Level of Significance:	SOME SIGNIFICANCE: Contributes to the heritage and/or historical development of the locality.
Management Recommendation:	Conservation of the place is desirable. Any proposed change to the place should be in sympathy with the heritage values of the place.

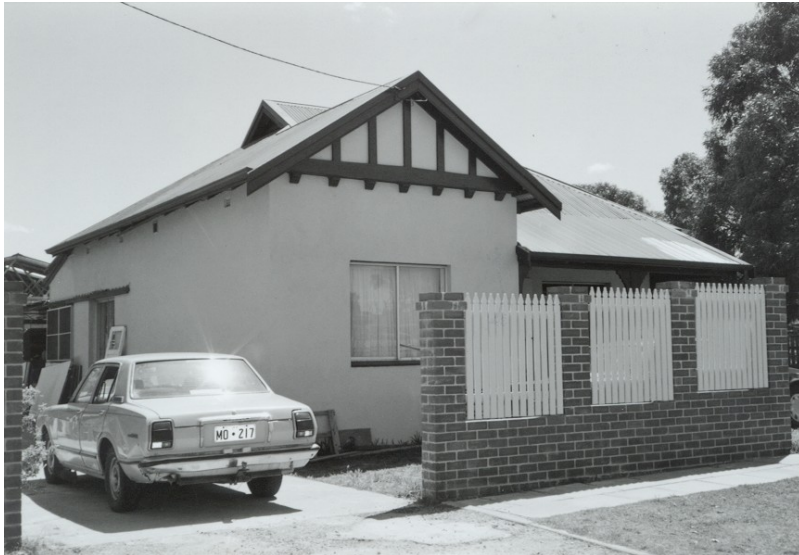
Original windows replaced.
