Area: Greenough	Place Number: 118	Category: 3
Assessment Date: 30/09/1997	Last Revision Date: 12/04/2005	
HCWA Number: 13899	Asset ID: MCH127076

Name:	Anderson Farmhouse
Other Names:	Readhead Farmhouse
Type of Place:	House
Address:	Short Road (north side)
Suburb:	Georgina

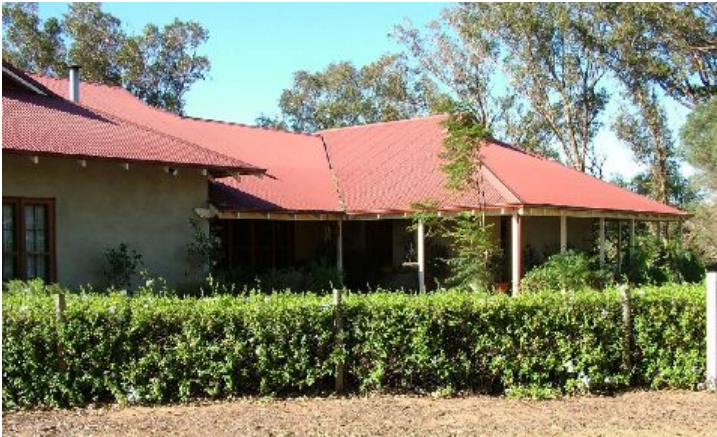
Photo Description:

12/04/2005
Martin
View from south

Walls:	Limestone	Roof:	Corrugated Iron
Condition:	Good	Integrity:	
Original fabric:			
Modifications:

The original stone cottage, which has been substantially added to, has a hipped corrugated iron roof with gablets which extends to cover verandahs to three sides. Supported on timber posts, the verandah has a concrete block enclosure to the east. Windows are timber framed and casement in style.

Management Category:	3
Level of Significance:	MODERATE SIGNIFICANCE: Important to the heritage of the locality.
Management Recommendation:	Conservation of the place is recommended. Any proposed change to the place should not unduly impact on the heritage values of the place and should retain significant fabric wherever feasible.
