11. ASSESSMENT OF CULTURAL HERITAGE SIGNIFICANCE

12.1 CONDITION

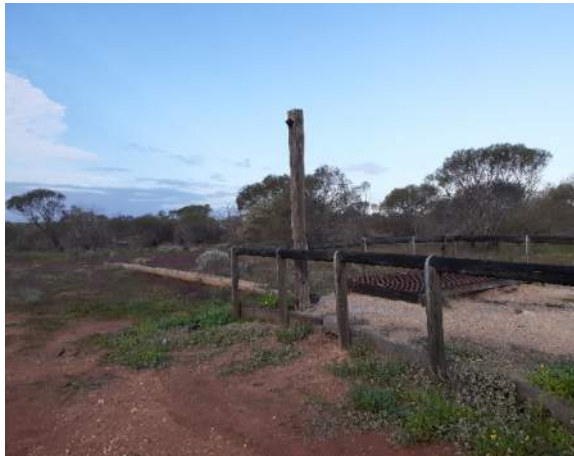
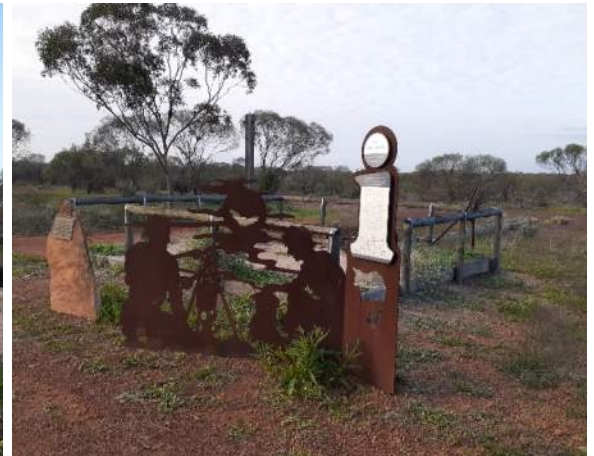
Used as a watering point and resting place along the stock route, Waterfall is a natural pool that collects water that flows from the Bingangwah Brook after rain. Water flows from the brook over a laterite stone ledge into the pool, hence the name 'Waterfall'. During the years when the stock route was in use, drovers constructed bush yards between Waterfall and Wooderarrung Spring to hold stock at night.⁷³ Due to the picturesque scenery and fresh water, the place has also been a popular picnic site since the early 1900s.

Access to Waterfall is down Nubberoo Road, west off the Carnarvon-Mullewa Road. Old Man Saltbush (*Attriplex nummularia*), Samphire (*Tecticornia bulbosa*), Flannel Bush (*Solanum lasiophyllum*) and Mulla Mulla (*Ptilotus nobilis*) grow along the Brook.

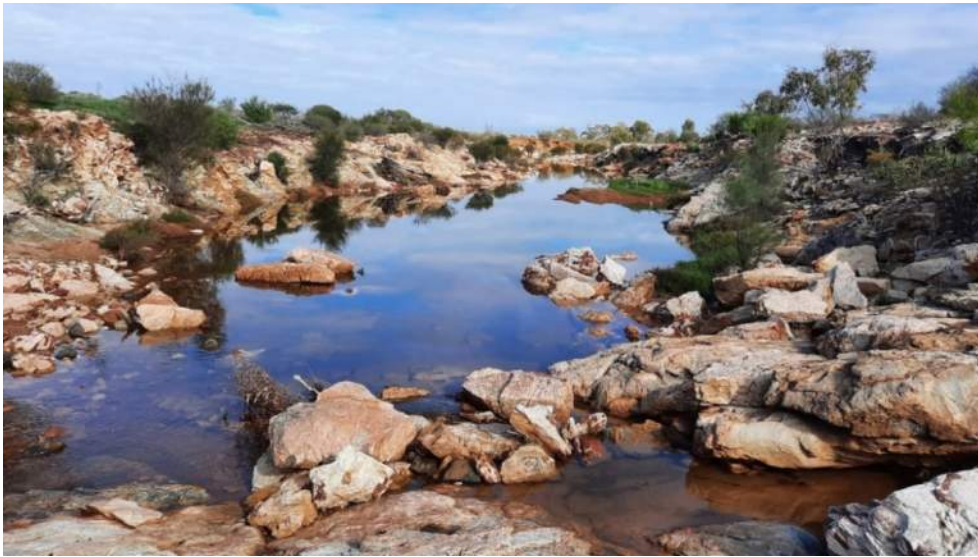
Well 2 (Woodenooka Government Well)

Built in July 1895, the Woodenooka Government well lies near the Woodenooka Spring and creek bed. The square well is 2.2 metres wide and 12 metres deep. It provided an average supply of 150 gallons (682 litres) per hour of brackish water. The original stonework, which lined the well, is still visible in some areas. The well is in an average to poor condition.

Water has risen to the top of the well where it is lined with stone around the opening. Timber planks and metal pipes likely once relating to the function of the well that are scattered around. Likely due to the unsafe nature of the well, given its high water level, it is surrounded by wire fencing. Grasses, large shrubs and small trees surround the well, due to the presence of water. Access to Woodenooka Government Well is down a gravel track east of the Carnarvon-Mullewa Road.

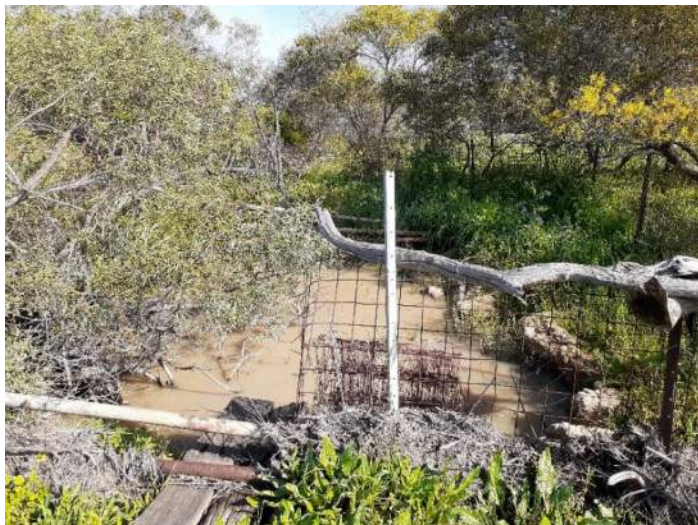
Bedan Well

This well is not listed as a government well, so it is likely it was privately sunk. Shrub and low-lying vegetation cover the opening of the well making it hard to see the stone that lines it. Four metal pickets indicate each side. Access to the well is along Bedan Road, which leads west from Carnarvon – Mullewa Road.

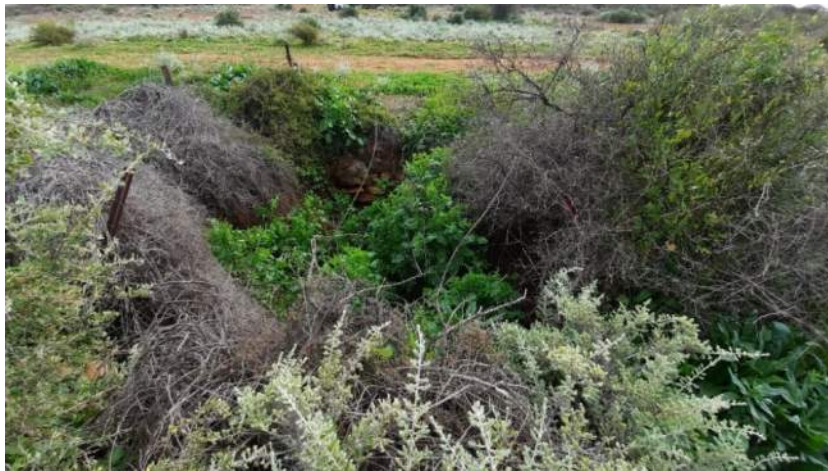
Well 3 is stone lined for the first 3 feet, and then is natural earth for the remaining depth. The round well is roughly one metre in diameter. Its water level was 12 feet from ground level in 1982, during Sharp's visit. The water trough leading from the well is in poor condition, having rusted at the base and is broken in other parts. A wire fence surrounds the well to keep livestock from falling in. Various grasses and low shrubs surround the well.

The well is located 250 metres east of the Carnarvon – Mullewa Road, just north of the Urawa River in Nunierra.

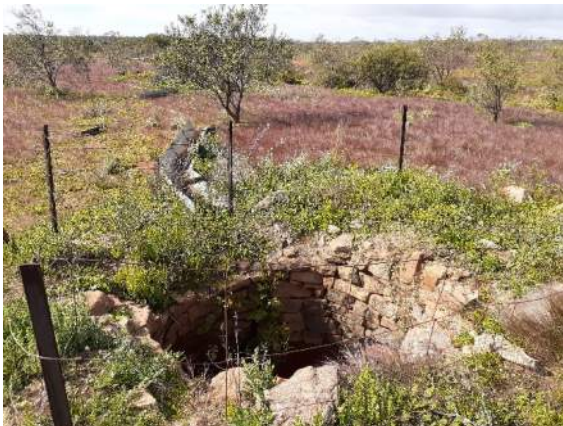
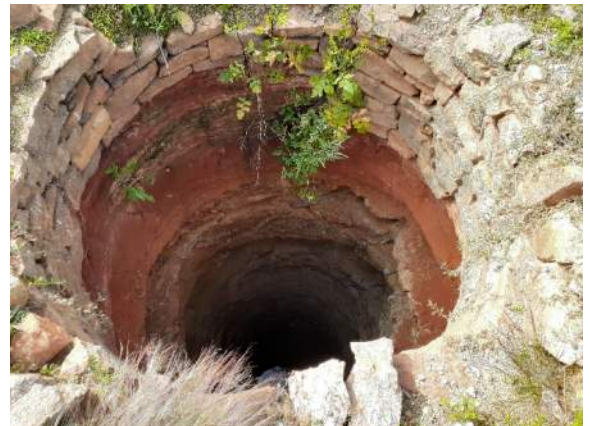
Well 3A is rectangular in shape and approximately one by two metres. The well appears to originally have been lined with stone for the first metre, but much of the stonework has eroded, exposing the soil beneath. Water is approximately two metres from ground level. Three metal stakes are located at three sides of the well, inserted into concrete. The remains of what may have been a windlass lie to the side of the well. Flannel Bush (*Solanum lasiophyllum*) and succulent ground cover grows around the well. The remnants of a rusted metal trough lie to one side of the well. On the other side is another trough and a concrete water tank.

Sharp refers to this particular well as Well 4 in her 1985 account, however it is known on maps as Well 3A. Sharp notes that, 'Well timbered 10 poles down then soils walls, water 20 ft from ground level, it stands near creek running into Greenough River'. The timbered poles no longer line the walls of the well.

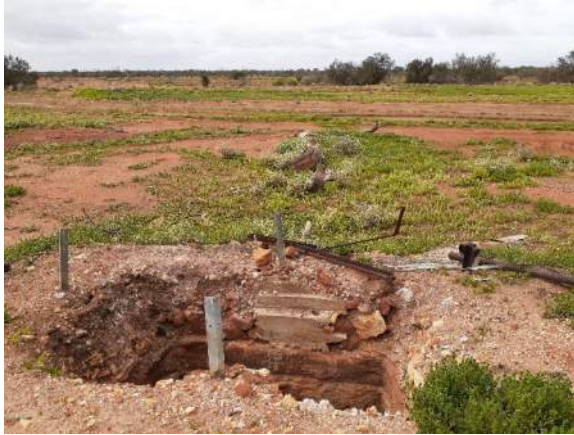
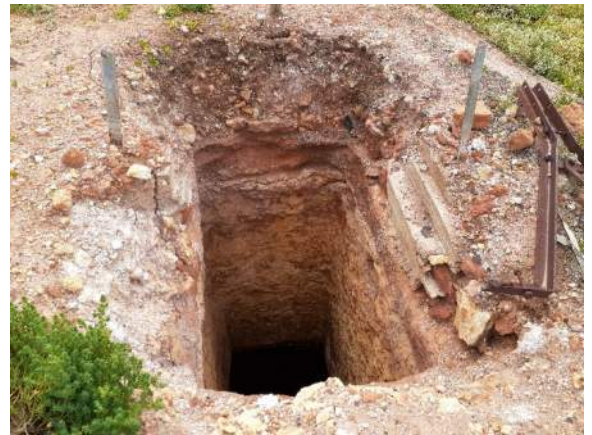
Bangemall Well 4 is square in shape measuring approximately one by one metre. The well is lined with timber planks for the first metre and then natural earth for the remaining depth. Stone is scattered around the opening of the well, concentrated to one side at the base of a rusted and broken windlass. Metal and timber cover the top of the well, acting as a make-shift barrier. A black pipe leads from the well to a nearby windmill. The pipe also extends from the windmill to a concrete water trough. A concrete water tank is also located to the north of the well, roughly one to two metres away. Access to the well is west from Tallering Peak Road in Nunierra.

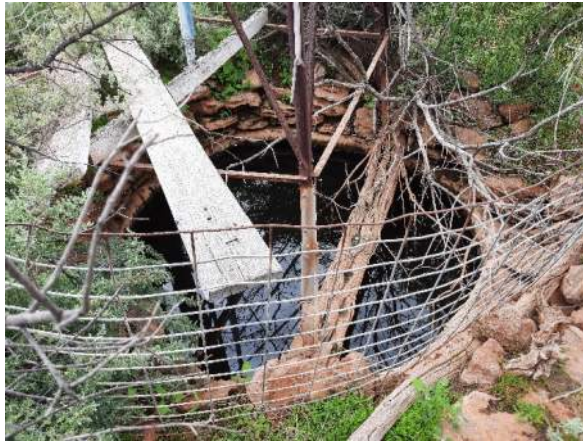
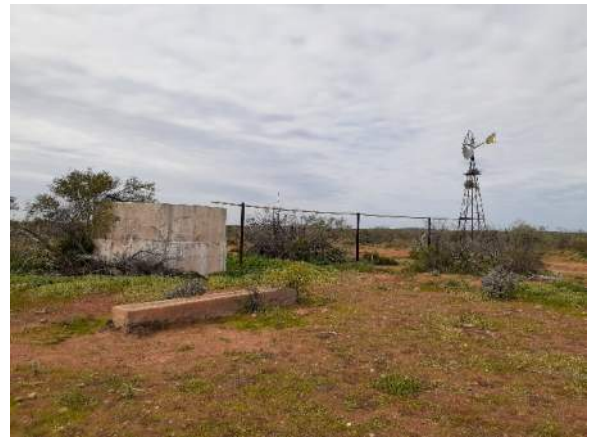
Well 8 is rectangular in shape, measuring approximately one metre by two metres. As noted in Sharp's 1985 account, Well 8 'stands out on a salt flat, in low scrub – Saltbush (*Atriplex bunburyana*) and a few Mulga (*Acacia aneura*) trees. The well ... is lined 6 poles down the soil walls'.⁷⁷ The fork and lever, whip and windlass have fallen into disrepair. A fence made of locally sourced mulga poles bound by wire surrounds the well but no longer stands upright. A metal bucket, and metal trough still remain. The trough has mulga bracing along its length to provide stability. Access is roughly 1.3 kilometres east of Carnarvon-Mullewa Road in Woolgorong.

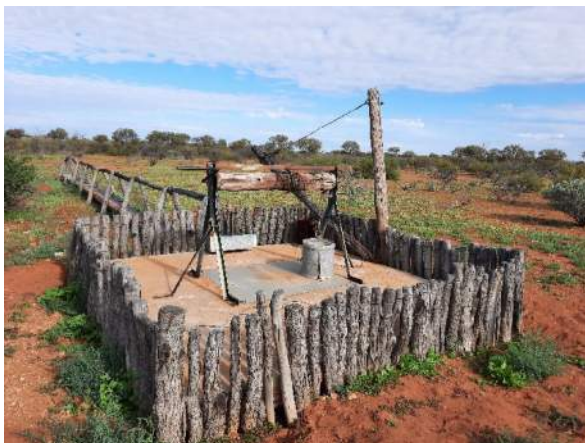
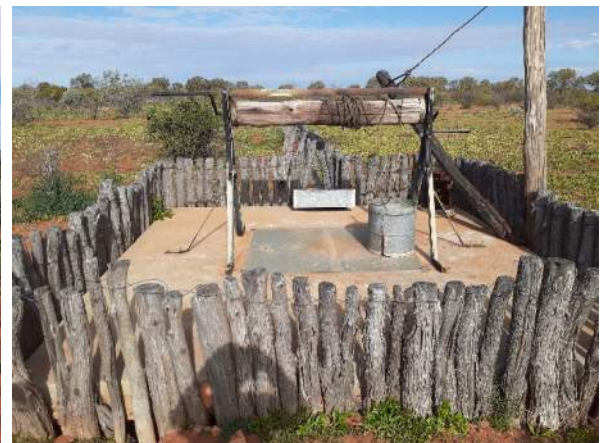
P18199 Well 9

At the time of construction, the Well 9 was equipped with a windlass only.⁷⁸ Some modifications were carried out to the historic well during the 2001 reconstruction works including the removal of the earth well mound and the installation of a concrete slab to replace the original timber plank well cover. At the centre of the concrete capping is a metal lid that can be lifted to view the well. Positioned over the timber cover is a metal framed windlass with a thick horizontal timber post at the axle. The original gin pole and swivel (of local blackheart timber) were disposed of in 2001 and replaced with telephone poles, however the original metal fittings were recovered and re-used. The well is surrounded by a square fence constructed of mulga poles bound by wire. The original semi-circular galvanised steel water trough extends for approximately 15 metres to the south of the well and is covered by original mulga bracing. A sign at the site states "E.T. Hooley Stock Route Well 9. Restored September 2001 by members North West District Rifle Clubs Association. Headquarters Bernard Clinch Memorial Rifle Range, Greenough".⁷⁹

Beneath the metal lid, the well is lined with stone for the first foot and then has natural soil walls. Around the well, the vegetation is comprised of low scrub with Prickly Acacia bushes as well as a few scattered gums. The well is approximately 26 feet, it stores approximately 4,500 gallons of brackish water quality and has a yield of 400 gallons per hour.⁸⁰ This information was written on a sign at the well viewed in 1982. The sign indicates that Well 8 is 17 miles away and Well 10 is 12 miles away.

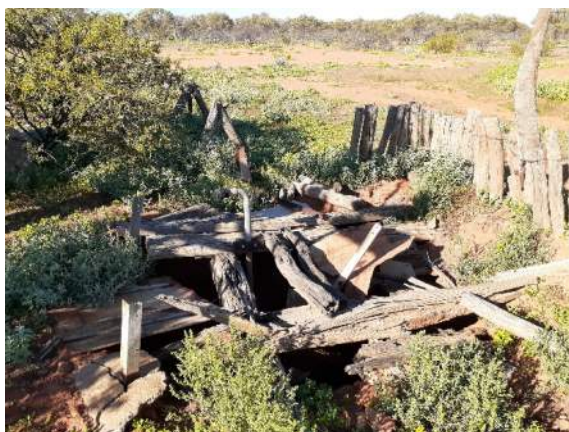
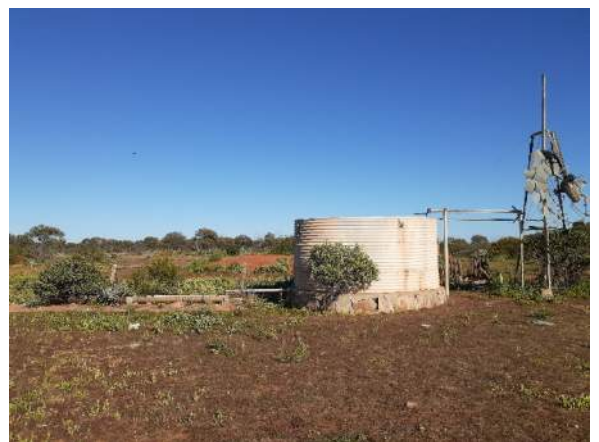
Well 11 is square in shape and has no lining, however there are stones surrounding the opening of the well. A mill is located over the well, but has fallen into disrepair and the blades have toppled over. The pole for the whip and part of the trough still stand. Mulga poles brace the trough and a mulga pole fence surrounds the well. Wooden planks have been placed over the surface of the well to act as a cover, but they have deteriorated due to insect activity and are in poor condition, falling into the well. Metal bracing appears to be at the corners of the well and a metal door extends partially over the opening.

A circular corrugated iron water tank atop a stone base stands immediately east of the well. An old brush yard is located close by where stock would have been kept. Low scrub and acacia trees surround the well. The Murchison River runs close by. Access to the well is roughly 700 west of Meeberrie-Wooleen Road, down a track from the road, one kilometre south of the point where the road crosses the Murchison River.

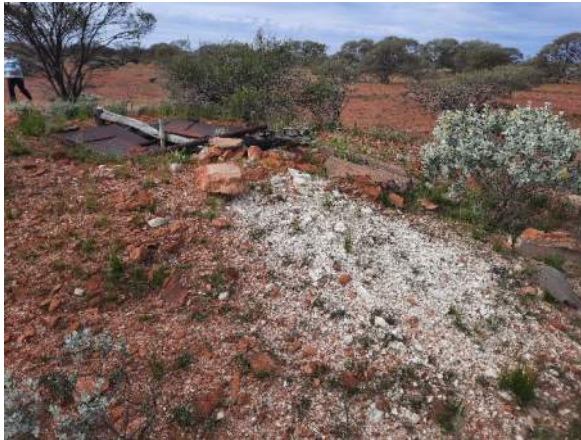
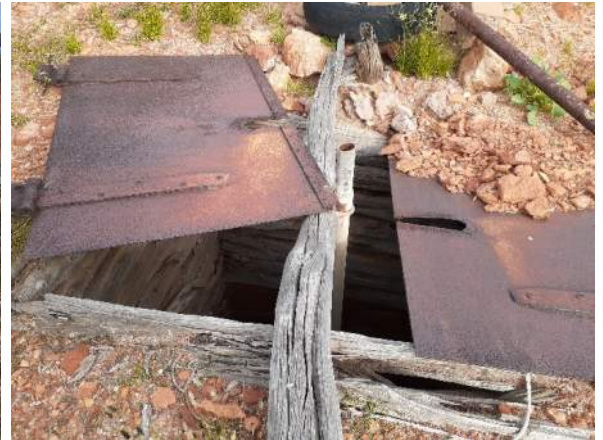
Rusted metal batwing covers partially cover the opening. They are no longer fixed to the timber and are slightly out of place. A Mulga pole extends over the opening of the well and a metal pipe is attached to it leading to the water. The remains of what may have been a gin pole or windlass lie close to the opening of the well, having deteriorated significantly from insect activity. Stone and cement that has broken apart lead away from the well, possibly once acting as a trough. A tire is also located at the well as well as portions of metal sheeting and a metal pole.

'Vegetation in the area is scarce, what there is mainly – Blue bush (*Maireana sedifolia*), Kurarra bush (*Acacia tetragonophylla*), a type of Mulla-Mulla and Mulga (*Acacia aneura*) trees.'⁹³The well is located 142 metres west of Carnarvon -Mullewa Road.

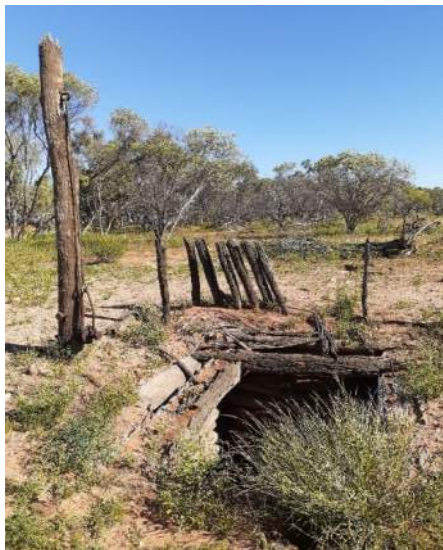
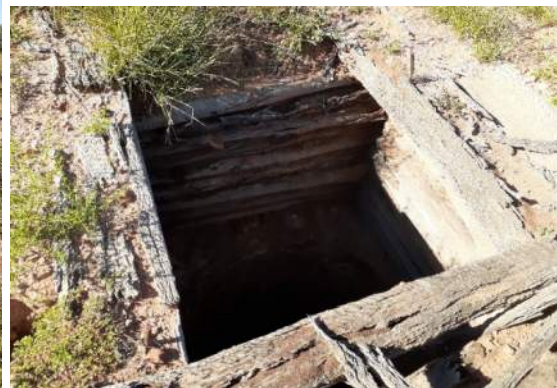
Well 35 'Coorabia'

As noted in Sharp's 1985 account, Well 35 is located 190 metres north of the Maroonah South Road. It 'stands about a mile east of the Alma River, it's limestone country, with Blue Bush (*Maireana sedifolia*). [There] are very few shade trees near the well... there was water in the well April 1982.'¹¹² At this time the mill, which is set over the well was derelict. A new mill has since been constructed that has a pipe leading from it to a round rusted water tank that sits on a stone base. Towards the other side of the water tank is a concrete trough, which has stone struts and ends supporting it. Various pieces of scrap metal and fence poles are scattered around the well. The square opening of the well has been edged with concrete. Timber poles

and corrugated iron lie over the opening, beneath the. A metal bucket previously used to draw water remains at the site.

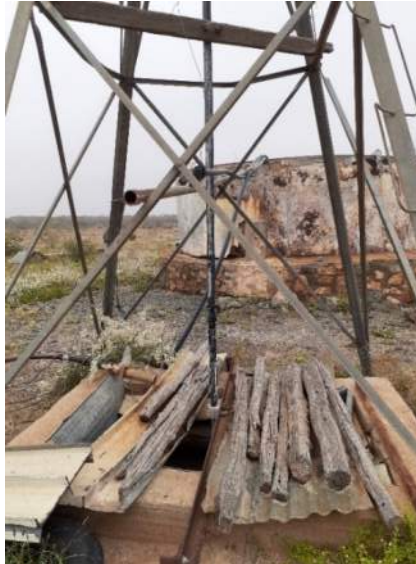
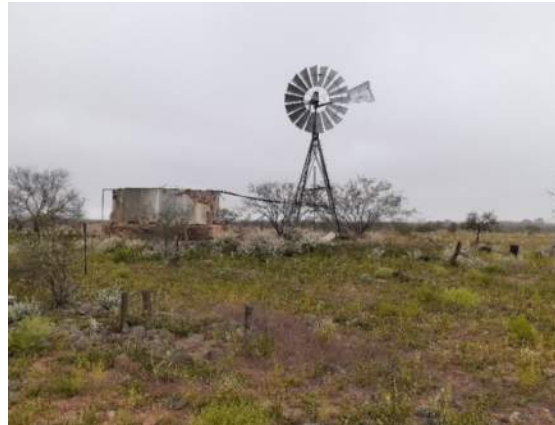
Well 36 'Deepwell'

A rusted water tank stands close to the well opening, which has caved in slightly. The mulga poles that lined the well have deteriorated due to insect activity and the mill has been removed. All that remains are the 4 metal rods at the base, which have been cemented into the rock surrounding the well opening. The trough bracing has also fallen into disrepair and is no longer standing.

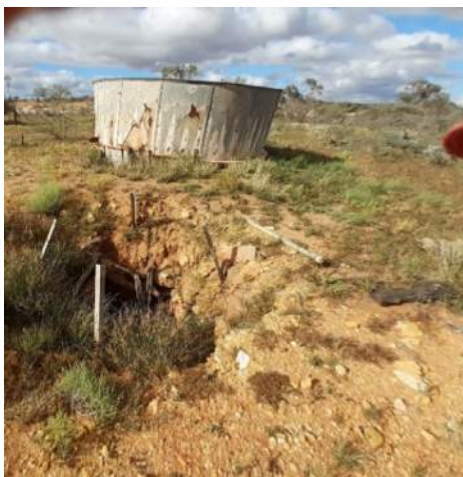
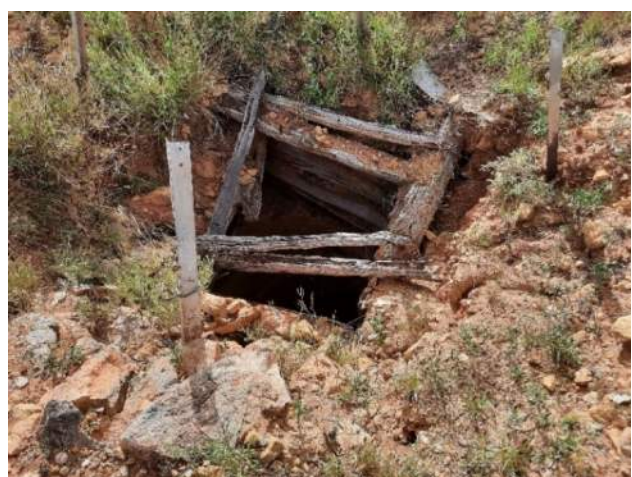
Well 37

The well has deteriorated significantly since Sharp's visit. The Mulga pole lining is no longer perfect with many of the lower poles having fallen away and only earth remaining. The timber planks around the square opening have been subject to insect activity and are falling apart. The piece of metal that was placed over the mouth of the well has rusted and partially fallen away. The timber bracing around the trough has also fallen away, likely due to insect activity.

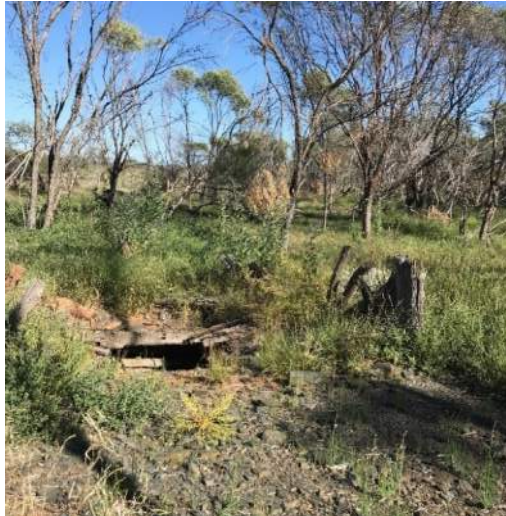
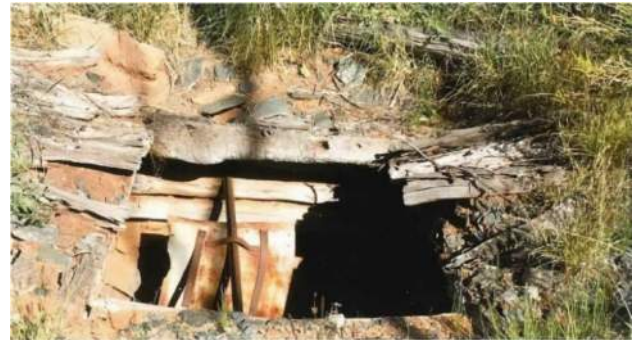
As noted in Sharp's 1985 account, Well 37 'is about 2 miles north east of the location given on maps. It stands... close to the bank of a small creek. It has its number clearly marked, a perfect Mulga pole lining with a good supply of water (1982).'¹¹⁴

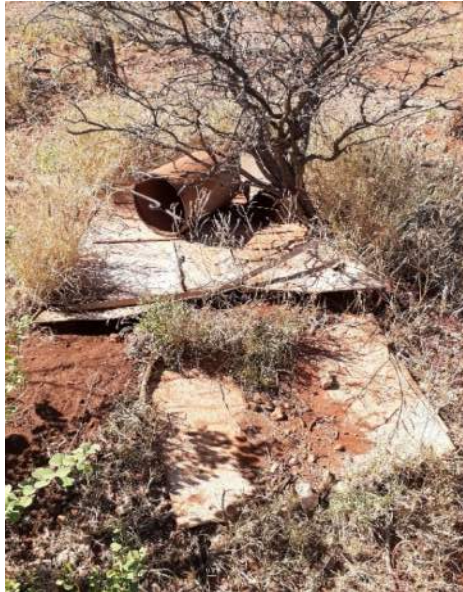
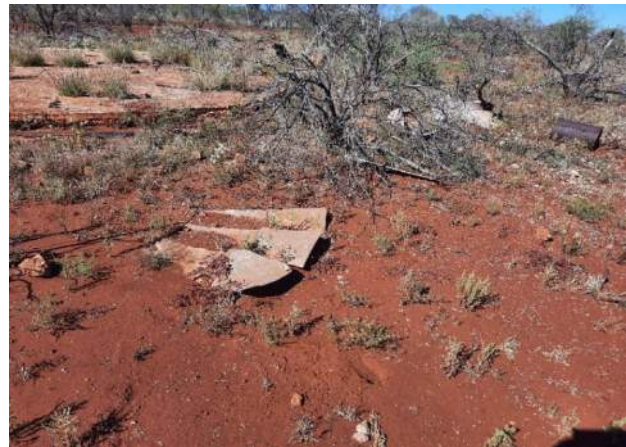
In 2021, the well appeared to be completely covered with metal sheets. Timber posts were still in place but had deteriorated significantly due to insect activity. A large circular concrete pad where a water tank would likely have sat remained. Metal artefacts relating to the well, such as buckets and pieces of the mill were scattered around the site.

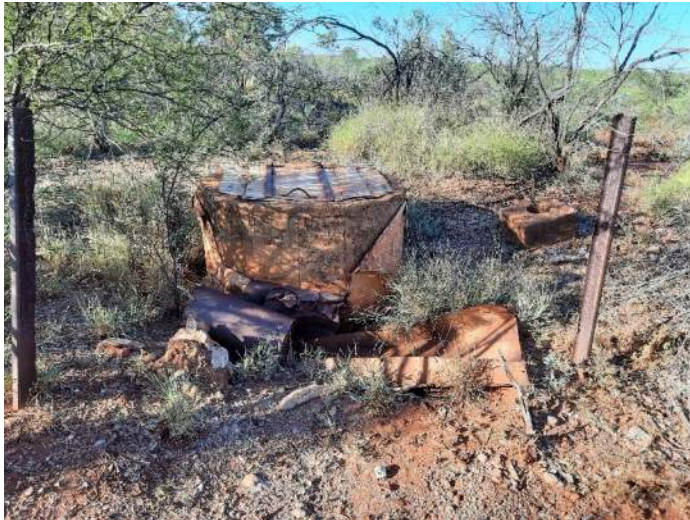
Well 45

As noted in Sharp's 1985 account, 'Well 45 stands in a creek lined with Bloodwood trees (*Corymbia terminalis*) and White (Eucalyptus alba) gums. There is very little of the well left, only the top 6 ft of timbers show. The trough and stand are all gone.'¹²² At this time a metal lid covered the opening of the well also.

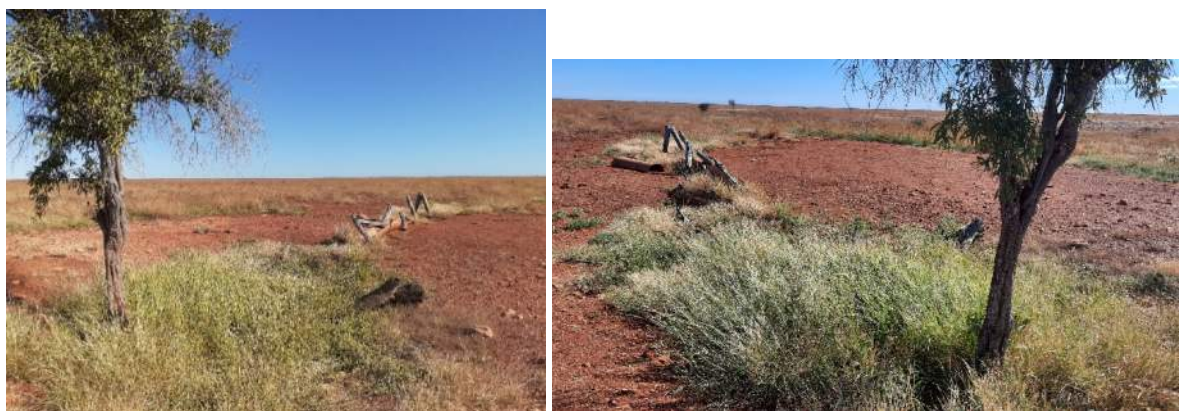
As noted in Sharp's 1985 account, 'Well 46 is 3 miles north of Yarraloola Homestead, out on the coastal plain. The well itself has fallen in, leaving no sign of any hole.' At the time of the 1982 site visit 'the metal trough and timber supports [were] still in fair order, also pieces of iron which would have been part of a windlass; timber and iron fittings that look like part of a whip. The Robe River is just south of here, white River Gums (*Eucalyptus camaldulensis*), Snakewood (*Acacia xiphophylla*), are the main shade trees, Spinifex (*Triodia pungens*) and various grasses are the ground cover.'¹²⁵

At the time of the site visit in 2021, the metal trough had been broken and portions had been moved out of place. The timber supports had deteriorated significantly due to insect activity. Grass covers the well and a single tree marks its place within the landscape. Pieces of the windlass, whip and other metal were still at the site.

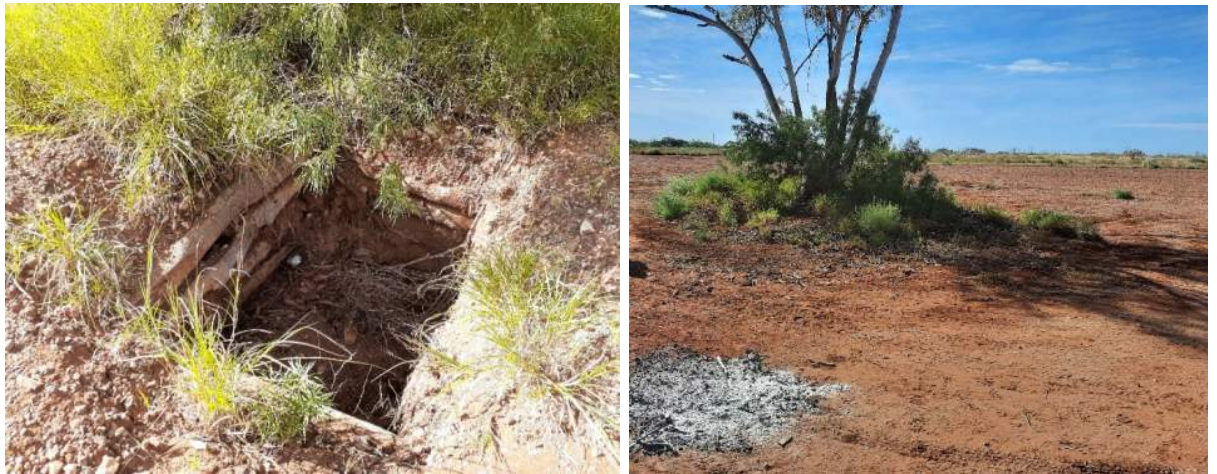
In 2021, the gum tree had grown significantly, and thick grass now covered the well making it hard to see. The well and tree are now located in the middle of a carpark.

This well is recognised by the City of Karratha as part of a discontinuous heritage place, P25267 Old Stock Route Wells and located at a resting stop along Fortescue River Road.

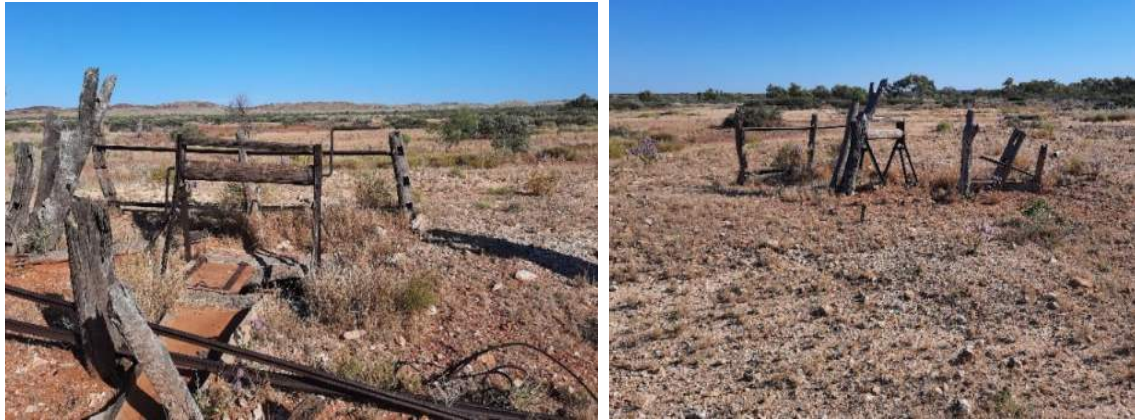
Well 49 is in good condition. The square shaped well opening is surrounded by wooden planks that have deteriorated due to insect activity. But the windlass is in good order with metal braces and wooden struts intact. Half of the metal door over the well opening remains. Prior to Sharp's 1981 visit, the whip had fallen over. A wooden fence surrounding the well is partially intact. The trough and its supports remain, albeit deteriorated.

This well is recognised by the City of Karratha as part of a discontinuous heritage place, P25267 Old Stock Route Wells. It is located approximately 2 kilometres west of North West Coastal Highway.

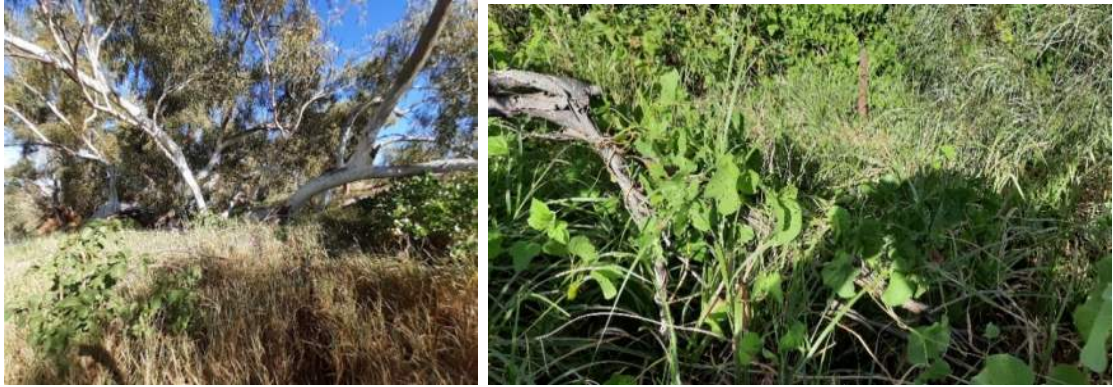
As noted in Sharp's 1985 account, Well 51 is located 'out on marsh-land country, only a short distance from the coast.' The well is in poor repair, and is falling in. The timber lining and timber lid have deteriorated due to insect activity and the windlass has fallen on top of it. The trough has rusted away and few of the timber supports remain intact.

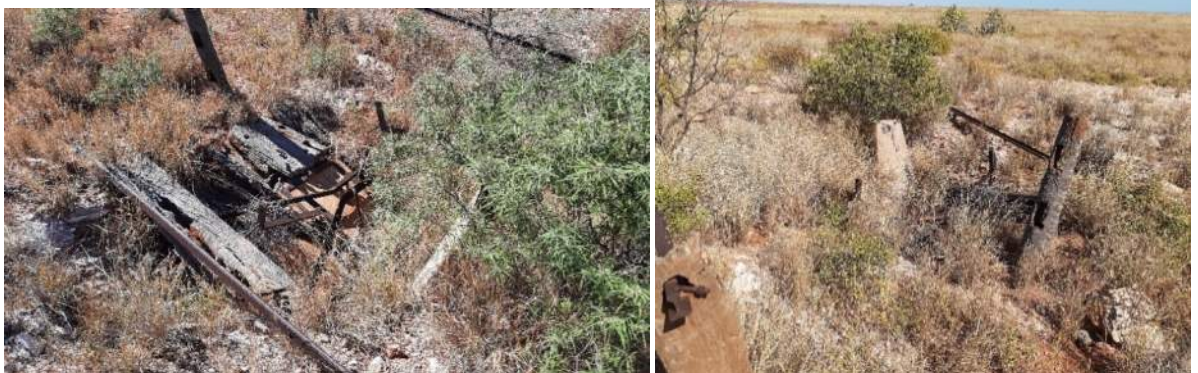
This well is recognised by the City of Karratha as part of a discontinuous heritage place, P25267 Old Stock Route Wells. It is located 2.7 kilometres west of the North West Coastal Highway.

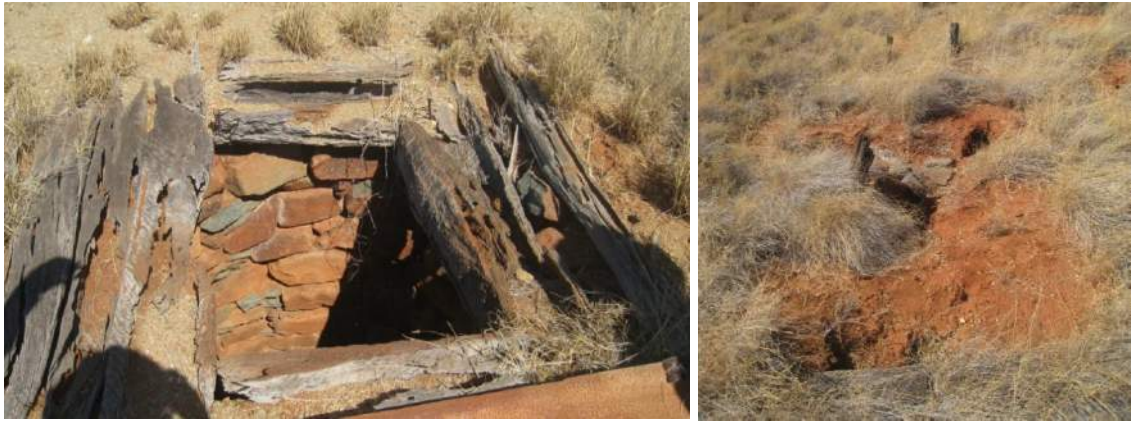
As noted in Sharp's 1985 account, Well 52 has a stone lining and its surroundings at the opening comprise of timber, which has deteriorated due to insect activity. In 1981 'little remained of the trough and stand.'¹³⁰ The whip was in good order and water level was about 15 feet in July 1981. The well stands in an open plain with few trees. The ocean is visible towards the west. This is the last government well along the route that was sunk in 1905.

Well 52 and remains of water trough, Shire of Roebourne (now City of Karratha) Local Government Heritage Inventory¹³¹

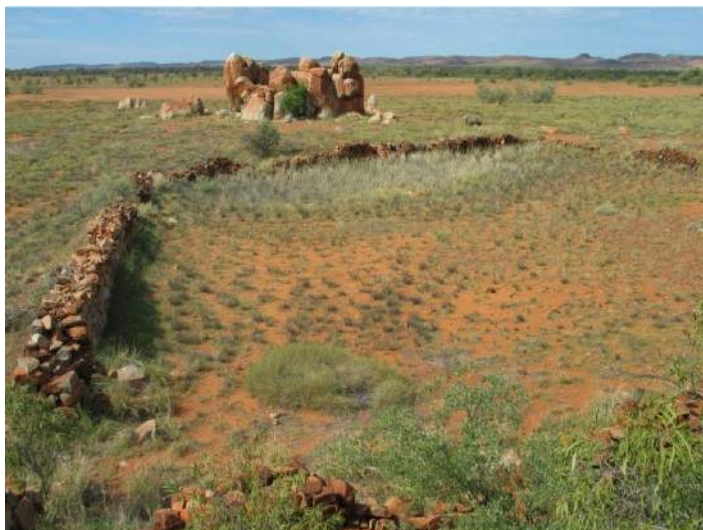
The stone yards appear to be an example of dry stone wall construction, which is particularly rare in Western Australia.

Stone yards, Shire of Roebourne (now City of Karratha) Local Government Heritage Inventory.¹³³

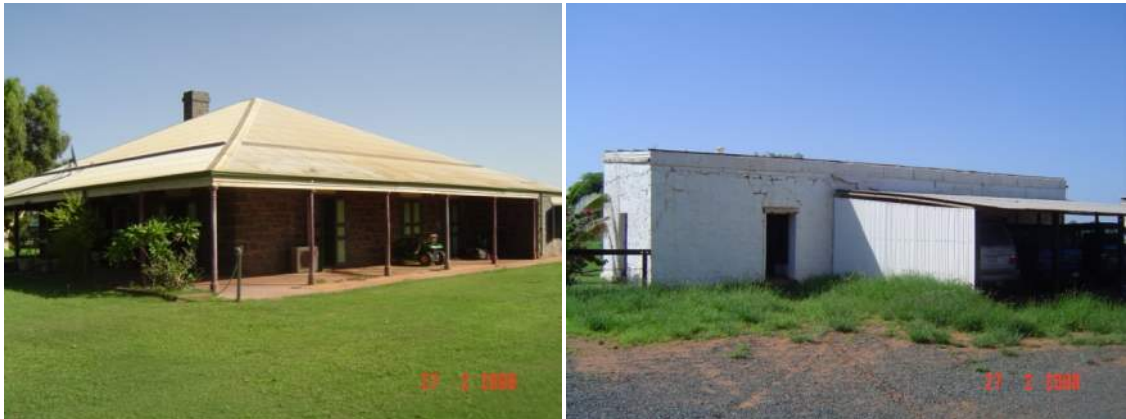
The single-storey homestead is comprised of bluestone and concrete and has an expansive single pitched roof and a surrounding verandah supported by cast iron posts.

Mundabullangana Homestead and Old Post Office & Store, taken by Department staff 2008.

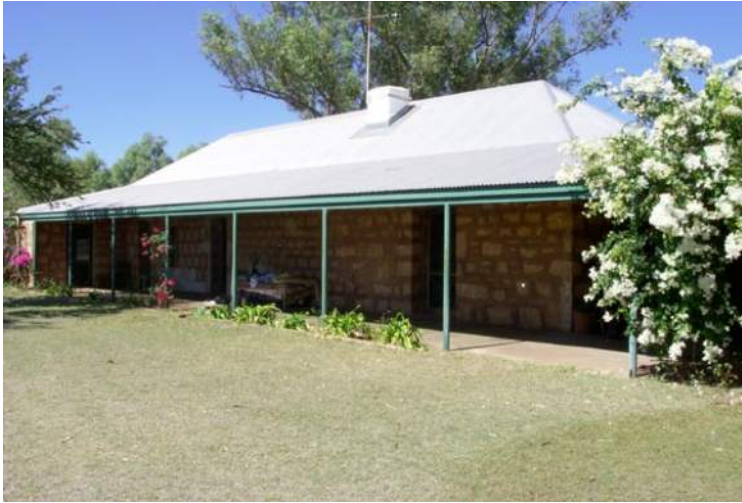
The homestead is comprised of stone and has a corrugated iron roof. A verandah surrounds the exterior.

Boodarie Station Homestead, taken by Department staff 2008.
