HERITAGE IMPACT STATEMENT

**22 TAMARISK WAY,
WOORREE**

DEVELOPMENT APPLICATION

DATE: 13 DECEMBER 2022

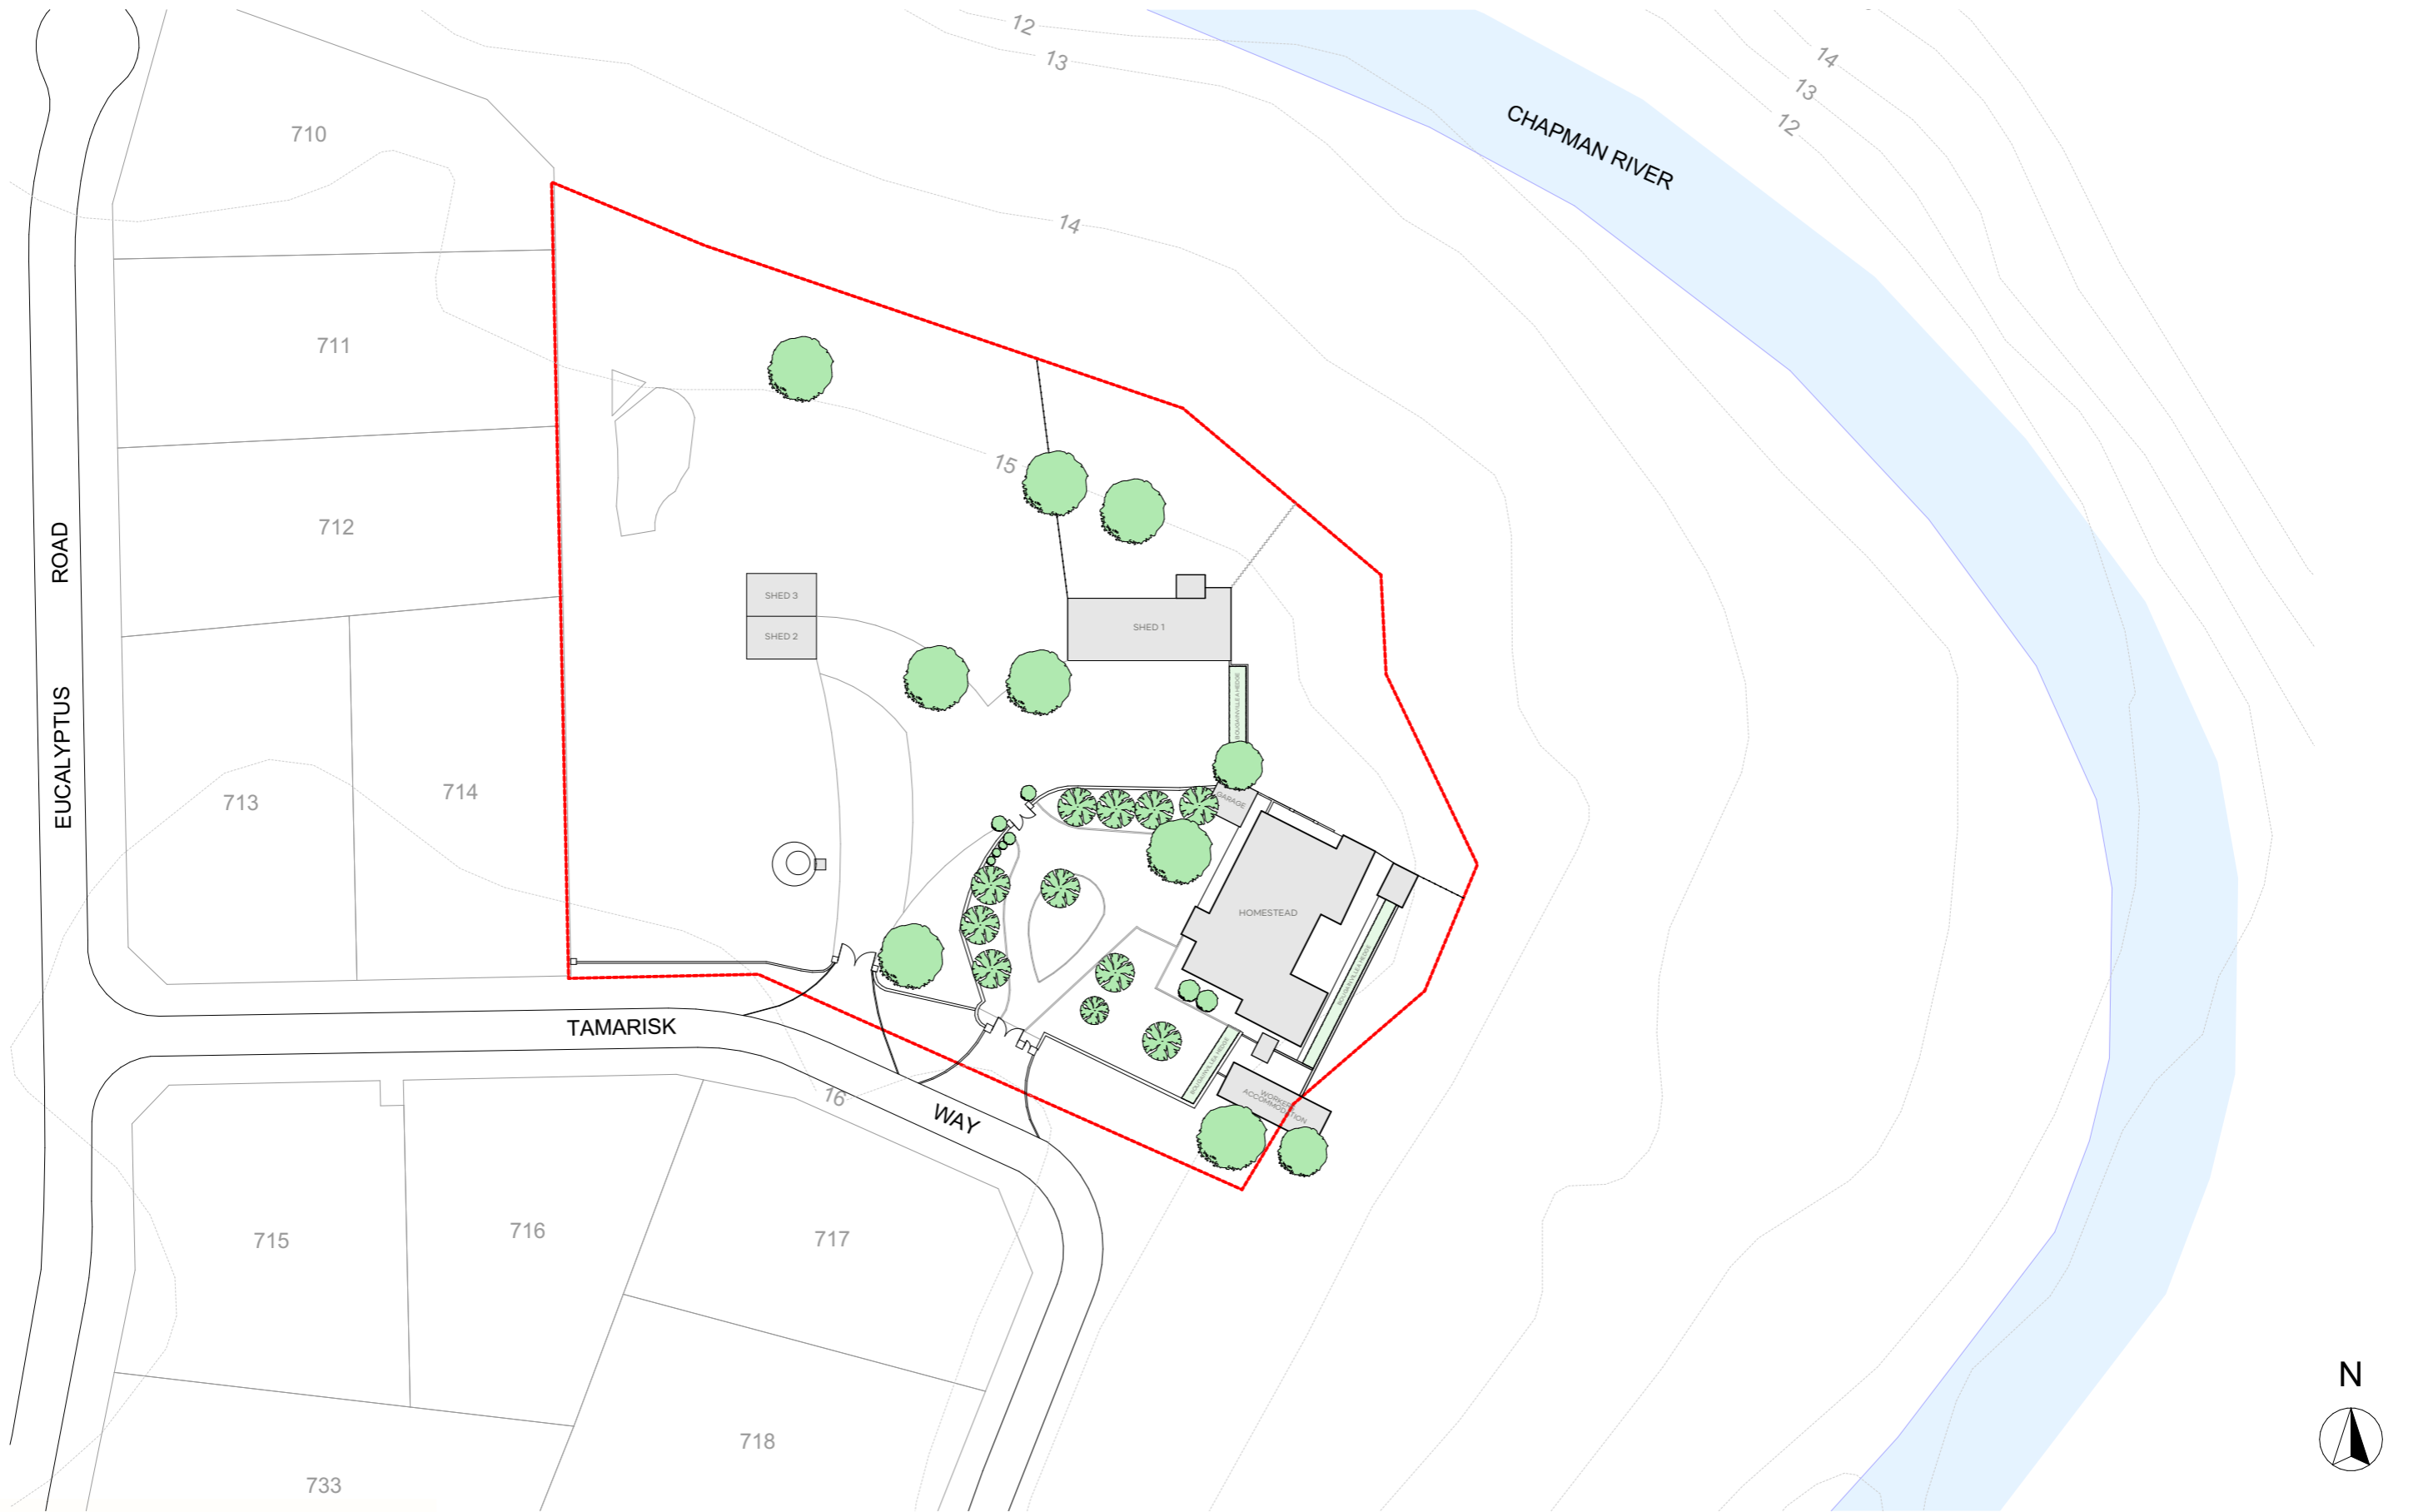
The following pages contain 'As Existing' Drawings prepared by Stephen Carrick Architects. Photographs of the existing place are included as an Appendix.

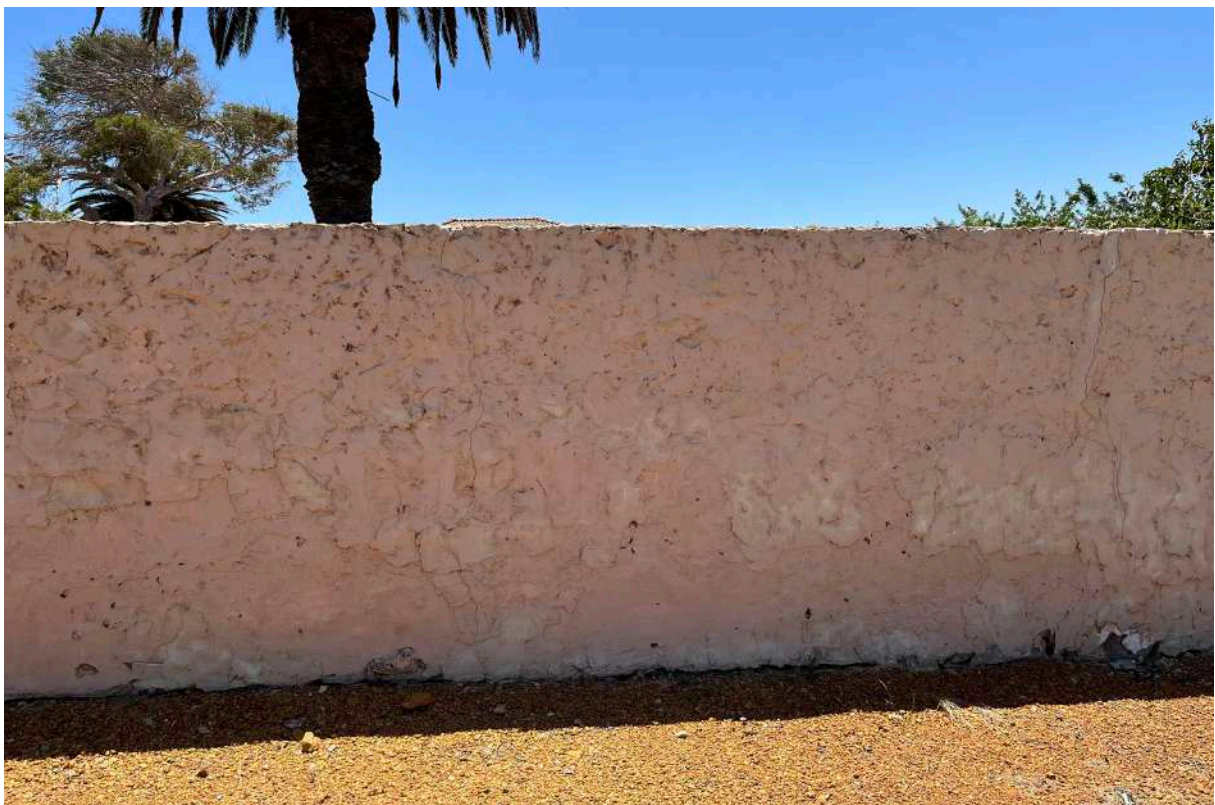
The Homestead is set within a large 1.5 hectare lot enclosed to the front by a stone wall approximately 1700mm high. The wall is predominately exposed stone work with prominent mortar joints. The south east section of the front wall has a textured external render.

02 Rendered stone perimeter wall

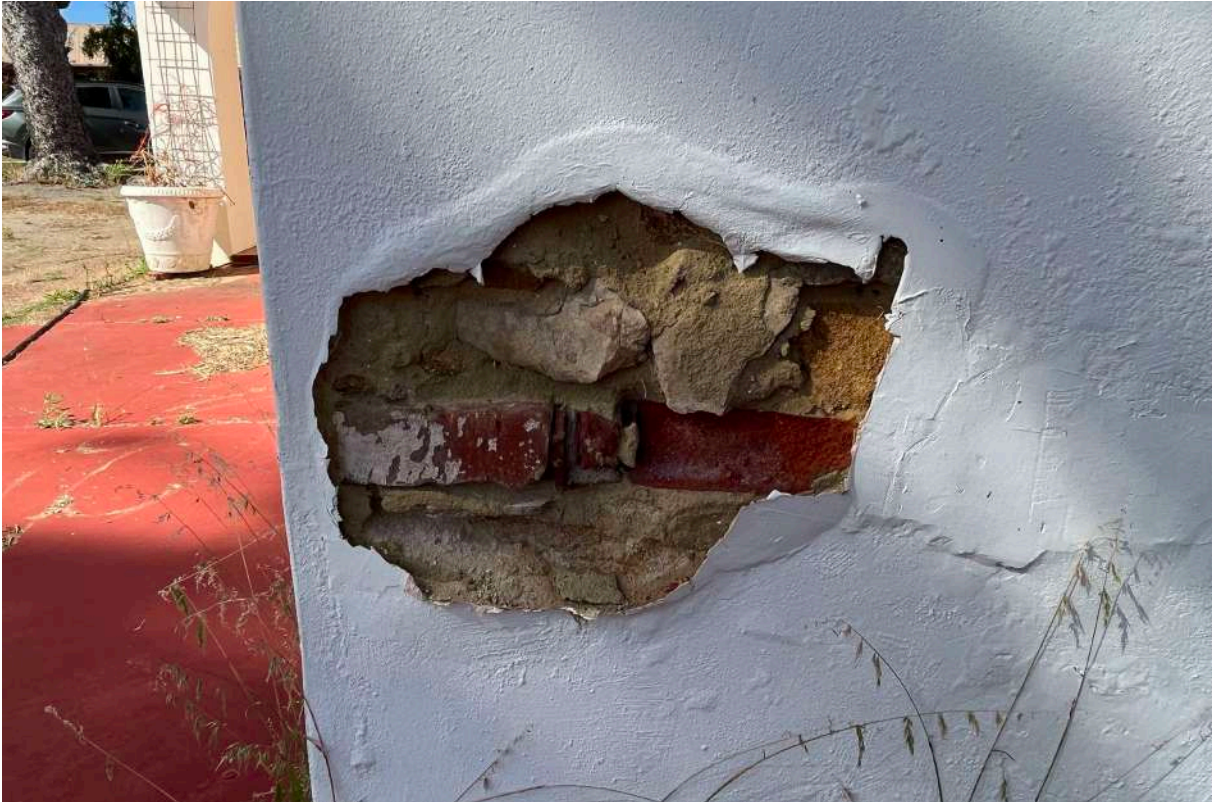
The exterior walls have a textured layer of render with a number of large cracks. The ground floor interior rooms to the main building are generally in sound condition. There is some evidence of termite damage to the door frame of Bedroom 1. The semi-detached laundry and kitchen block is in poor condition. The ceiling to the kitchen has partially collapsed with water damage to the floor of Living Room 5. Part of the ceiling above the rear verandah has also collapsed.

09 Missing render to south west corner

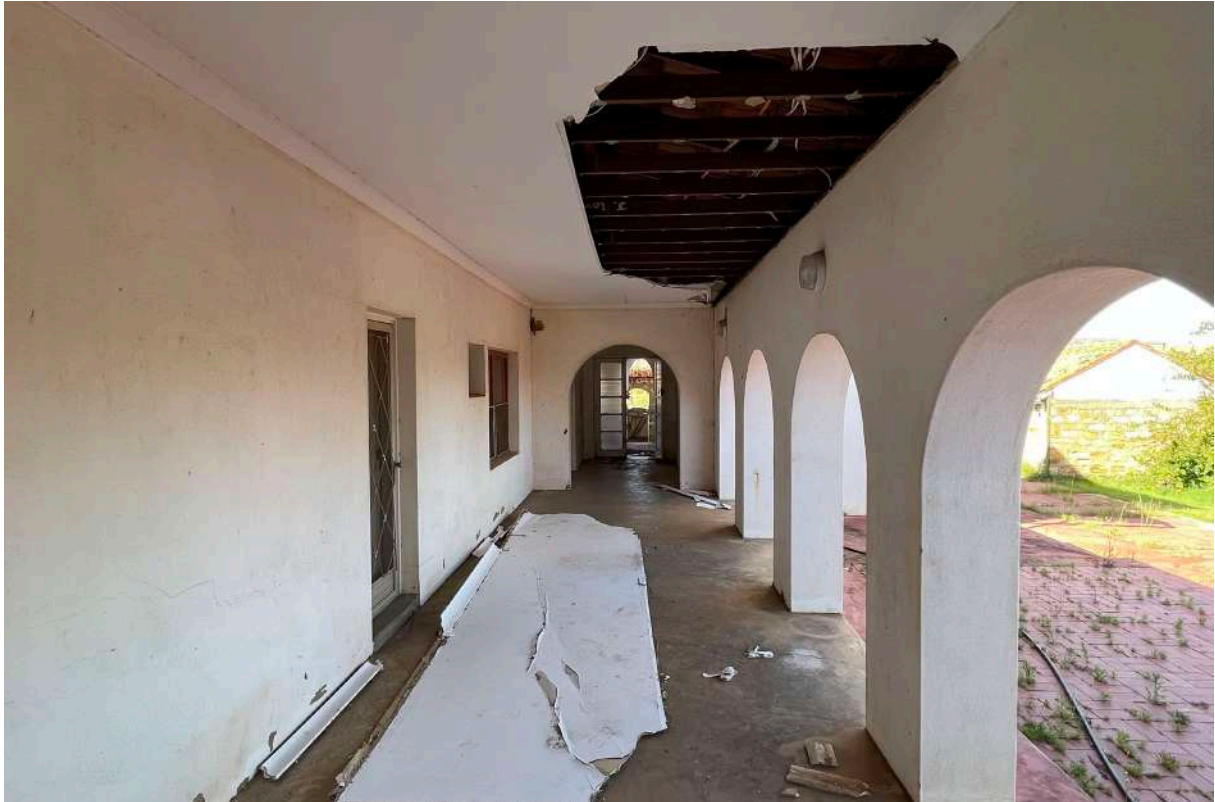
23 Rear verandah with damaged ceiling

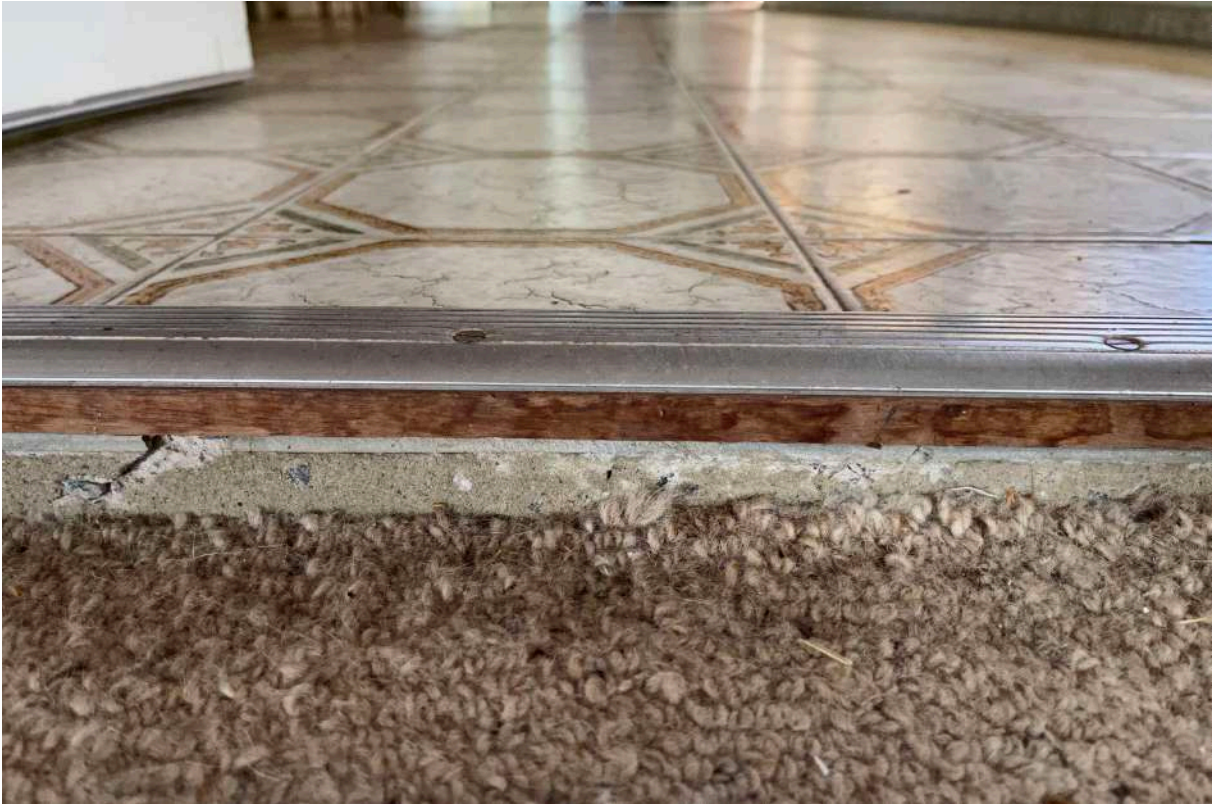
27 Concrete floor overlay to enclosed verandah

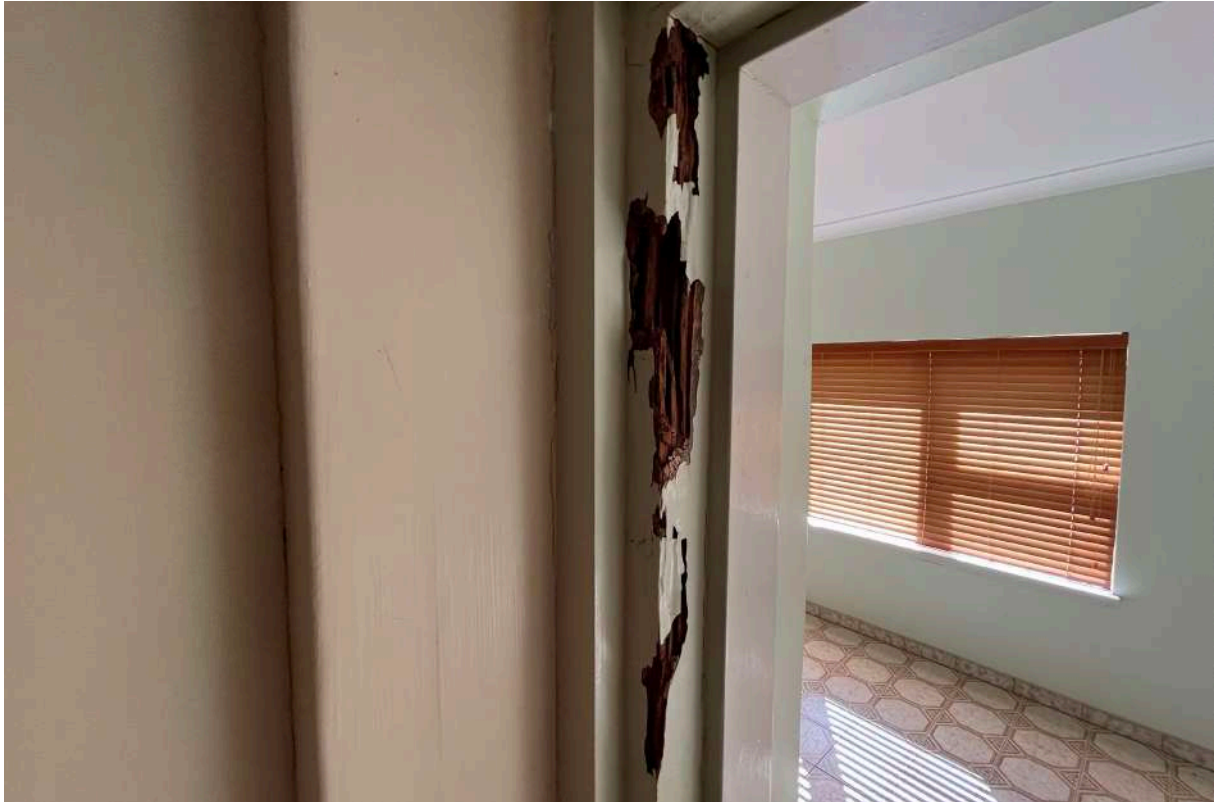
Bedroom 1 has a built in timber wardrobe and an en suite bathroom. The bathroom contains a toilet, vanity and shower. The bedroom door is a single hollow core with termite damage to the timber frame. The room has contemporary down lights.

33 Bed 1 door frame termite damage

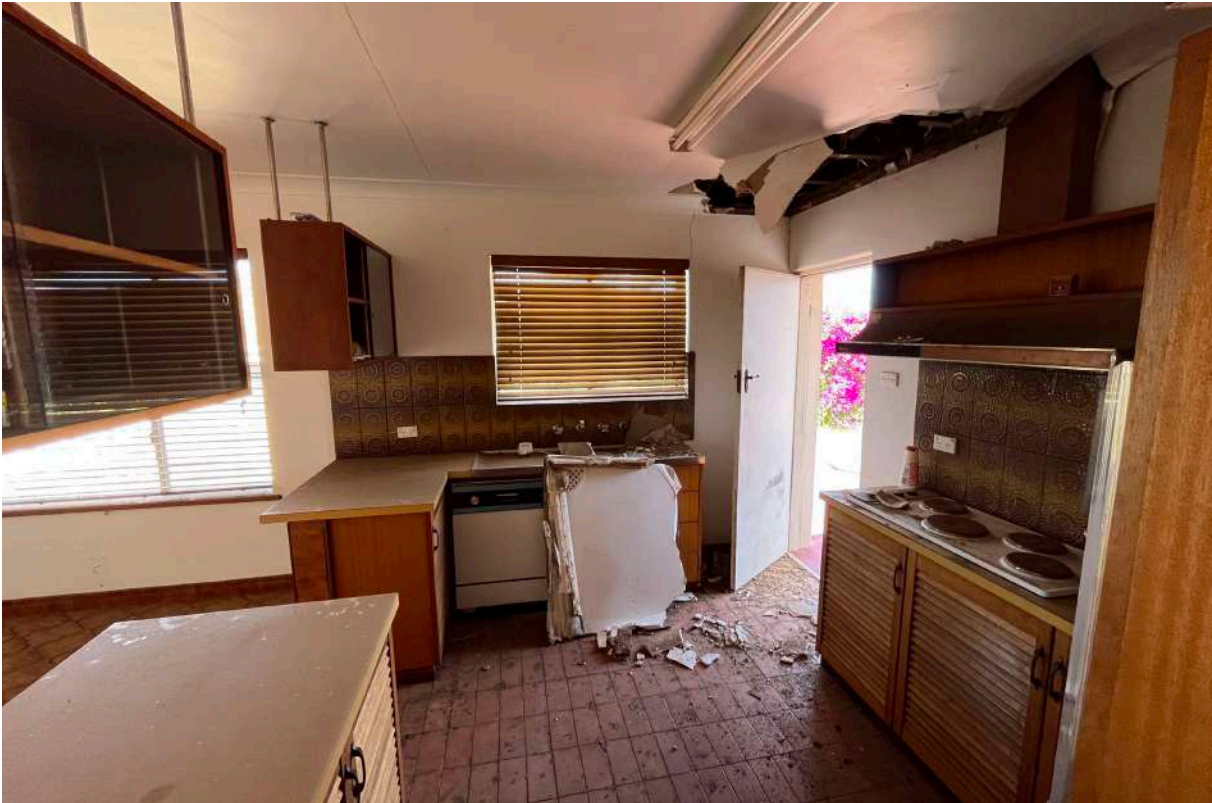
56 Kitchen 2 with damaged ceiling

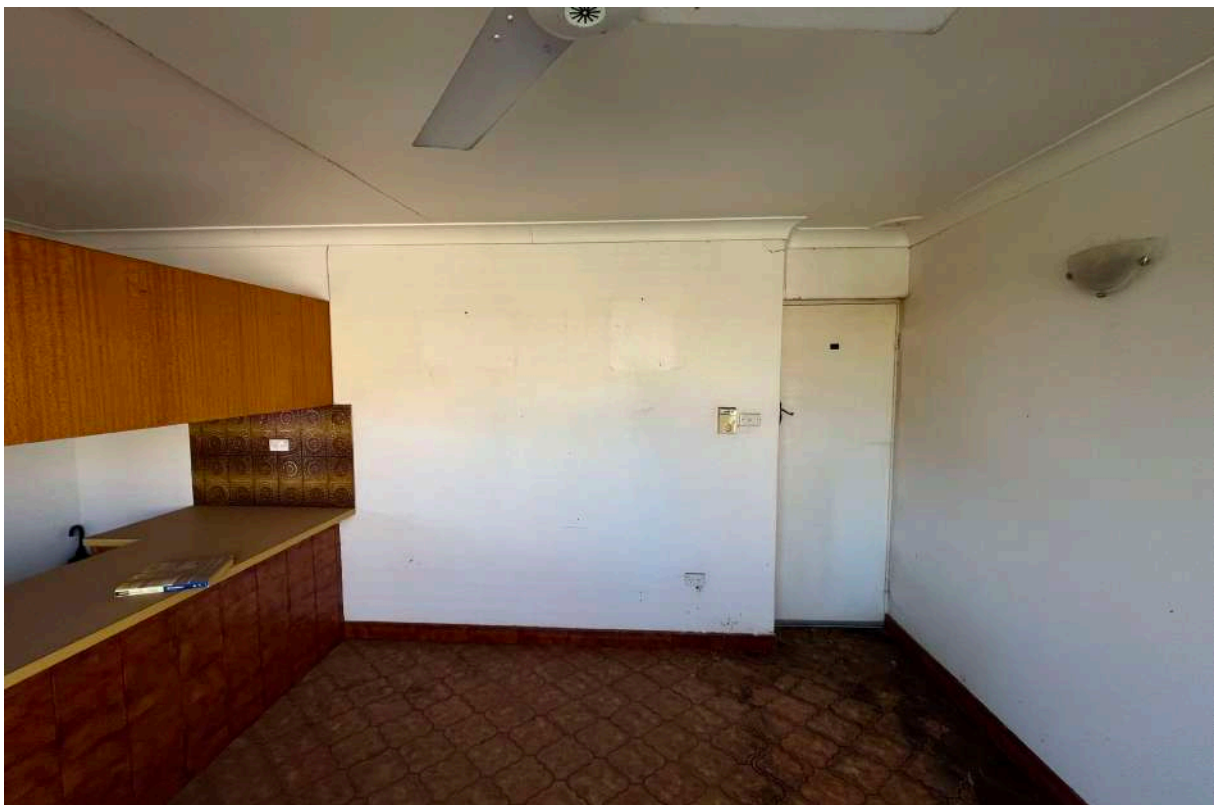
58 Living 5 with floor damage

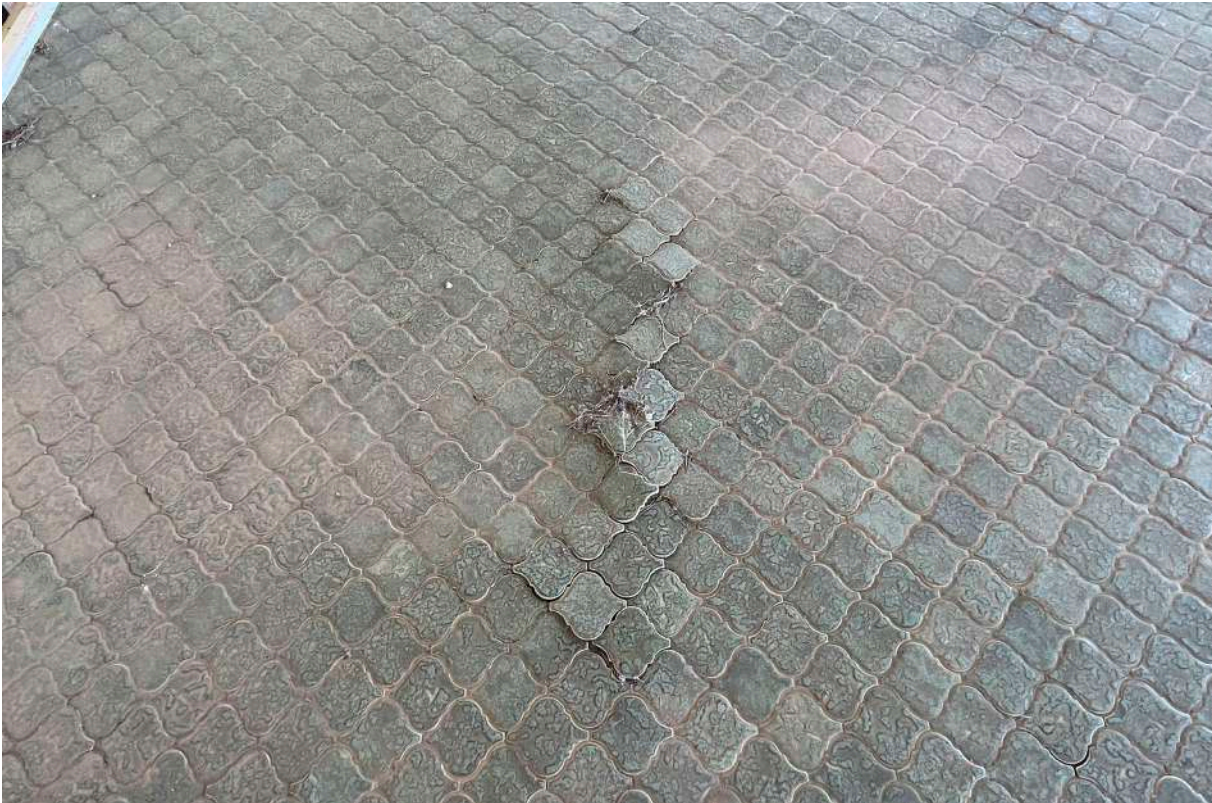
The first floor level is in fair/poor condition. The balcony floor is damaged with delaminated, loose and dislodged tiles. Bedroom 3 has water ingress through the roof. The first floor bathroom is in poor condition with mould build up and damage to the wall tiles.

62 Damage to balcony tiles

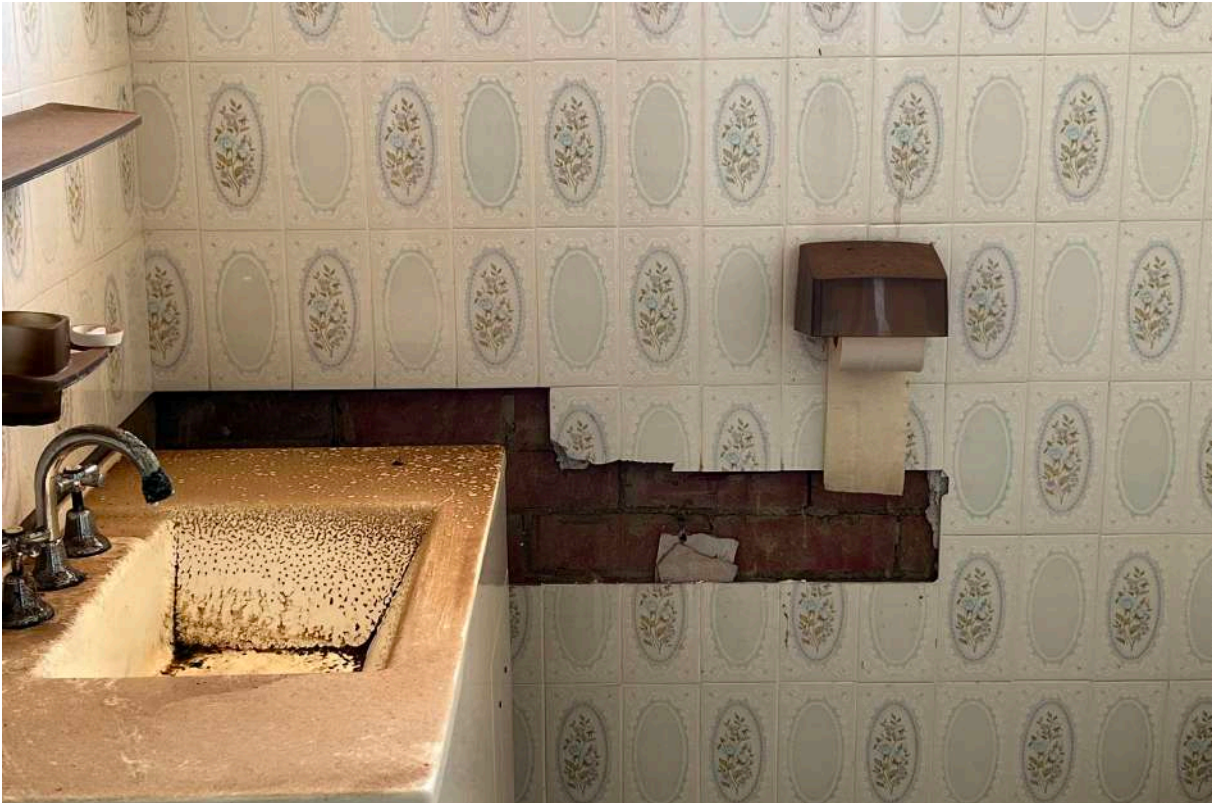
70 Mould and damage to wall tiles in Ensuite
