RE: TP17/201 LOT 72 (206) CHAPMAN ROAD, BERESFORD

**Condition Report**

**Residence at Lot 72, No. 206 Chapman Road, Beresford**

**17AUG2017**

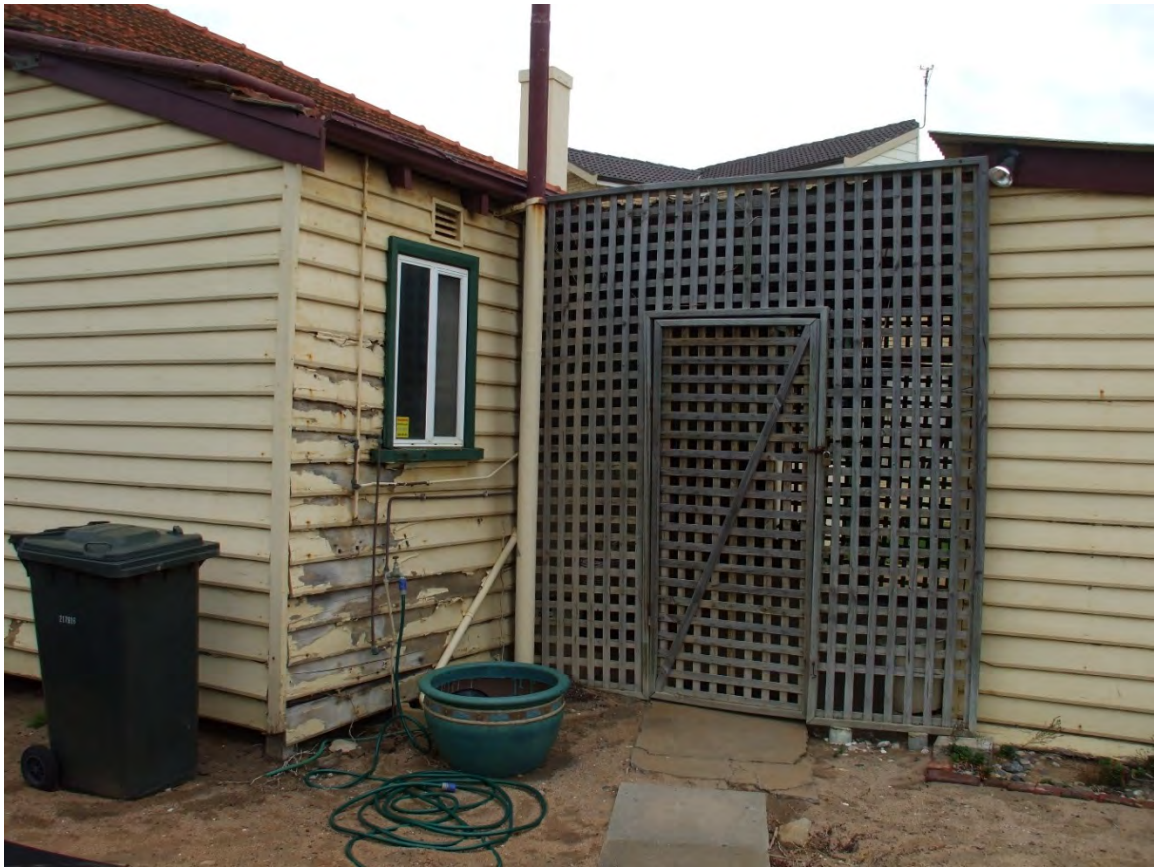
6. Side view Laundry

The next nearest structure to the above is another former outbuilding (the laundry and toilet building) that is now joined to the rear verandah by a flat substandard roof. This building is also of a poor standard with no internal linings, cracked concrete floors, gaps in the laundry where the wall meets the floor and roof and severe subsidence at the north toilet end. This area of roof has been enclosed at some stage in the past with a CCA pine lattice fence and gates to presumably secure the back of the house from intruders.
