DATE: 10 February 2012. **Order/Ref No:**

JOB: Inspection of old timber frame house for structural adequacy.

ADDRESS: No. 18 Lewis Street, City of Greater Geraldton.

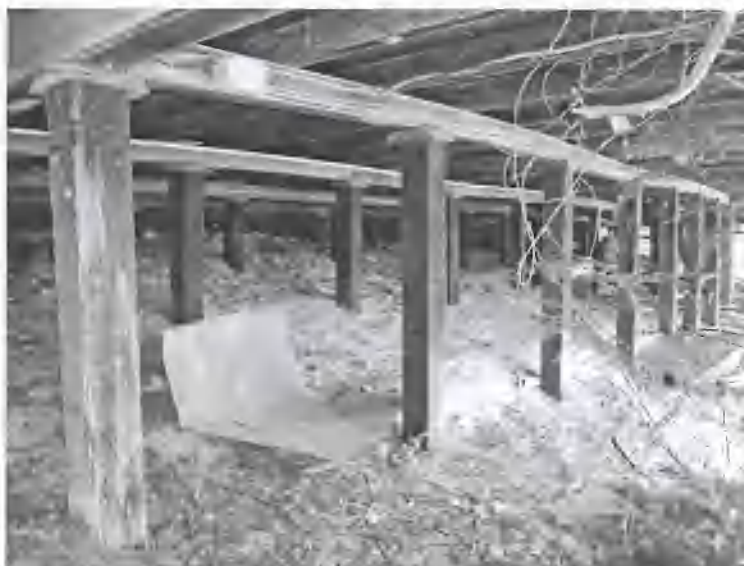
The house was built in 1913. It is about 300m from the foreshore and not protected from the salt laden sea breeze. With the exception of the custom orb roof sheeting, it is entirely made of timber, even the clinker plank clad walls. The ground slopes to the South-East at about 18°.

The stumps are 120x120 (5 inch square) set typically at the old 4 foot (1200mm) spacing. They do not have concrete footings, and depend on natural high ground compaction to restrain them.

Since the house sits on a sloping site, the compaction is relaxed due to pressure being relieved on the down-slope.

The result is that the stumps sink at different rates, and the bearers begin to tip to one side or other.
