City of Greater Geraldton
The Rocks Building
Structural Condition Survey and
Concept Report

REP-001

Issue | 5 March 2018

Job number 259677

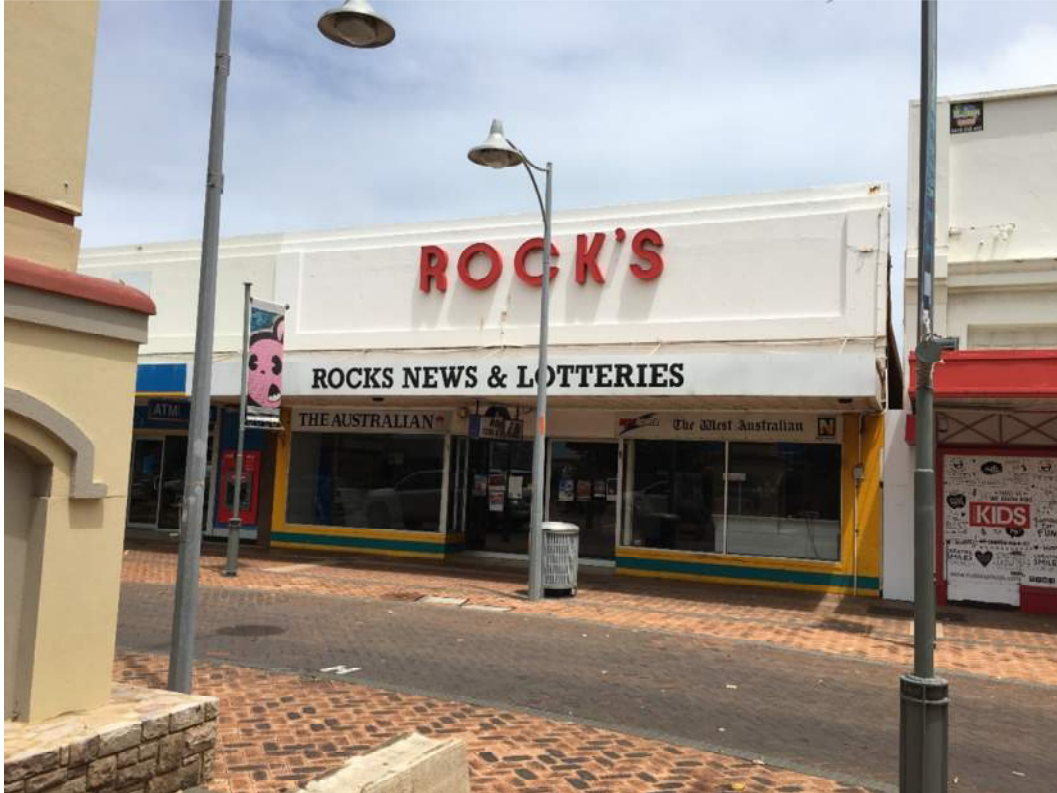
Figure 1: The Rocks building

The Marine Terrace Shop Front consists of a glazed shop front with a lightweight canopy and masonry parapet, which can be seen in Figure 1. The condition of the masonry parapet is unknown as this area in the roof space was not safely accessible, however the area below the tin ceiling can be seen in Figure 16.
