REMOVAL OF HERITAGE LISTED PLACE – 140 FLORES ROAD, WEBBERTON

REPORT

ATTACHMENT 3

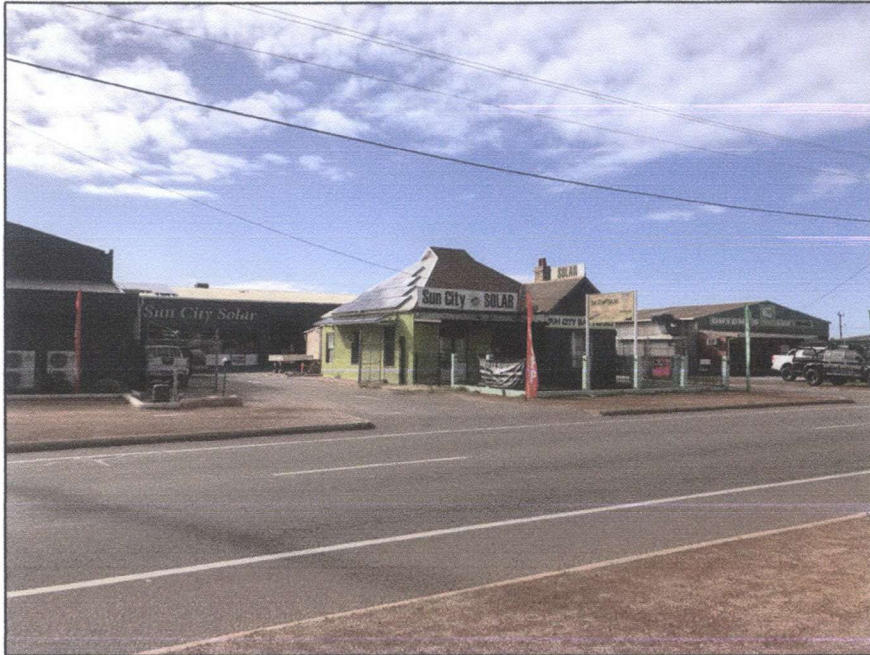
Figure 1 – View of building from western side of Flores Road

By 2011 however, it was apparent that the works they had undertaken to restore the building (rendering, painting, reinforcing of walls, new facilities) were not enough to hold back the deterioration of the building. The deterioration was largely based on issues that related to the insufficient quality of the original building materials used. The building was subsequently abandoned and stripped when mortar, blocks and plaster began to fall away exposing the rusted out lintels, large cracks and compromised block work structure.
