# **CITY OF GERALDTON – GREENOUGH**

## **REPORT ON WONTHELLA OVAL**

**JANUARY 2010**

**SPORTS TURF  
TECHNOLOGY**

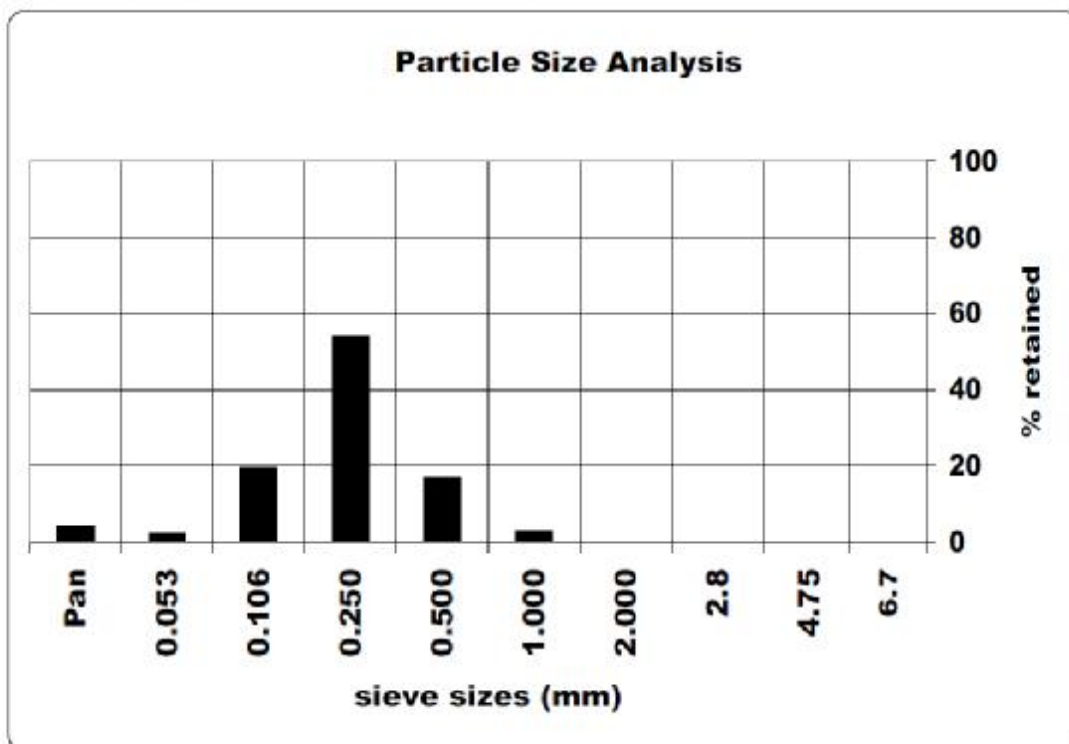
# Particle Size Analysis

- § The particle size distribution of the existing soil type at Wonthella Oval is within the ideal range for a turf root zone. This is based on the specification for P-Type sand, which is the industry standard benchmark in Australia.
- § The locally available soils supplied by Catalano's were tested for their suitability as top dressing materials. Catalano's screened sand and loam sand were both found to have unsuitable particle size distribution of for use on turf.
- § The particle size distribution of Catalano's Bullsbrook sand is close to the existing soil at Wonthella Oval and would be suitable for top dressing.
