# City of Greater Geraldton Municipal Inventory of Heritage Places Place Record

Area: Geraldton Place Number: 111 Category: 4

Name: House

Address: 162 Durlacher Street

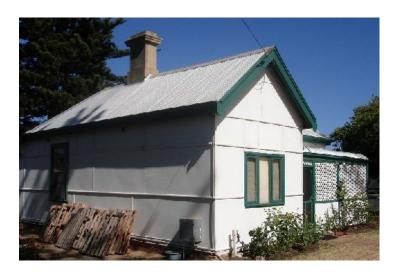
## **Photo Description:**

17/01/2008 Rod Milne Simple fibro cottage.

This is a small timber framed fibro clad cottage with a hipped corrugated iron roof with a separate gable roof to the main room. A separate bull nose verandah is supported on timber posts with a fibro balustrade and lattice infill above. Windows are a mixture of casement and double hung, all timber framed. There is a tall rendered brick corbelled chimney punctuating the roof.

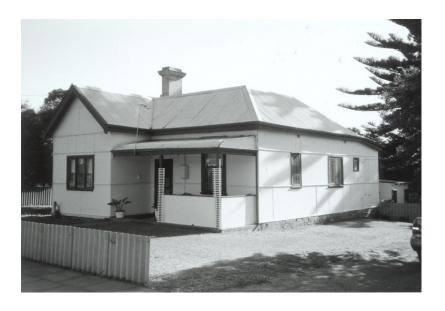
Photo Description: 24/10/1996

Suba & Grundy
Bullnosed verandah and corbelled brick chimney.
