Area: Geraldton	Place Number: 113	Category: 3
Assessment Date: 24/10/1996	Last Revision Date: 28/10/2009	
HCWA Number: 13364	Asset ID: MCH126594

Name:	House
Other Names:	166 Durlacher Street
Type of Place:	House
Address:	166 Durlacher Street
Suburb:	Geraldton

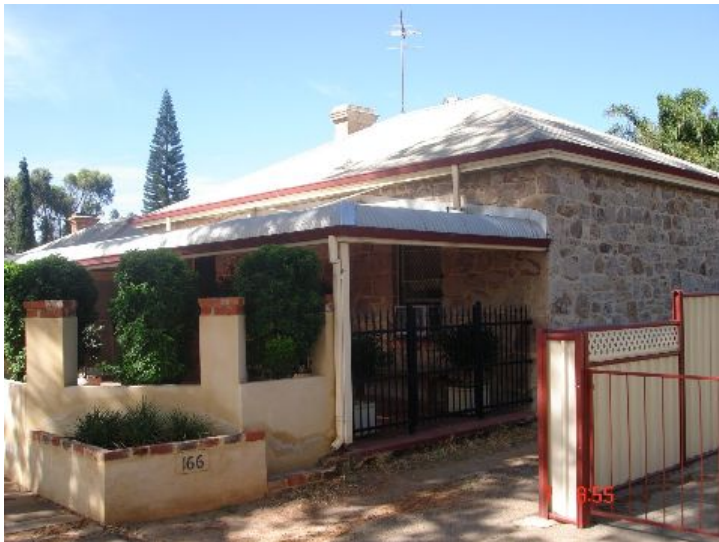
Extra wide bullnose verandah added to front facade.

This stone house has a corrugated iron hipped roof with a rendered corbelled chimney to the south west. The stone work to the front of the building is finely pointed with red brick arches above the central entry door and windows. The windows are double hung and timber framed with rendered window ledges. Random rubble stonework is used to the sides with rendering to the window openings. A wide bullnose verandah has been added to the front facade while a rendered masonry wall with piers marks the property frontage.

Management Category: 3
Level of Significance: MODERATE SIGNIFICANCE: Important to the heritage of the locality.
Management Recommendation: Conservation of the place is recommended. Any proposed change to the place should not unduly impact on the heritage values of the place and should retain significant fabric wherever feasible.

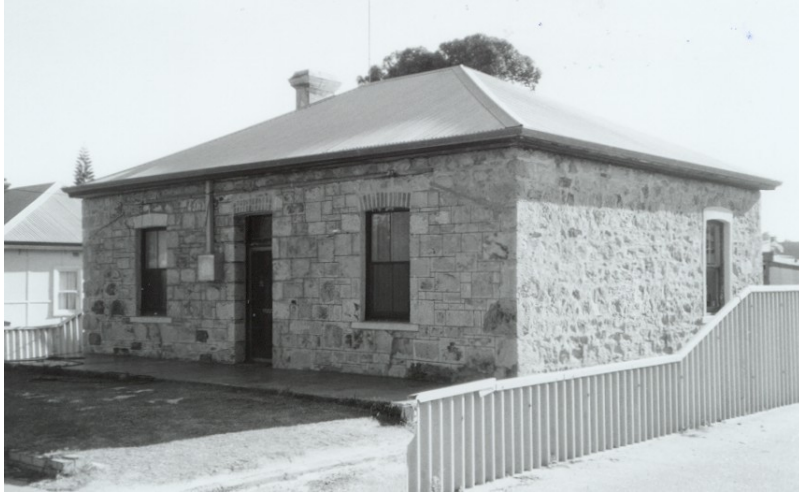
Simple stone house prior to reinstatement of verandah.
