# City of Greater Geraldton Municipal Inventory of Heritage Places Place Record

Area:	Geraldton	Place Numb	ber:	118	Catego	ory:	3
Assess	ment Date:	24/10/1996	Last Re	evision [	Date:	30/10	0/2009
HCWA	Number:	13369	Asset	ID:		MCH	1126610

Name:	House
Other Names:	222 Durlacher Street
Type of Place:	House
Address:	222 Durlacher Street
Suburb:	Geraldton

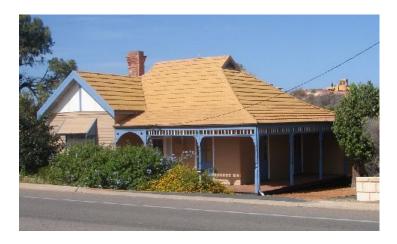
Photo Description: 7/01/2008 Rod Milne Decorative verandah frieze and corbelled chimney.

Walls:	Weatherboard	Roof:	Aluminium Tile
Condition:	Good	Integrity:	
Original fabric: Modifications:	: Original roof shee	ting replaced

This is a timber framed and weatherboard clad house with an aluminium tiled gambrel roof with a separate gable roof to the front elevation. The main roof extends to cover the verandahs to the north and north east. The verandah is supported on turned timber verandah posts with a decorative timber frieze. There is a lean to roof to the rear and awnings to windows. A corbelled brick chimney punctuates the roof to the south.

Management Category:	3
Level of Significance:	MODERATE SIGNIFICANCE: Important to the heritage of the locality.
Management Recommendation:	Conservation of the place is recommended. Any proposed change to the place should not unduly impact on the heritage values of the place and should retain significant fabric wherever feasible.

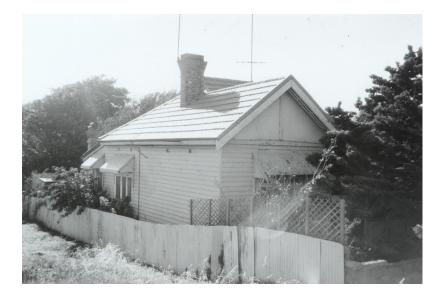
#### Photo Description: 24/10/1996 Suba & Grundy House partly hidden by vegetation.
