# City of Greater Geraldton Municipal Inventory of Heritage Places Place Record

Name: Warehouse

Other Names: 26 Durlacher Street (rear of)

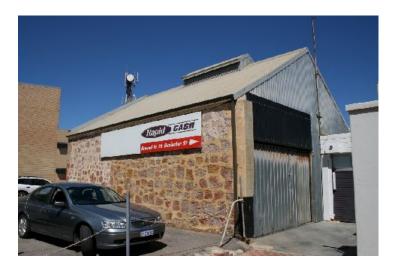
Original stone walls of the warehouse.

This building is a medium sized rectangular stone warehouse with a corrugated iron gable roof. The top of the roof features a small gabled skylight. The wall to the north end of the building has been replaced with corrugated iron. The gable end to the south has a large timber slatted vent with red brick quoining. The building is constructed in random rubble style with some evidence of coursing to the gable end and semi formal stone quoining to the corners of the structure.

**Management** Conservation of the place is highly

**Recommendation:** recommended. Any proposed change should

not unduly impact on the heritage values of the

place and should retain significant fabric

wherever feasible.

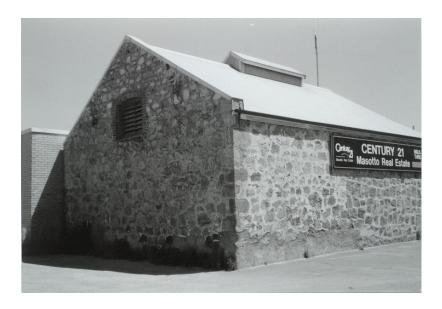
Photo Description: 8/12/1996 Suba & Grundy Steeply pitched gable roof.
