# City of Greater Geraldton Municipal Inventory of Heritage Places Place Record

Name: Other Names:	House 76 Gregory Street
Type of Place:	House
Address:	76 Gregory Street
Suburb:	Beachlands

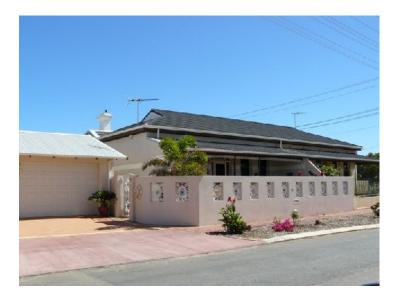
Photo Description: 13/04/2008 Tanya Henkel New front fence and garage.

DESCRIPTION				
Walls: Condition:	Brick Good	Roof: Integrity:	Aluminium Tile	
Original fabric:				
Modifications:	New Garage and	front fence

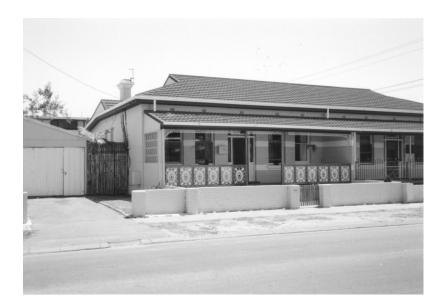
This is one of two semi detached brick houses. This house has an aluminium tiled gambrel roof with a lean-to roof to the rear (west) and a separate verandah roof with a metal lace frieze below. The verandah is supported on timber posts. To the front facade, the painted brick has a rendered masonry band to half window height. Twin windows are set each side of the central doorway. Windows are timber framed and double hung. A brick wall to the north separates the two verandahs while to the south end there is brick and breeze block infill. There is a new garage to the south and a rendered masonry fence with metal lacework infills to the property frontage. (See also 74 Gregory Street).

Photo Description: 14/10/1996 Suba & Grundy View from Gregory Street.
