## City of Greater Geraldton Municipal Inventory of Heritage Places Place Record

Name: Other Names:	House 107 Shenton Street
Type of Place:	House
Address:	107 Shenton Street
Suburb:	Geraldton

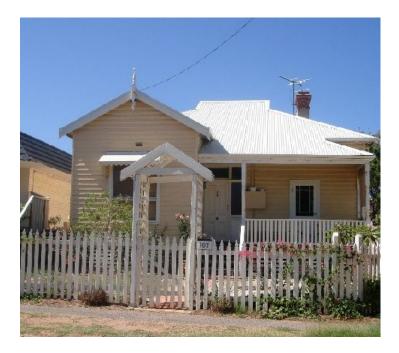
Photo Description: 1/02/2008 Rod Milne Front facade from the street.

Walls: Condition: Original fabric Modifications:		Roof: Integrity:	Corrugated Iron	
This timber framed weatherboard clad house has a gambrel corrugated iron roof which is punctuated by a brick and partially rendered corbelled chimney to the west. To the street elevation, the main roof extends to cover a verandah which is hipped to the west while a separate gable roof covers the main room. The verandah is supported on turned timber posts

with a timber balustrade. The verandah is accessed via four timber steps which have timber handrails. The apex of the gable end of the main room has a small finial and pendant and the window below has a curved metal awning. Windows to the side are timber framed and double hung while the window to the main room has been replaced with an aluminium framed window.

Management Category:	3
Level of Significance:	MODERATE SIGNIFICANCE: Important to the heritage of the locality.
Management Recommendation:	Conservation of the place is recommended. Any proposed change to the place should not unduly impact on the heritage values of the place and should retain significant fabric wherever feasible.

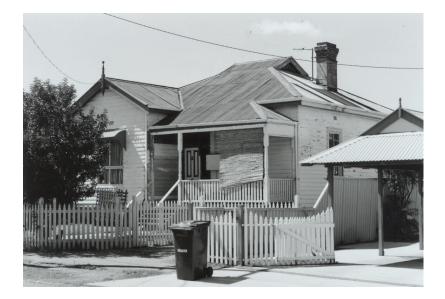
#### **Photo Description:** 24/10/1996 Suba & Grundy

Hipped verandah an extension of the main roof.
