City of Greater Geraldton Municipal Inventory of Heritage Places Place Record

Area: Greenough Place Number: 134 Category: 2

Name: Island Farm

Type of Place: Farmhouse

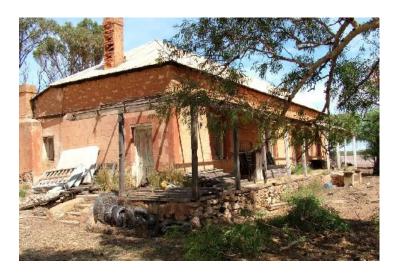
Daemeon and Martin
north and west facades of house

Island Farmhouse is situated on a property which is surrounded on three sides by the Greenough River, hence the feeling of being on an island. The large stone house has a steeply pitched hipped corrugated iron roof. A separate verandah roof is supported on chamfered timber posts. The house, which features brick quoining to openings and corners, has timber framed double hung windows. Below the verandah the walls are rendered with an ashlar finish. Steps lead up to the verandah and the front entrance to the west. There is a lean-to roof to the rear. Adjoining the north-east corner of the house is a kitchen building constructed of stone with a corrugated iron gable roof.

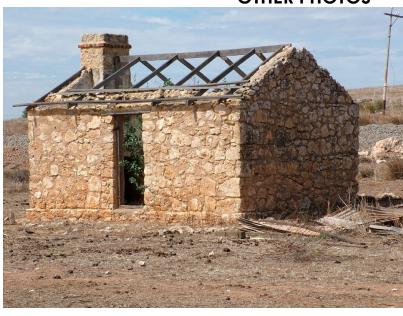
Located immediately to the north-east of the house is the Shepherd's Cottage, a small stone building which had a corrugated iron gable roof elevation.

2004/5 Review: A section of the east wall of the former kitchen has collapsed. Cracks in the limestone walls of the Shepherd's Cottage have been repaired, but the building still remains unroofed. Some minor restoration works were carried out to the Shepherd's Cottage as part of a stonemasonry workshop conducted by MidWest Heritage Inc in 1998. The south east corner of the stone outbuilding has collapsed and the structure is now without a roof.

29/03/2005 Daemeon & Martin view of Shepherd's Cottage

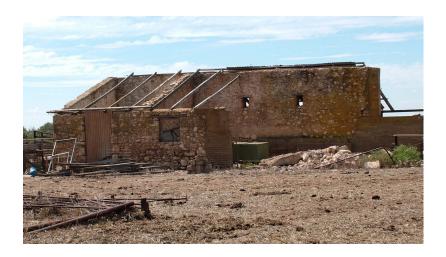
Nearby is a stone outbuilding with a hipped and gable corrugated iron roof which is in poor condition. There is evidence of some concrete repairs to the walls.

Photo Description: 29/03/2005 Daemeon & Martin view of barn from the south
