Area: Geraldton	Place Number: 100	Category: 3
Assessment Date: 25/10/1996	Last Revision Date: 28/10/2009	
HCWA Number: 13353	Asset ID: MCH126550

Name:	House
Other Names:	12 Du Boulay Street
Type of Place:	House
Address:	12 Du Boulay Street
Suburb:	West End

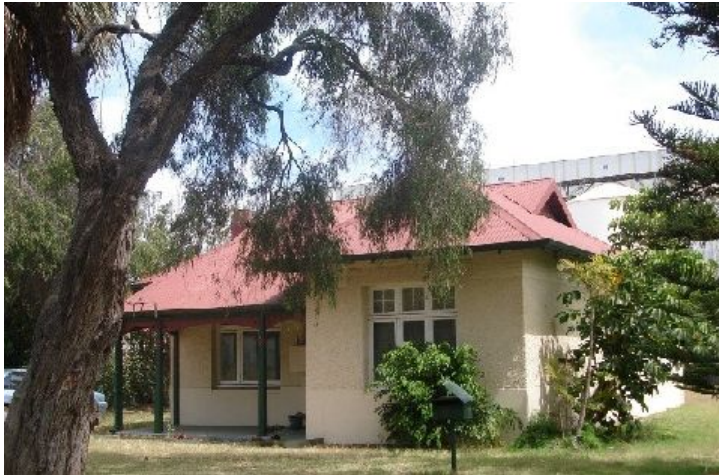
View of house from Du Boulay Street.

Walls:	Brick (Rendered)	Roof:	Corrugated Iron
Condition:	Fair	Integrity:	
Original fabric:	Two chimneys		
Modifications:	Fibro clad lean-to

This stucco rendered brick house has a corrugated iron gambrel roof with a separate dutch gable to the main room. The roof extends to cover the front verandah which is supported on timber posts which have decorative banding and an arched decorative timber frieze between them. Windows are casement style with a transom above each. There is a rendered brick chimney to the west elevation.

Management Recommendation: Conservation of the place is recommended. Any proposed change to the place should not unduly impact on the heritage values of the place and should retain significant fabric wherever feasible.

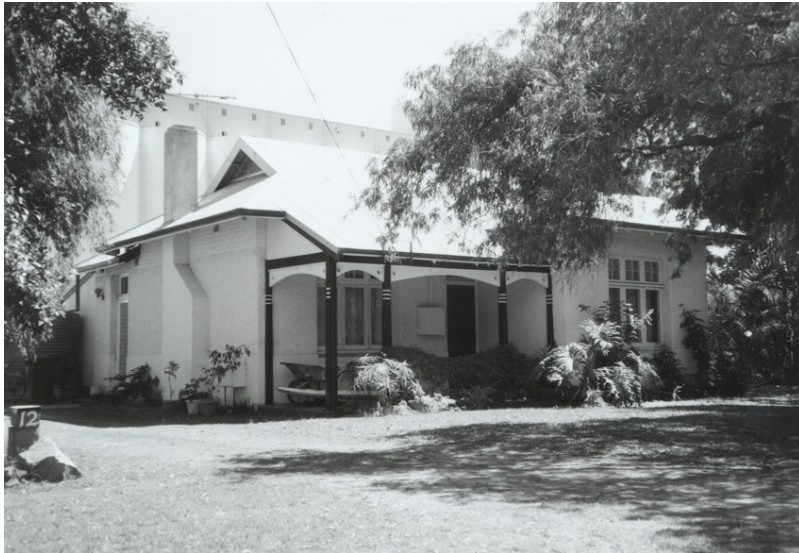
Front facade showing decorative verandah detailing.
