Area: Geraldton	Place Number: 107	Category: 2
Assessment Date: 29/10/1996	Last Revision Date: 28/10/2009	
HCWA Number: 1059	Asset ID: MCH126572

Name:	Salvation Army Barracks
Other Names:	Druid's Hall
Type of Place:	Offices
Address:	65 Durlacher Street, cnr Sanford Street
Suburb:	Geraldton

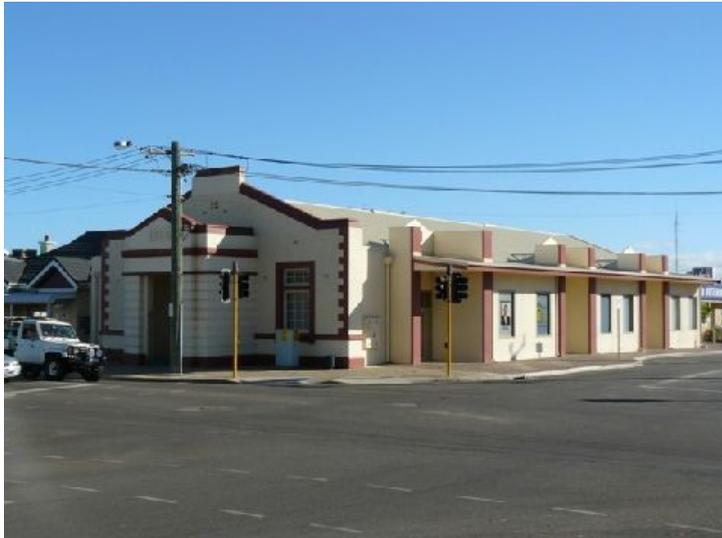
Original facade retained in redevelopment of site.

Present: The front facade facing Durlacher Street and the entry porch are all that remain of the hall which was largely demolished for redevelopment purposes. The new adjoining building is of concrete tilt up panel construction with a zincalume roof and features buttressing details with triangular pediments to the Sanford Street frontage to differentiate between the different office accommodation.

Management Category:	2
Level of Significance:	CONSIDERABLE SIGNIFICANCE: Very important to the heritage of the locality.
Management Recommendation:	Conservation of the place is highly recommended. Any proposed change should not unduly impact on the heritage values of the place and should retain significant fabric wherever feasible.

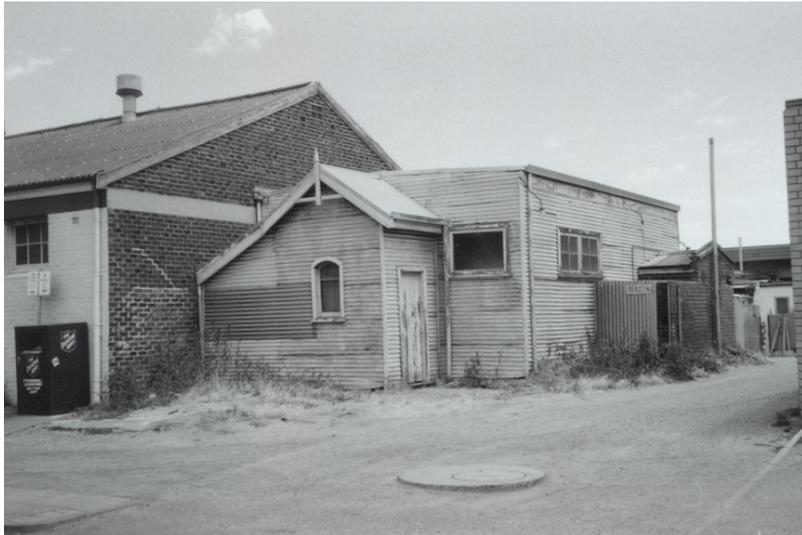
Original CGI clad Druid's Hall to rear.

The corrugated iron section to the rear was the original Druid's Lodge. The building was also used for dances and was used as Doreen Dawson's Dance Studio for many years. The main section was built in 1934. (Sources: GLLSVF & Shirley Scotter).

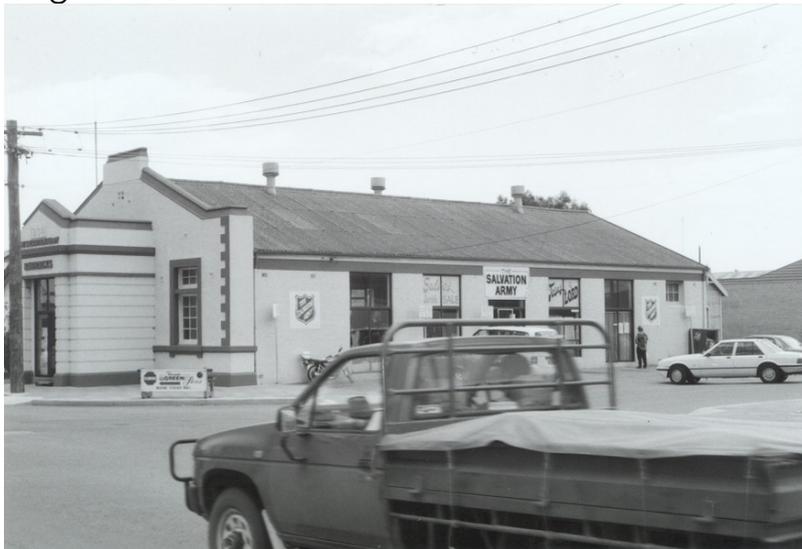
The Hall prior to demolition.
