Area: Geraldton	Place Number: 137	Category: 3
Assessment Date: 15/10/1996	Last Revision Date: 03/11/2009	
HCWA Number: 13387	Asset ID: MCH127075

Name:	Residence
Other Names:	72-74 Fitzgerald Street
Type of Place:	Residence
Address:	72-74 Fitzgerald Street
Suburb:	Geraldton

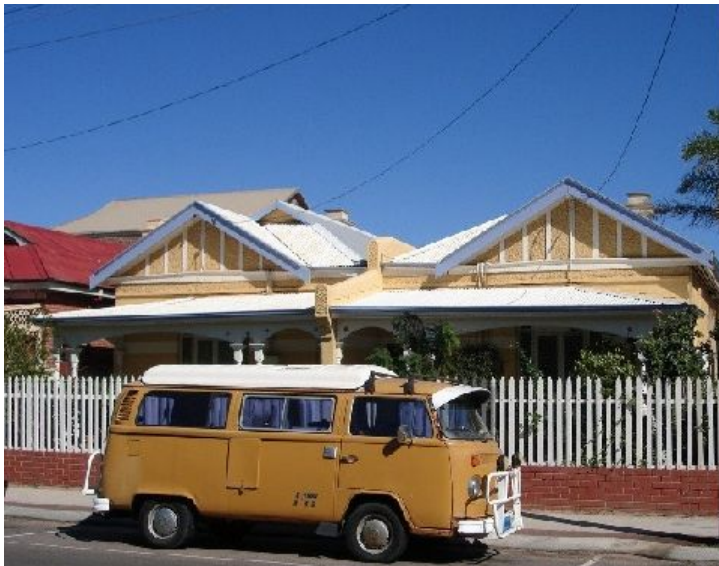
Photo Description:
10/08/2007
Rod Milne
Two semidetached houses.

This property has two identical semi detached buildings. Each painted brick building is separated by a parapet wall and has a gambrel corrugated iron roof to the rear with a separate gable to the front. The gable end has roughcast and timber infill. Below the gable a separate verandah roof joins to the central parapet wall at the centre and is hipped at each end. The verandah is supported on turned double half timber posts on brick columns. The verandah has a decorative timber arched frieze. Entry doors are situated each side of the dividing parapet wall and there is a french door with glassed surround to the verandah.

Management Category: 3
Level of Significance: MODERATE SIGNIFICANCE: Important to the heritage of the locality.
Management Recommendation: Conservation of the place is recommended. Any proposed change to the place should not unduly impact on the heritage values of the place and should retain significant fabric wherever feasible.

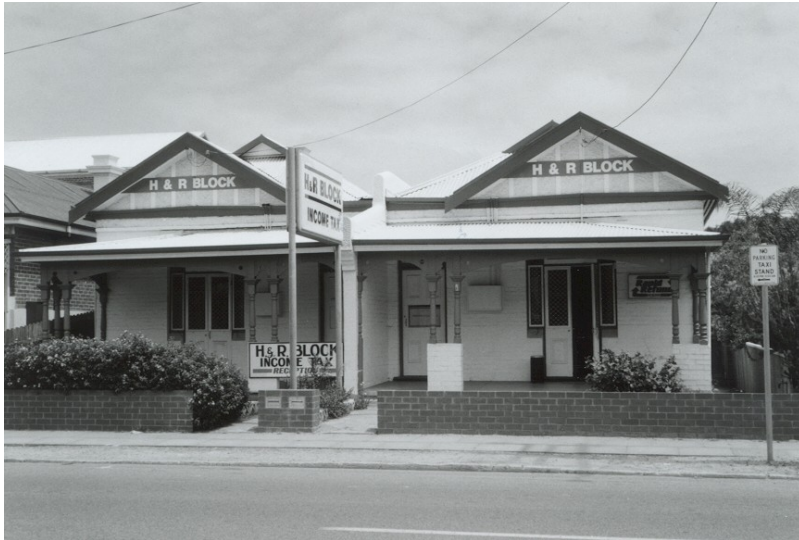
Photo Description:
15/10/1996
Suba & Grundy
Previously used as offices.
