Area: Geraldton	Place Number: 142	Category: 3
Assessment Date: 15/10/1996	Last Revision Date: 03/11/2009	
HCWA Number: 13392	Asset ID: MCH127109

Name:	House
Other Names:	87 Fitzgerald Street
Type of Place:	House
Address:	87 Fitzgerald Street
Suburb:	Geraldton

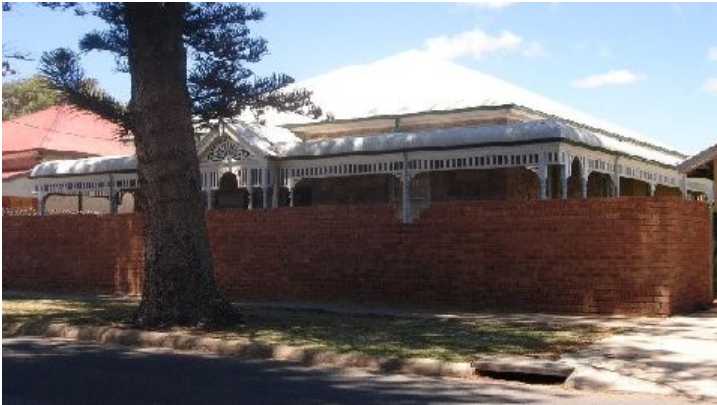
Front facade concealed by a high wall.

Walls:	Stone	Roof:	Corrugated Iron
Condition:	Good	Integrity:	
Original fabric:	Highly intact		
Modifications:	Tall brick wall to street frontage

This stone house has a hipped steeply pitched corrugated iron roof with a separate bullnose verandah roof to the front which is supported on turned timber posts. The stone work to the front is pointed. Windows are timber framed and double hung. The front boundary of the property is separated from the street by a high brick wall.

Management Category: 3
Level of Significance: MODERATE SIGNIFICANCE: Important to the heritage of the locality.
Management Recommendation: Conservation of the place is recommended. Any proposed change to the place should not unduly impact on the heritage values of the place and should retain significant fabric wherever feasible.

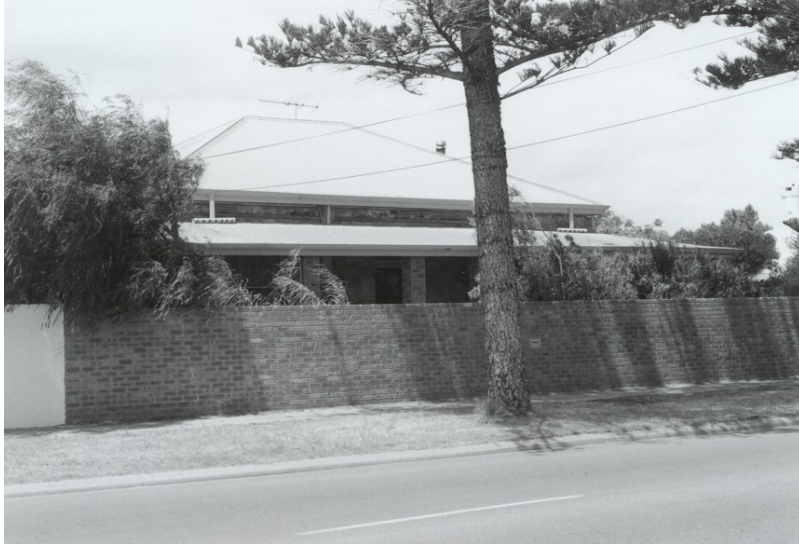
Note former verandah form and brick piers.
