Area: Geraldton	Place Number: 162	Category: 3
Assessment Date: 15/10/1996	Last Revision Date: 18/11/2009	
HCWA Number: 13261	Asset ID: MCH127029

Name:	House
Other Names:	152 Fitzgerald Street
Type of Place:	House
Address:	152 Fitzgerald Street
Suburb:	Beachlands

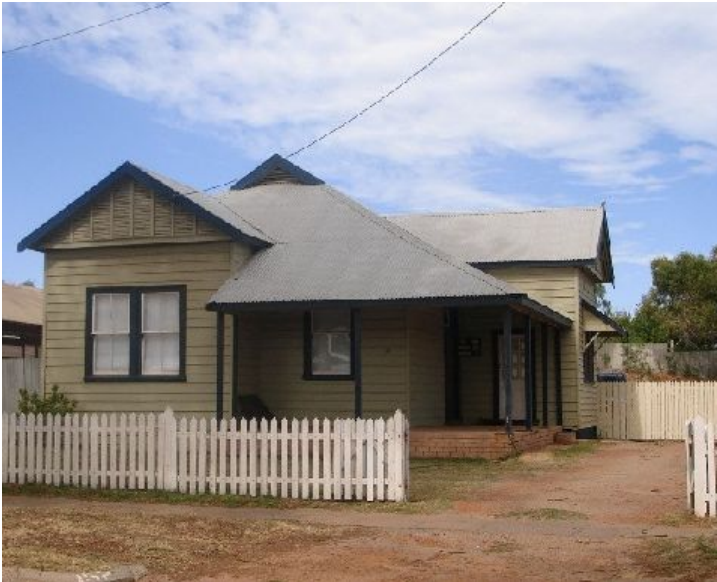
Picket fence to street frontage.

Walls:	Weatherboard	Roof:	Corrugated Iron
Condition:	Good	Integrity:	
Original fabric:			
Modifications:

This timber framed weatherboard clad house has a gambrel roof with two separate gable roofs to the east and north. The gable ends are enclosed with lath and timber batten. Between the gables the main roof extends to cover verandahs which are supported on timber posts. The window to the north gable has a corrugated iron awning. Windows are timber framed and double hung. There is a lean-to roof to the rear. A timber picket fence forms the property frontage.

Management Category:	3
Level of Significance:	MODERATE SIGNIFICANCE: Important to the heritage of the locality.
Management Recommendation:	Conservation of the place is recommended. Any proposed change to the place should not unduly impact on the heritage values of the place and should retain significant fabric wherever feasible.

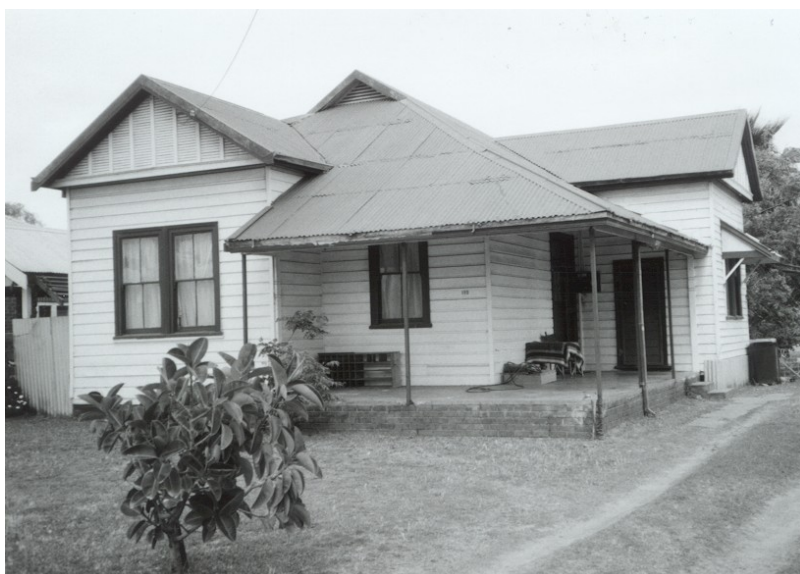
Metal verandah poles since replaced.
