Area: Geraldton	Place Number: 177	Category: 2
Assessment Date: 14/10/1996	Last Revision Date: 19/11/2009	
HCWA Number: 13274	Asset ID: MCH126845

Name:	House
Other Names:	16 Francis Street
Type of Place:	House
Address:	16 Francis Street
Suburb:	Geraldton

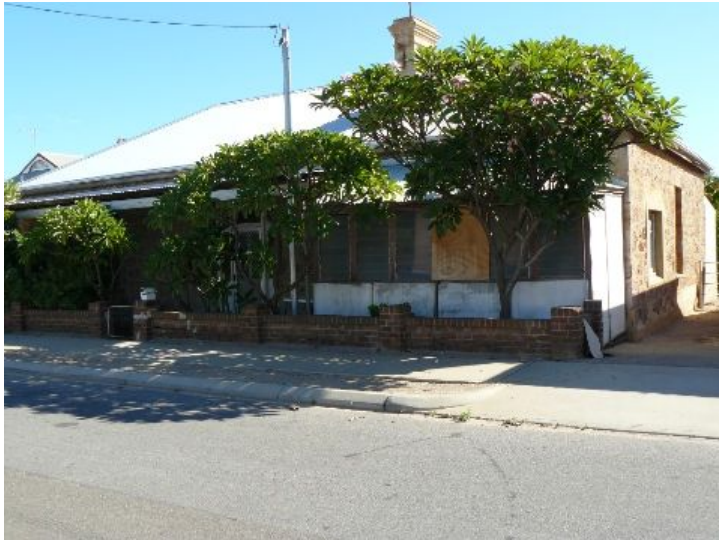
6/04/2009

Large stone house fronting onto Francis Street.

Set close to the street boundary, this large stone house has a hipped corrugated iron roof punctuated by a rendered masonry corbelled chimney to the north east. The separate verandah roof to the front facade is hipped, with a section enclosed with fibro and louvre windows. To the south east the verandah has been remodeled to a shallower pitch and is supported on metal posts. The stone work to the front facade is coursed and pointed with random rubble to the sides. The openings of the windows to the south side have been rendered.

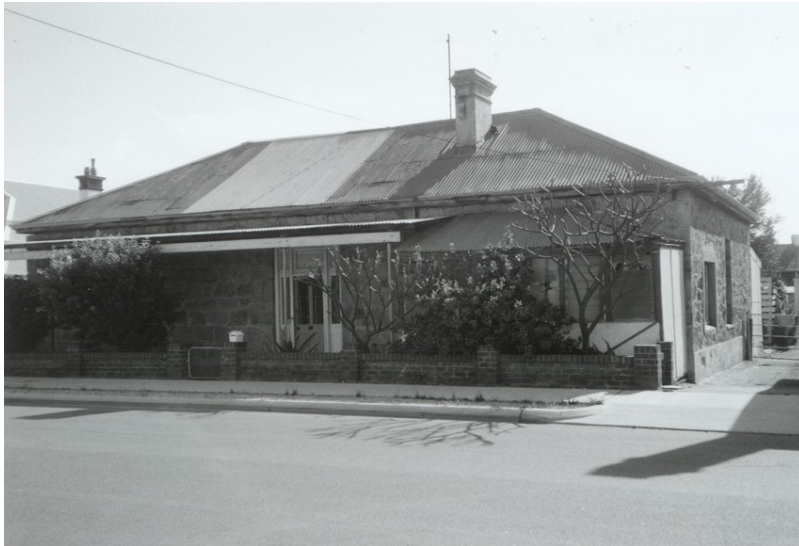
14/10/1996

Corbelled chimney a feature of the roofscape.
