<b>Area:</b> Geraldton	<b>Place Number:</b> 18	<b>Category:</b> 4
<b>Assessment Date:</b> 15/10/1996	<b>Last Revision Date:</b> 08/07/2009	
<b>HCWA Number:</b> 13210	<b>Asset ID:</b> MCH126938

<b>Name:</b>	House
<b>Other Names:</b>	191 Augustus Street
<b>Type of Place:</b>	House
<b>Address:</b>	191 Augustus Street
<b>Suburb:</b>	Beachlands

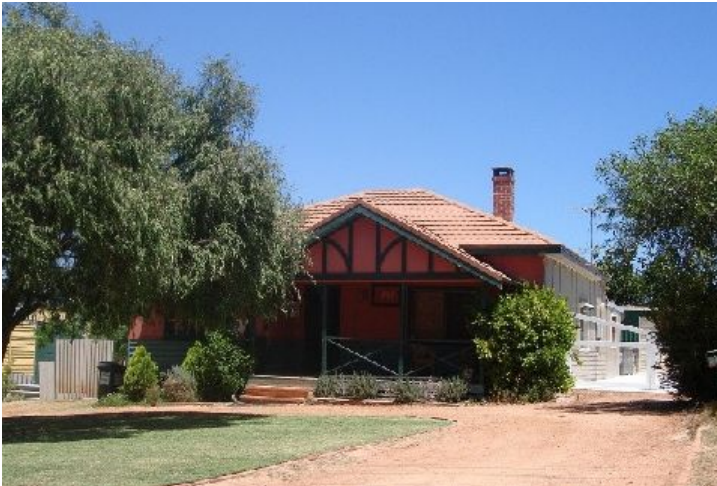
The front (north) elevation of the house.

This house has a hipped aluminium tiled roof with additional gable roofs to the front verandah and main room to the north east. The building is clad with weatherboards to window sill height with fibro above. There is a fibro clad lean-to to the rear. The front verandah is supported on timber posts. The gable ends have decorative vertical timber work and there is a corrugated iron awning to the window below the gable end of the main room. A brick chimney is situated to the south west. The windows are eight pane casement style.

<b>Walls:</b>	Weatherboard/Fibro	<b>Roof:</b>	Aluminium Tile
<b>Condition:</b>	Good	<b>Integrity:</b>	
<b>Original fabric:</b>			
<b>Modifications:</b>	Aluminium tile sheeting laid over original corrugated iron

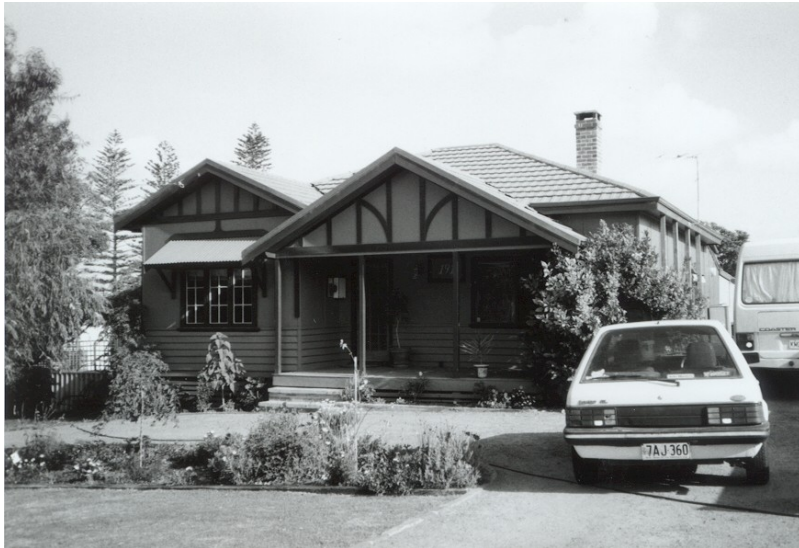
View of the house from Augustus Street.
