Area: Geraldton	Place Number: 43	Category: 4
Assessment Date: 08/12/1996	Last Revision Date: 29/09/2009	
HCWA Number: 13233	Asset ID: MCH126681

Name:	Murchison Tavern
Other Names:	20 Chapman Road
Type of Place:	Hotel
Address:	20 Chapman Road
Suburb:	Geraldton

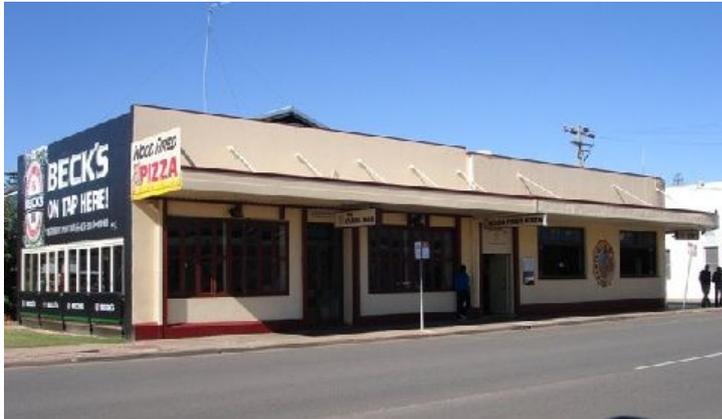
Building has been considerably altered over time.

Walls:	Stone/Brick	Roof:	Corrugated Iron/ Asbestos
Condition:	Good	Integrity:	
Original fabric:	Some stone walling		
Modifications:	Numerous changes

Set on a corner location this rendered masonry building has a complex roof structure. A skillion roof is situated behind the low parapet to the street facade to the south with a gabled and hipped roof to the north. The northern (possibly original) section of the building is constructed of rendered stone with double hung windows to the rear and added brick buttresses and aluminium windows to the front. A box awning runs around the street facades. The northern wall was altered to accommodate timber bi-fold doors during restaurant renovations in c1996.

Management Category:	4
Level of Significance:	SOME SIGNIFICANCE: Contributes to the heritage and/or historical development of the locality.
Management Recommendation:	Conservation of the place is desirable. Any proposed change to the place should be in sympathy with the heritage values of the place.

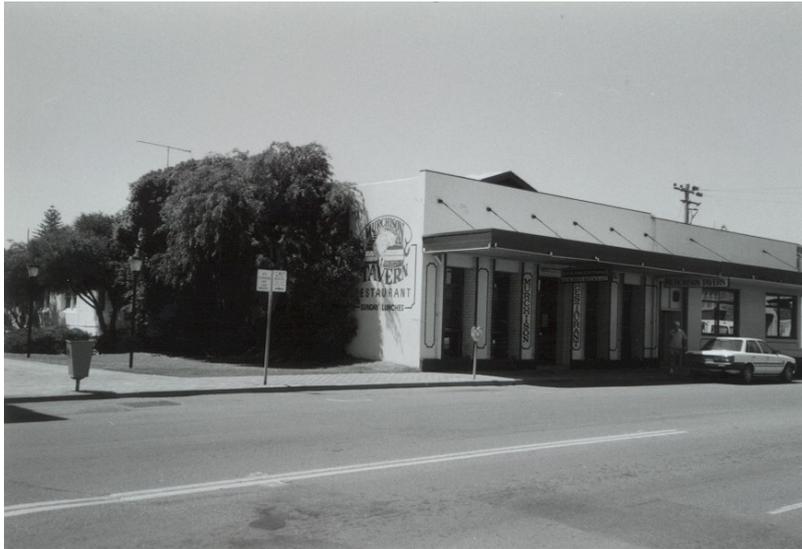
Building fronts directly onto Chapman Road.
