Area: Geraldton	Place Number: 61	Category: 3
Assessment Date: 05/12/1996	Last Revision Date: 06/10/2009	
HCWA Number: 13245	Asset ID: MCH126793

Name:	House
Other Names:	212 Chapman Road
Type of Place:	House
Address:	212 Chapman Road
Suburb:	Beresford

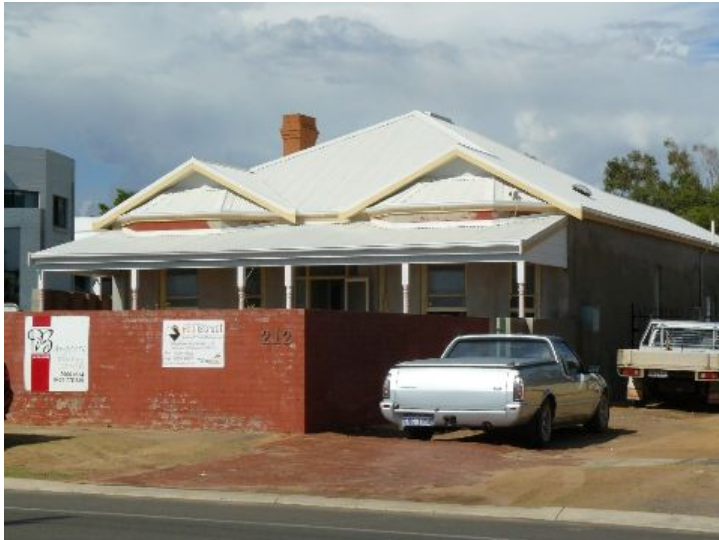
22/03/2010

View of house following renovations.

Walls:	Brick	Roof:	Colorbond
Condition:	Good	Integrity:	
Original fabric:			
Modifications:

This painted brick house has a steeply pitched colorbond hipped roof with two feature gables to the front elevation and a separate verandah roof. Twin bay windows are placed each side of the central entry door. Windows are timber framed and double hung. There is a corbelled brick chimney to the north east corner. Views to the house are partly obscured by a tall brick wall to the lot frontage.

Management Category: 3
Level of Significance: MODERATE SIGNIFICANCE: Important to the heritage of the locality.
Management Recommendation: Conservation of the place is recommended. Any proposed change to the place should not unduly impact on the heritage values of the place and should retain significant fabric wherever feasible.

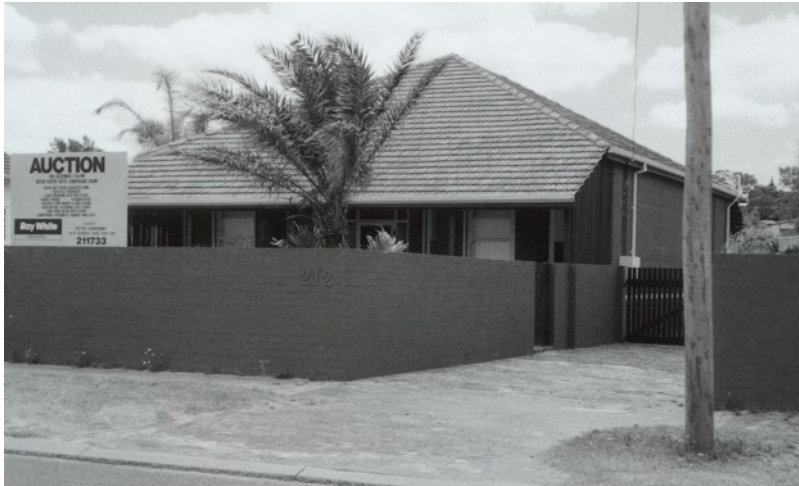
5/12/1996

View of house prior to roof modifications.
