<b>Area:</b> Geraldton	<b>Place Number:</b> 207	<b>Category:</b> 3
<b>Assessment Date:</b> 14/10/1996	<b>Last Revision Date:</b> 24/11/2009	
<b>HCWA Number:</b> 13304	<b>Asset ID:</b> MCH126674

<b>Name:</b>	House
<b>Other Names:</b>	5 Grant Street
<b>Type of Place:</b>	House
<b>Address:</b>	5 Grant Street
<b>Suburb:</b>	Beachlands

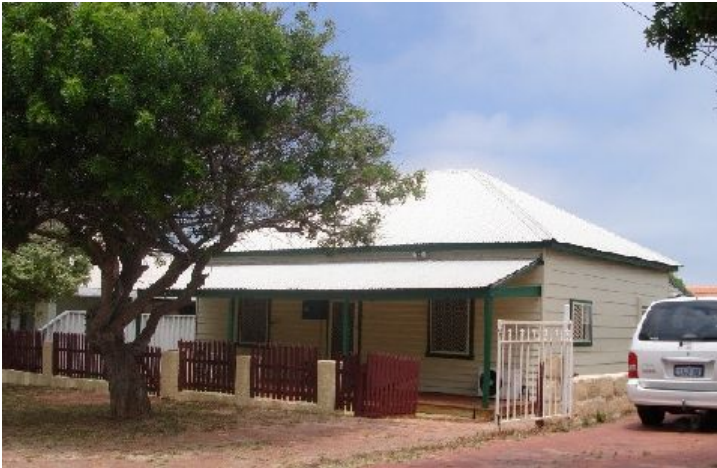
Front facade from street.

<b>Walls:</b>	W'board/Hardiplank	<b>Roof:</b>	Corrugated Iron
<b>Condition:</b>	Good	<b>Integrity:</b>	
<b>Original fabric:</b>			
<b>Modifications:</b>	Side wall reclad

This timber framed house has a hipped corrugated iron roof with a separate verandah roof to the front facade which is supported on timber posts. The front facade has weatherboard cladding, the sides have been reclad with fibro weatherboard and there is a weatherboard clad lean-to to the rear. Windows are double hung and timber framed to the front and aluminium framed to the side. There is a brick chimney to the rear. A masonry pier fence with timber picket infill forms the front boundary.

**Management Category:** 3  
**Level of Significance:** MODERATE SIGNIFICANCE: Important to the heritage of the locality.  
**Management Recommendation:** Conservation of the place is recommended. Any proposed change to the place should not unduly impact on the heritage values of the place and should retain significant fabric wherever feasible.

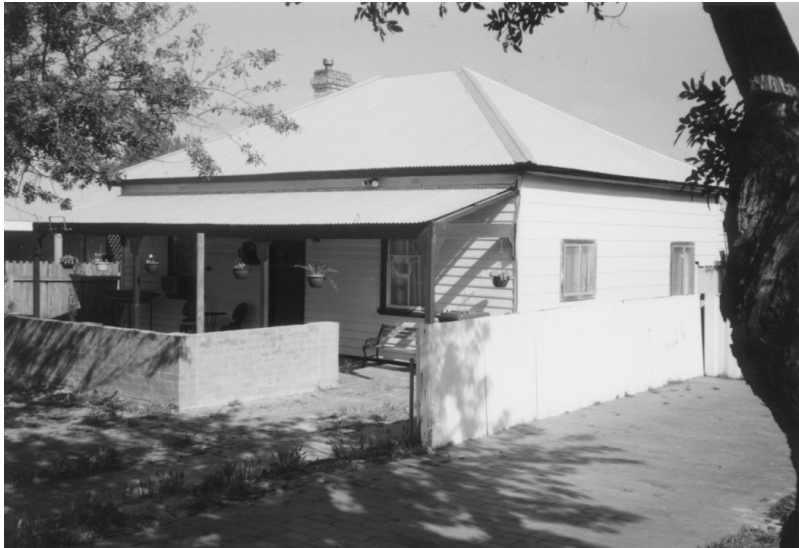
Low front wall since replaced.
