Area: Geraldton	Place Number: 219	Category: 2
Assessment Date: 14/10/1996	Last Revision Date: 25/11/2009	
HCWA Number: 13314	Asset ID: MCH126725

Name:	House
Other Names:	Meadowcroft's House
Type of Place:	House
Address:	62 Gregory Street
Suburb:	Geraldton

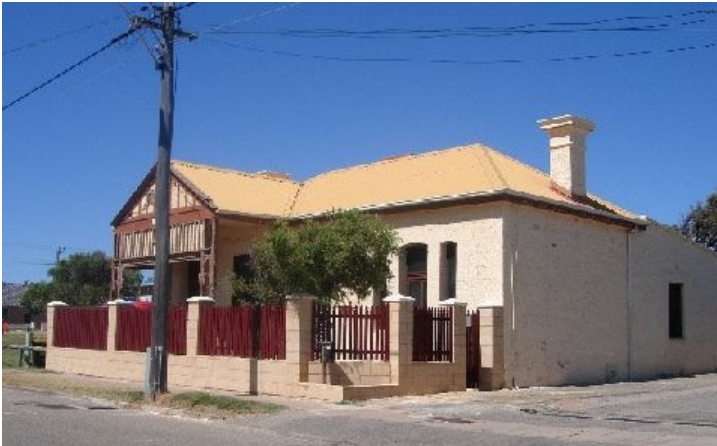
7/12/2007

New fence to property frontage.

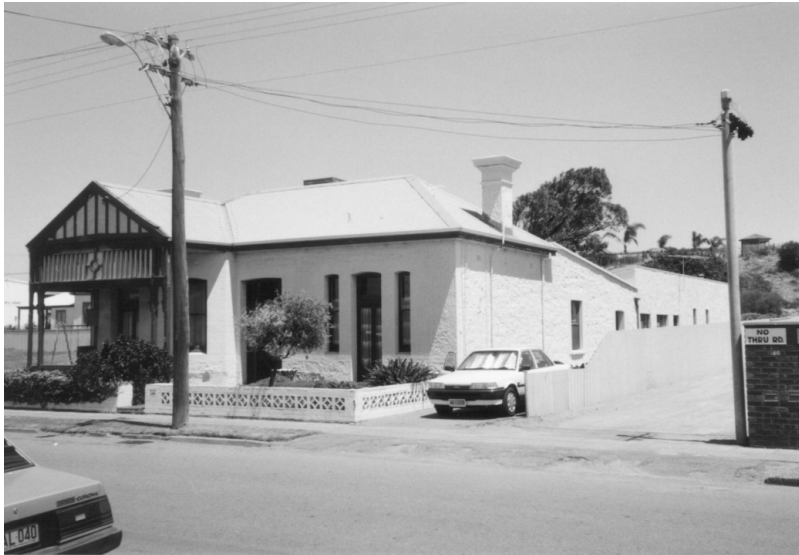
14/10/1996

This stone building has a hipped corrugated iron roof with a separate gable extending beyond a bay to the main room (south east) to form a verandah. To the rear the main roof has a skillion roof running to the west beyond which is a large extension with a skillion roof running to the south. The gable end has roughcast finish with timber batten, below which is a fibro and timber frieze. The gable is supported on chamfered timber posts. The stonework is painted with ashlar finish to the building frontage. The bay has three windows, while to the north east, tall french doors have narrow tall windows to each side. Windows to the house are timber framed and double hung. To the north and south of the main roof there are two painted stone chimneys with large corbelling to the top and a label mould below.

Front facade showing decorative gable treatment.
