Area: Geraldton	Place Number: 227	Category: 3
Assessment Date: 14/10/1996	Last Revision Date: 25/11/2009	
HCWA Number: 13322	Asset ID: MCH127034

Name:	House
Other Names:	82 Gregory Street
Type of Place:	House
Address:	82 Gregory Street
Suburb:	Beachlands

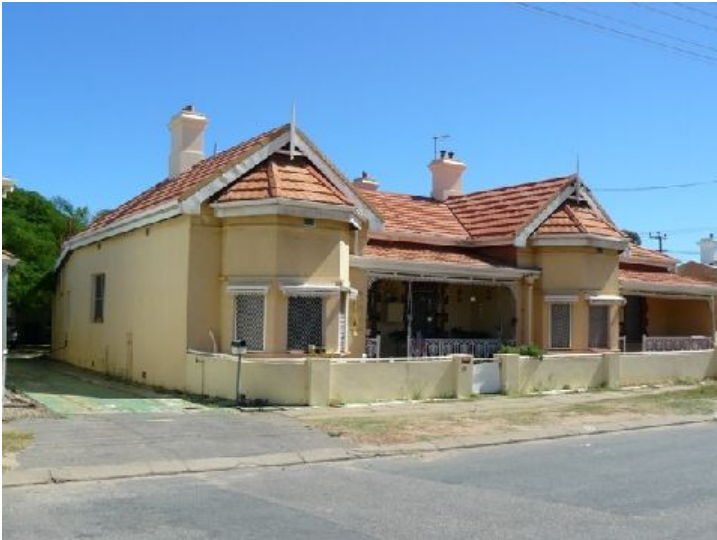
13/04/2008
Tanya Henkel
Feature bay window.

Walls:	Brick (Rendered)	Roof:	Aluminium Tile
Condition:	Good	Integrity:	
Original fabric:			
Modifications:

This is one of a pair of semi detached rendered brick houses with an aluminium tiled roof. The roof is hipped to the north end with a separate gable to the front which has a small finial and pendant. The gable end contains a small hipped roof to a bay. To the north east of the bay a separate verandah has a decorative lacework frieze and balustrade. The openings to the front facade under the verandah are quoined with red tuckpointed brickwork. Windows to the bay are aluminium framed with small awnings and aluminium security grilles. Rendered masonry chimneys to the south, west and northwest are tall and corbelled with terra cotta chimney pots. There is a fibro enclosed lean-to to the rear with a corrugated iron roof. A low rendered masonry wall forms the street boundary of the property.

Management Category:	3
Level of Significance:	MODERATE SIGNIFICANCE: Important to the heritage of the locality.
Management Recommendation:	Conservation of the place is recommended. Any proposed change to the place should not unduly impact on the heritage values of the place and should retain significant fabric wherever feasible.

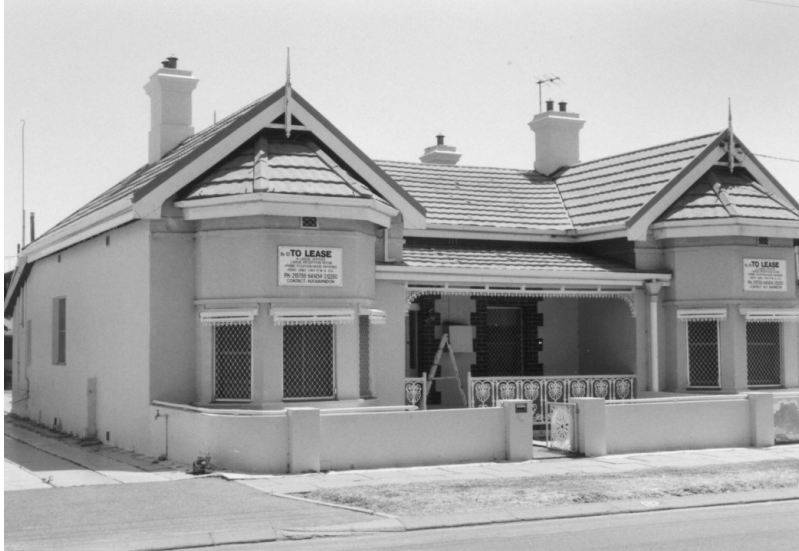
14/10/1996

Semi-detached house.
