Area: Geraldton	Place Number: 231	Category: 2
Assessment Date: 14/10/1996	Last Revision Date: 25/11/2009	
HCWA Number: 13326	Asset ID: MCH127043

Name:	House
Other Names:	90 Gregory Street
Type of Place:	House
Address:	90 Gregory Street
Suburb:	Beachlands

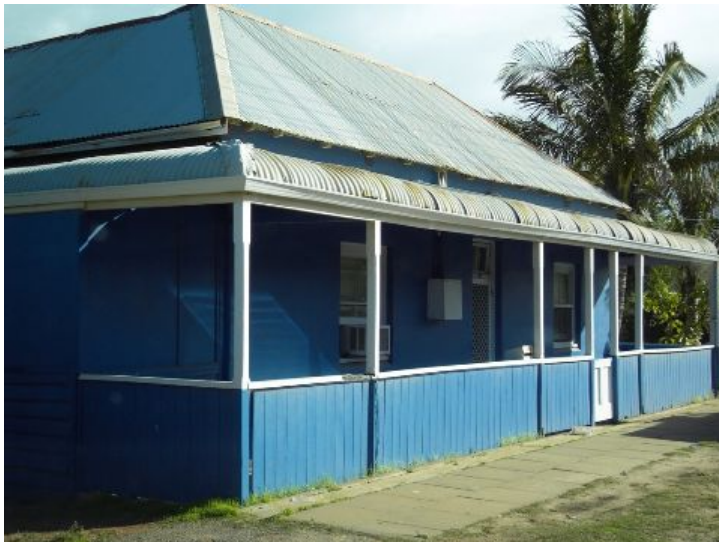
26/06/2009

Bull nose verandah to street facade.

This stone house is set close to the street with the verandah balustrade forming the street boundary. A steeply pitched corrugated iron roof has a gable roof to the south west which covers a timber framed fibro clad extension. A separate bull nose hipped verandah to the front (east) and south east is supported on chamfered timber posts with a plank balustrade with some fibro infill to the south east. There is a rendered brick chimney to the south east. Windows are timber framed and double hung. The house is painted blue.

Management Category: 2
Level of Significance: CONSIDERABLE SIGNIFICANCE: Very important to the heritage of the locality.
Management Recommendation: Conservation of the place is highly recommended. Any proposed change should not unduly impact on the heritage values of the place and should retain significant fabric wherever feasible.

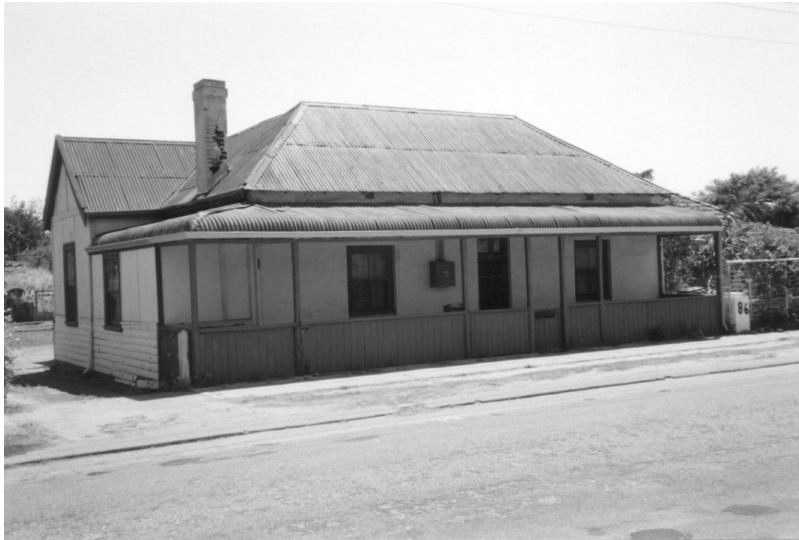
14/10/1996

House fronts directly onto footpath.
