Area: Geraldton	Place Number: 247	Category: 4
Assessment Date: 14/10/1996	Last Revision Date: 27/11/2009	
HCWA Number: 13417	Asset ID: MCH126587

Name:	House
Other Names:	132 Gregory Street
Type of Place:	House
Address:	132 Gregory Street
Suburb:	Beachlands

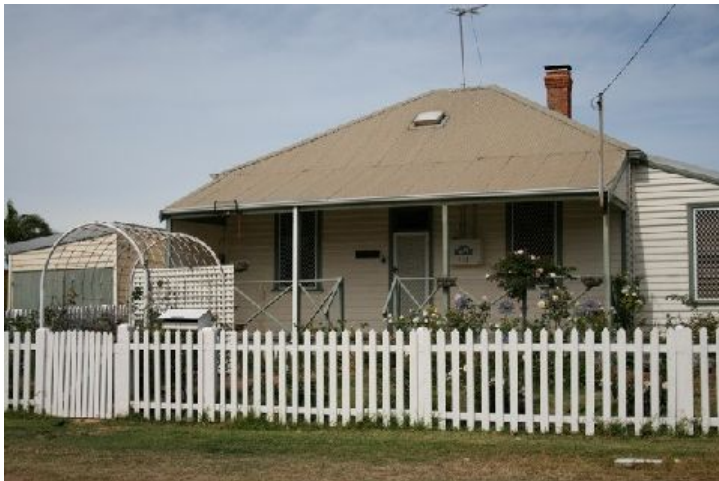
21/12/2007

Small weatherboard house.

Walls:	Weatherboard	Roof:	Corrugated Iron
Condition:	Good	Integrity:	
Original fabric:			
Modifications:	Much wall cladding replaced

This timber framed weatherboard clad house has a hipped corrugated iron roof which extends to cover the verandah to the front (east) elevation. The verandah is supported on chamfered timber posts and has a timber criss-cross balustrade. The windows are timber framed and double hung. There is an addition to the north facade. A brick chimney is sited to the rear of the main roof. The street boundary of the property has a Gothic picket fence.

Management Category:	4
Level of Significance:	SOME SIGNIFICANCE: Contributes to the heritage and/or historical development of the locality.
Management Recommendation:	Conservation of the place is desirable. Any proposed change to the place should be in sympathy with the heritage values of the place.

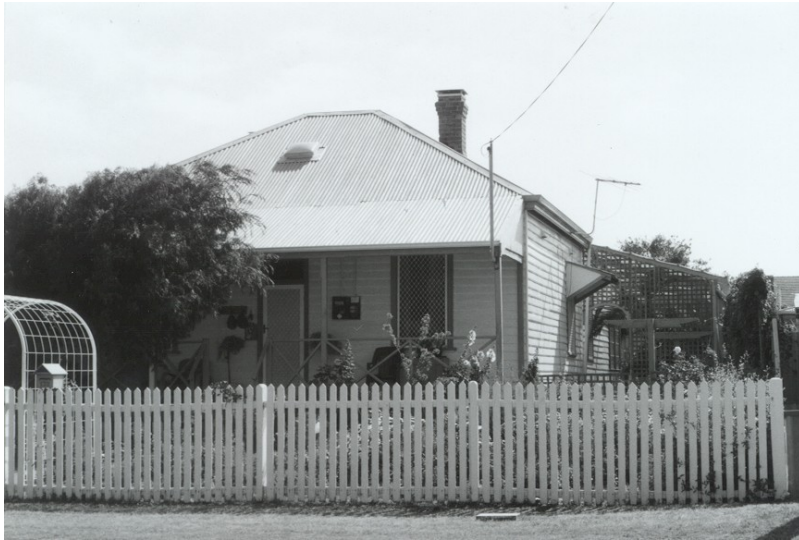
14/10/1996

Prior to side addition.
