Area: Geraldton	Place Number: 321	Category: 4
Assessment Date: 05/12/1996	Last Revision Date: 10/03/2010	
HCWA Number: 13715	Asset ID: MCH126689

Name:	House
Other Names:	381 Marine Terrace
Type of Place:	House
Address:	381 Marine Terrace
Suburb:	West End

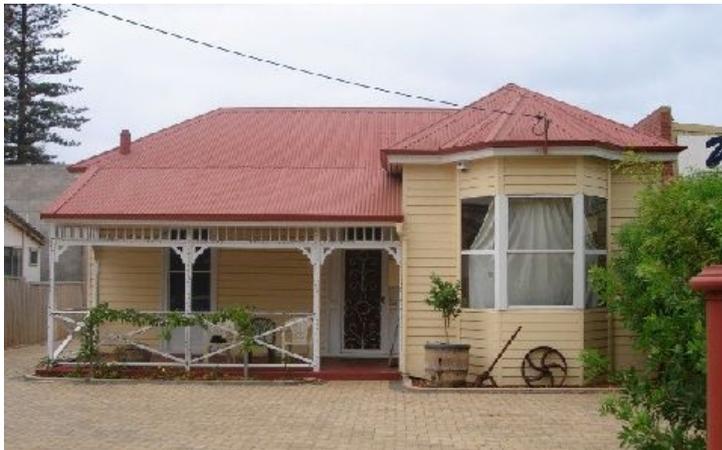
Photo Description:

18/01/2008
Rod Milne
Small weatherboard cottage.

Walls:	Weatherboard/Fibro	Roof:	Corrugated Iron
Condition:	Good	Integrity:	
Original fabric:			
Modifications:

This timber framed weatherboard clad house has a hipped corrugated iron roof with a skillion roof to the rear and a lean-to roof to a fibro clad extension beyond. To the front elevation a separate hipped roof covers the main room which has a multi hipped roof to a bay. The cladding to the bay is fibro weatherboard. The main roof extends to cover the front verandah which is supported on chamfered timber posts with brackets to a small frieze with balusters. The verandah has a criss-cross balustrade. Windows are timber framed and double hung.

Management Category:	4
Level of Significance:	SOME SIGNIFICANCE: Contributes to the heritage and/or historical development of the locality.
Management Recommendation:	Conservation of the place is desirable. Any proposed change to the place should be in sympathy with the heritage values of the place.

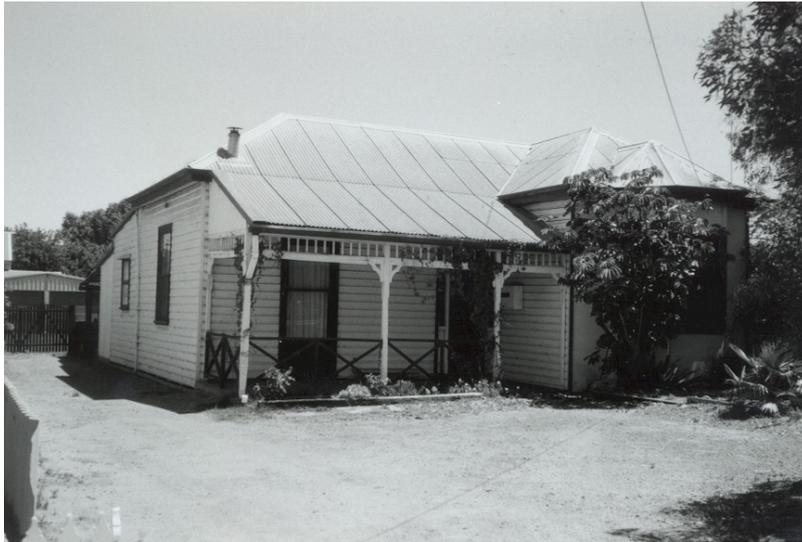
Photo Description:

Decorative verandah detailing.
