Area: Geraldton	Place Number: 340	Category: 3
Assessment Date: 24/10/1996	Last Revision Date: 11/03/2010	
HCWA Number: 13732	Asset ID: MCH127035

Name:	House
Other Names:	20 Queen Street
Type of Place:	House
Address:	20 Queen Street
Suburb:	Geraldton

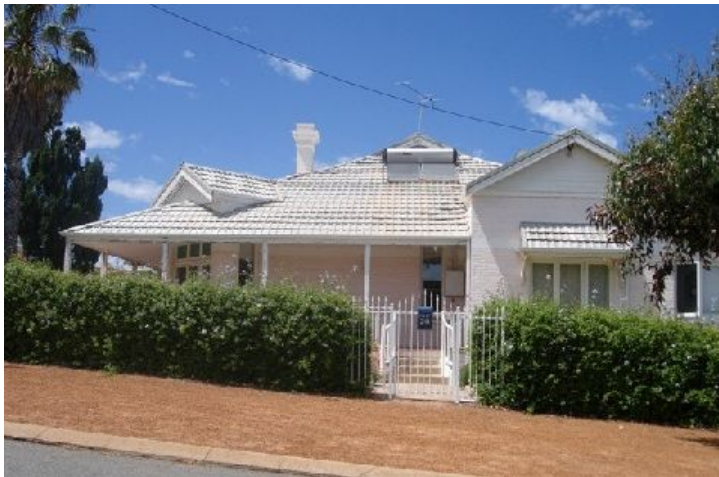
5/11/2007

North elevation addressing Queen Street.

Walls:	Brick	Roof:	Aluminium Tile
Condition:	Good	Integrity:	
Original fabric:			
Modifications:	Reroofed

Situated on a prominent corner this large painted brick house has a complex gambrel aluminium tiled roof with gables to the west and north and a feature gable to the north west which covers a bay. The main roof extends to the north and east, between the gables, and covers a verandah which is supported on timber posts with decorative brackets to the verandah beam and a timber balustrade. There is a rendered masonry band at window ledge and lintel height. Windows are timber framed, a mixture of double hung and casement styles. The windows to the gables have a tiled awning. There are two tall rendered brick corbelled chimneys.

Management Category:	3
Level of Significance:	MODERATE SIGNIFICANCE: Important to the heritage of the locality.
Management Recommendation:	Conservation of the place is recommended. Any proposed change to the place should not unduly impact on the heritage values of the place and should retain significant fabric wherever feasible.

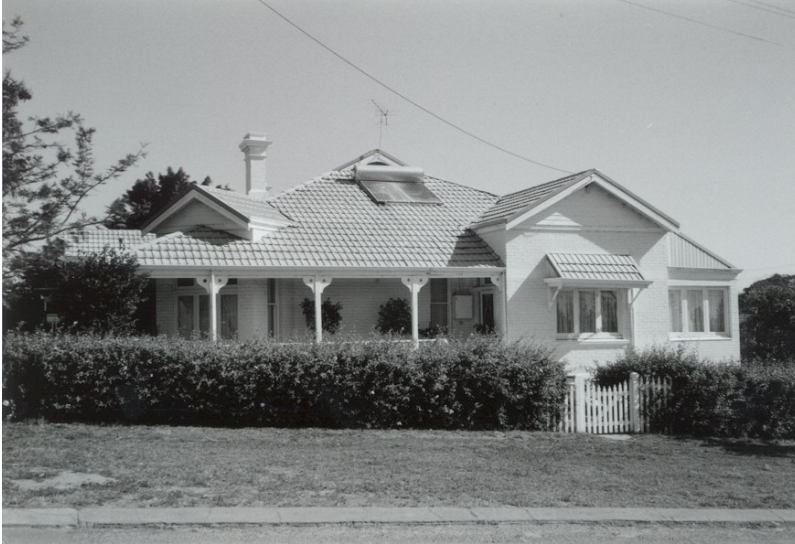
24/10/1996

Elevated corner location.
