Area: Geraldton	Place Number: 358	Category: 2
Assessment Date: 24/10/1996	Last Revision Date: 11/03/2010	
HCWA Number: 13751	Asset ID: MCH126486

Name:	House
Other Names:	132-138 Sanford Street
Type of Place:	House
Address:	132-138 Sanford Street
Suburb:	Geraldton

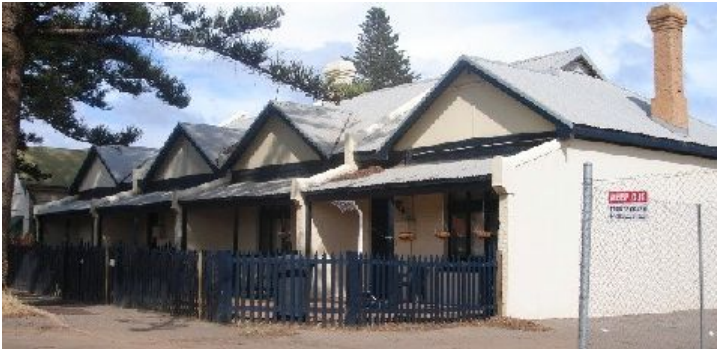
Photo Description:

Front facade of the four cottages.

Walls:	Brick	Roof:	Corrugated Iron
Condition:	Good	Integrity:	
Original fabric:			
Modifications:	Aluminium tile sheeting laid over original corrugated iron

This assessment covers four single storey painted brick terrace houses. A corrugated iron gambrel roof covers the four houses and each house has a separate gable roof to the front (south) facade with a separate verandah roof below and a lean-to roof to the rear. Houses are divided by a low capped parapet wall to the main and verandah roofs and have brick infill to the verandah ends. The gable ends are clad with fibro. Windows are timber framed, double hung to the rear and casement to the front. There are corbelled brick chimneys to the centre and ends of the building. Picket fences divide the front yards of each house and form the street boundary.

Management Category:	2
Level of Significance:	CONSIDERABLE SIGNIFICANCE: Very important to the heritage of the locality.
Management Recommendation:	Conservation of the place is highly recommended. Any proposed change should not unduly impact on the heritage values of the place and should retain significant fabric wherever feasible.

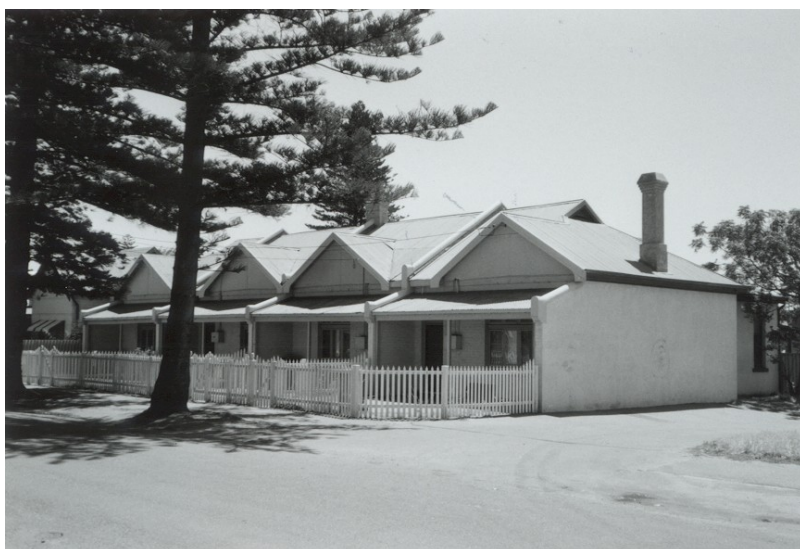
Photo Description:

Tall corbelled brick chimney a feature of the roofscape.
