Area: Geraldton	Place Number: 368	Category: 2
Assessment Date: 24/10/1996	Last Revision Date: 12/03/2010	
HCWA Number: 13762	Asset ID: MCH126538

Name:	Seventh Day Adventist Church, Fmr
Other Names:	Seventh Day Adventist Church
Type of Place:	House
Address:	119A Shenton Street
Suburb:	Geraldton

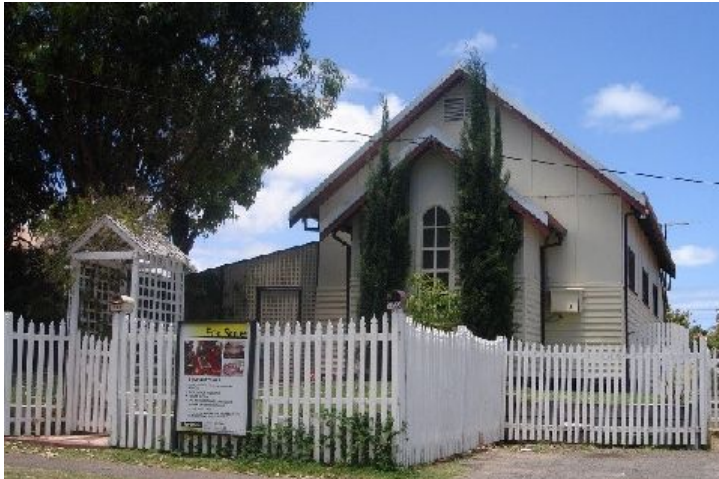
Former Seventh Day Adventist Church, front facade.

This former church has a steeply pitched corrugated iron gable roof with a small gable to a porch to the front elevation. The building is clad with weatherboard to half height with fibro above. The gable end has a slatted timber framed air vent. Windows to the sides are timber framed casement style. The front facade of the porch has three narrow arched timber framed windows. There is an extension to the rear built in sympathetic style. The front of the property is bounded by a picket fence which is inset to provide parking.

Management Category: 2
Level of Significance: CONSIDERABLE SIGNIFICANCE: Very important to the heritage of the locality.
Management Recommendation: Conservation of the place is highly recommended. Any proposed change should not unduly impact on the heritage values of the place and should retain significant fabric wherever feasible.

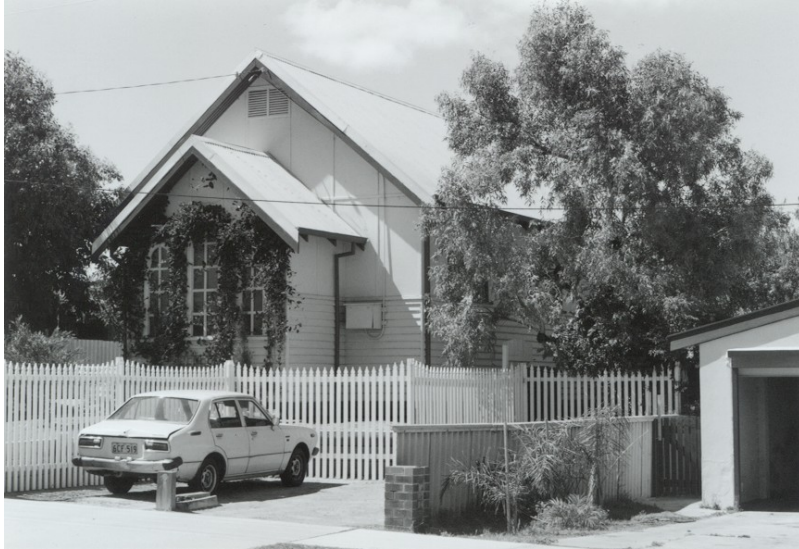
Former Seventh Day Adventist Church, now a residence.
