Area: Geraldton	Place Number: 394	Category: 2
Assessment Date: 05/11/1996	Last Revision Date: 15/03/2010	
HCWA Number: 13788	Asset ID: MCH126662

Name:	Fmr Victoria Flour Mill Manager's Residence
Other Names:	9 Urch Street
Type of Place:	House
Address:	9 Urch Street
Suburb:	Beresford

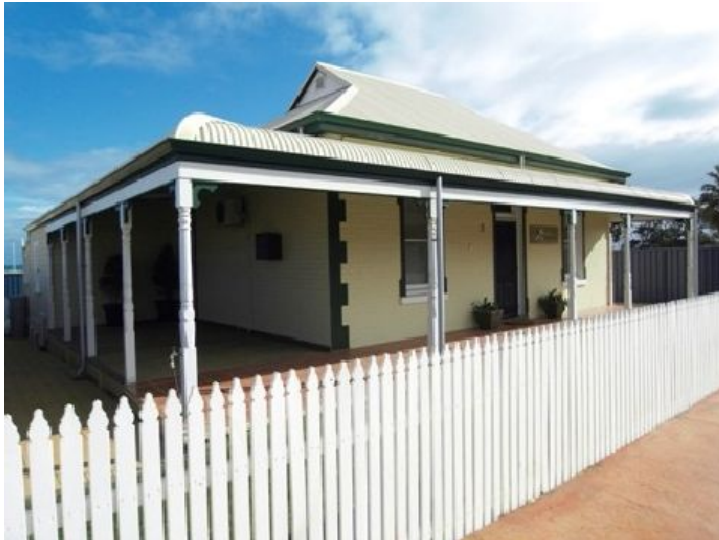
26/06/2009

Following restoration works.

This cream painted brick house has a colorbond gambrel roof and a separate hipped bullnose verandah on two sides. To the rear there is a framed weatherboard clad lean-to. The verandah is supported on turned timber posts with brackets to the verandah beam. Windows are double hung and timber framed. The building was renovated in c2007, including reroofing.

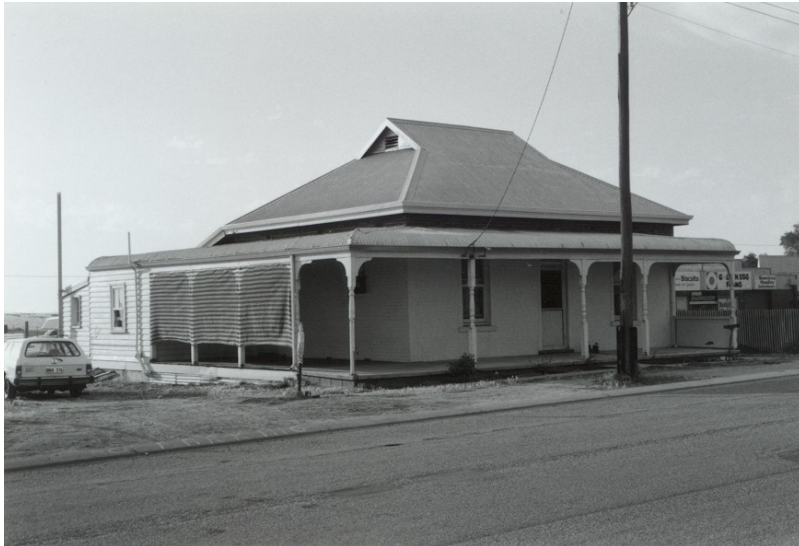
5/11/1996

South and east elevations.
