Area: Greenough	Place Number: 125	Category: 4
Assessment Date: 30/09/1997	Last Revision Date: 24/02/2015	
HCWA Number: 13905	Asset ID: MCH127099

Name:	Padbury Road Cottage
Other Names:	Padbury Road
Type of Place:	Cottage
Address:	Padbury Road
Suburb:	Walkaway

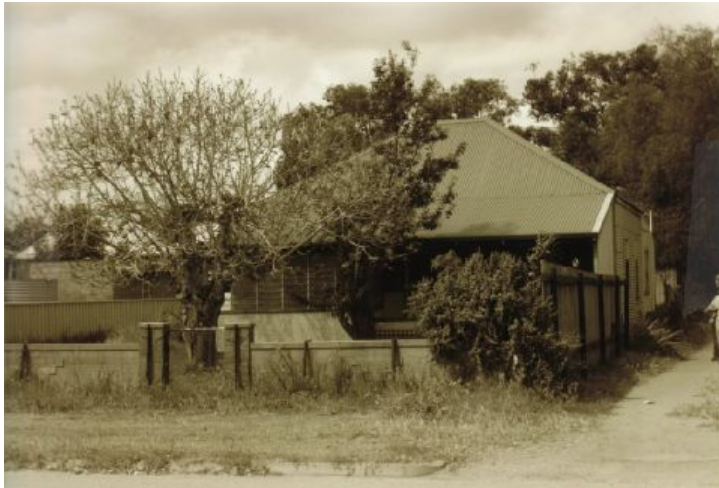
30/09/1997

Front (West) elevation of cottage from road

Walls:	CGI/ Concrete Block	Roof:	Corrugated Iron
Condition:	Poor	Integrity:	
Original fabric:	Highly intact		
Modifications:

This small and simple cottage is timber framed and clad with horizontally placed corrugated iron with a steeply pitched hipped corrugated iron roof. The roof extends broken back to cover the front verandah which is partly enclosed with concrete block and louvre windows. The front (west) facade features concrete block which is painted to look like pointed brickwork. There is a lean-to roof to the rear.

Management Category:	4
Level of Significance:	SOME SIGNIFICANCE: Contributes to the heritage and/or historical development of the locality.
Management Recommendation:	Conservation of the place is desirable. Any proposed change to the place should be in sympathy with the heritage values of the place.

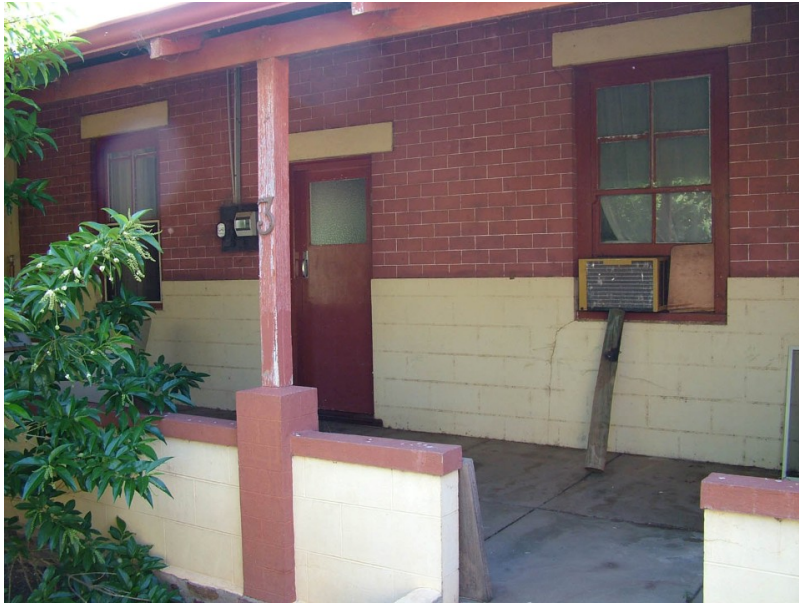
29/03/2005

Front facade of cottage
