**Shire: Mullewa**

**Name:** Kinkora Farmhouse

**Name:** Pindar Post Office & Store Fmr

**Name:** Thomas Lintott's Grave

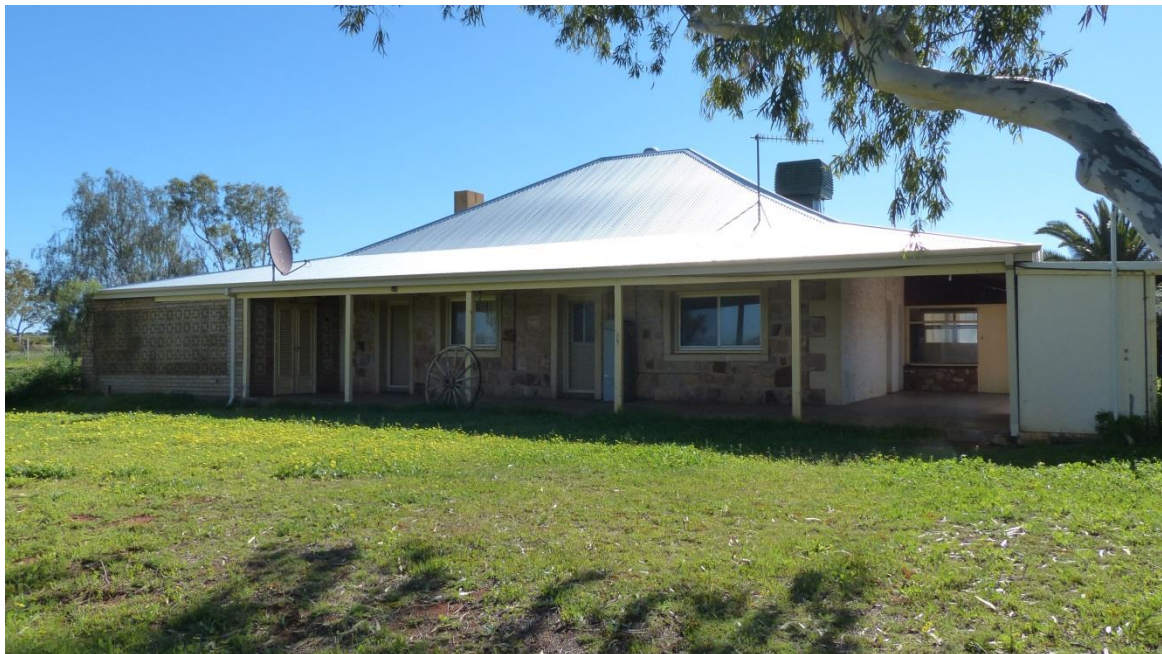
Southern façade of the stone farmhouse.

<b>Walls:</b>	Stone	<b>Roof:</b>	Zincalume
<b>Condition:</b>	Good	<b>Integrity:</b>	High
<b>Original Fabric:</b>	Stone Walls	<b>Modifications:</b>	Large extension to rear

Located to the south west of the Mullewa townsite in the locality of Devils Creek, this large farmhouse is of local stone construction with a hipped roof clad with zincalume sheeting, which has recently replaced the original clay tile roof. The roof extends broken back to cover surrounding verandahs which are supported on timber posts. The western roofscape is punctuated by a plain, rendered chimney. The original stone farmhouse has been extended and altered over time to accommodate additional living space; work which partly obscures the original form of the stone building. This work includes a large painted brick extension to the north under a gable roof, an enclosed outdoor area to the western side of the house constructed with concrete breeze blocks and a small stone partial verandah enclosure to the eastern facade. The hues of the original stonework are evident to the south and west facades while the remaining stone walls of the farmhouse have been painted white. The stonework features rendered surrounds around window and door openings and a stepped quoining to the corners of the building.

Conservation of the place is desirable. Any proposed change to the place should be in sympathy with the heritage values of the place.

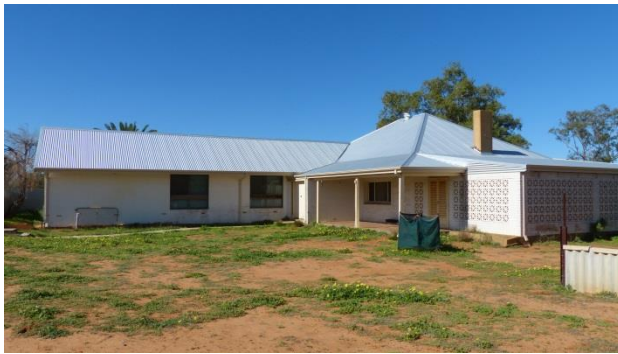
Large extension to the north side of the farmhouse.

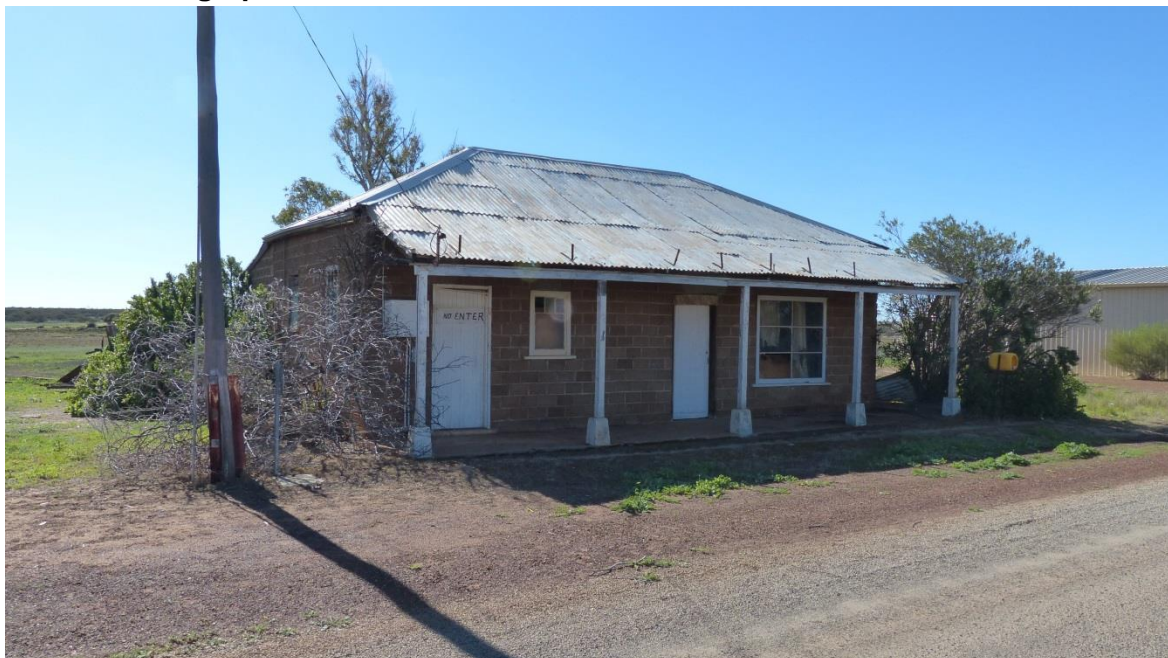
Front façade addressing Sharpe Street, Pindar.

Located on the main street of the little townsite of Pindar, immediately east of the Pindar Hotel Fmr and opposite the grain silos, this small building fronts directly onto Sharpe Street. With walls of concrete block construction, the hipped roof is clad with short sheets of corrugated iron. The roof extends at the same pitch to cover the front verandah which is supported on timber posts mounted on small concrete plinths. The front façade of the building features two doors and two windows – one large and one small. There is a rear lean-to which appears to have been constructed at a later date as it has a different colour concrete block and mortar joint.

Conservation of the place is desirable. Any proposed change to the place should be in sympathy with the heritage values of the place.

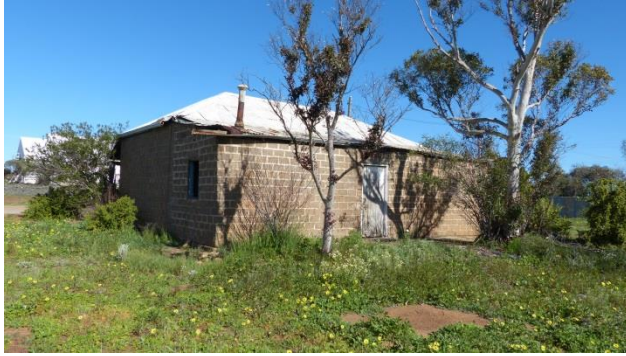
Rear view of building.

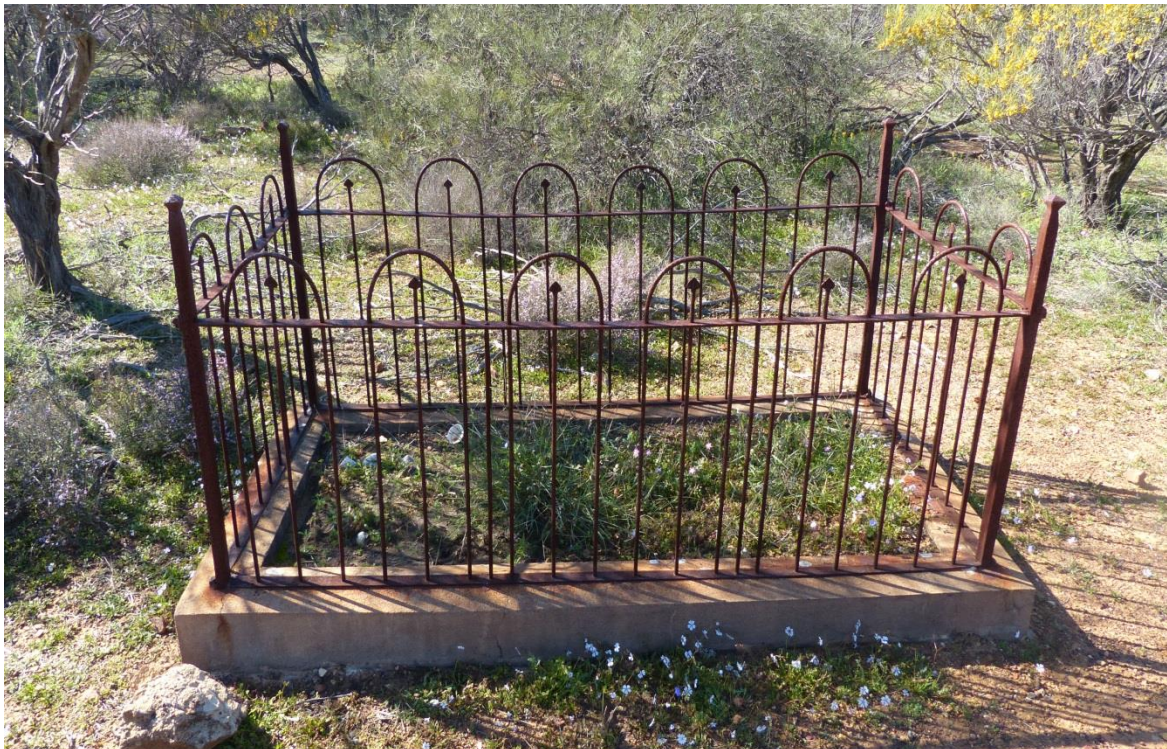
Lonely grave of Thomas Lintott surrounded by decorative metal railings.

Located approximately 1km north-west of the small townsite of Pindar and about 60 metres north of the Old Pindar-Mullewa Road, this lonely grave is situated in a small clearing amongst the bushland. Consisting of a rectangular concrete base with a tall decorative metal grave surround atop, the grave is not marked by a headstone or any other marker to identify who is buried there. The grave remains in remarkably good condition considering its age, however this could also be due to its remote location which could reduce the likelihood of any vandalism or inadvertent damage.

Conservation of the place is recommended. Any proposed change to the place should not unduly impact on the heritage values of the place and should retain significant fabric wherever feasible.

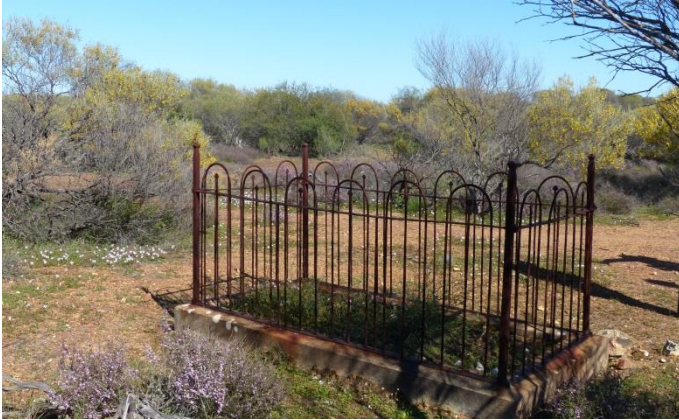
No headstone or grave marker to identify lonely grave.

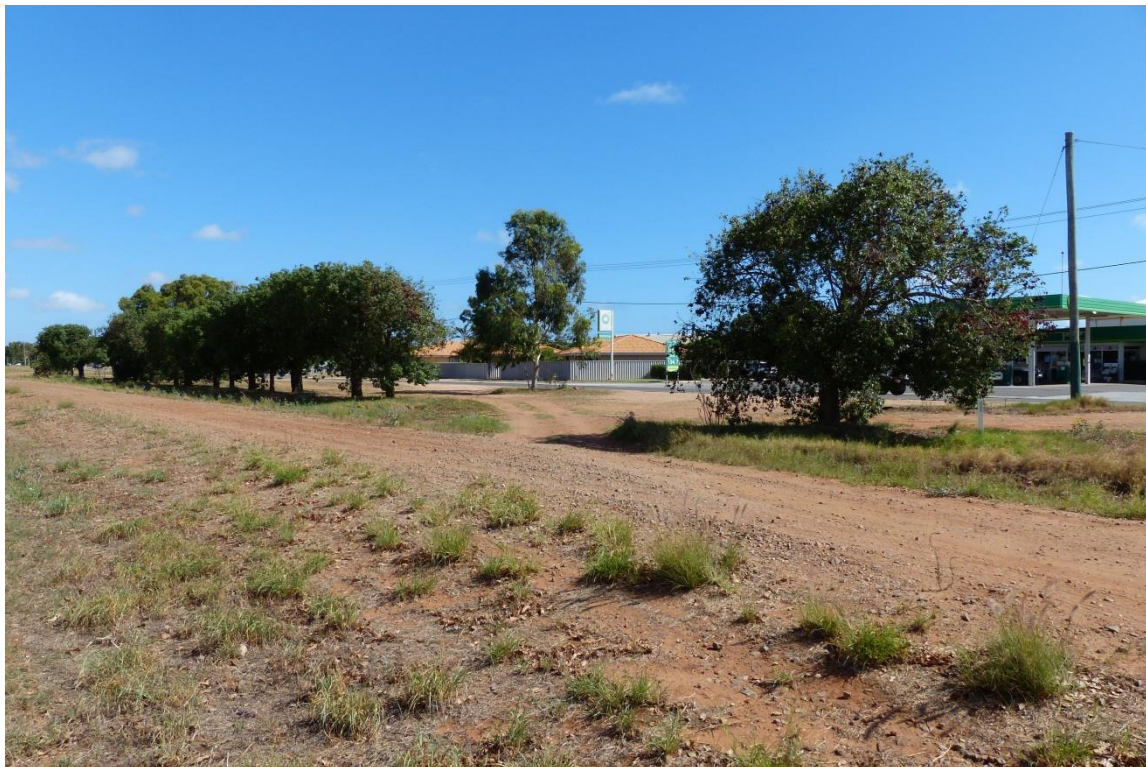
Row of 18 Kurrajong trees adjacent to Flores Road.

The row of 18 Kurrajong trees (*Brachychiton populneus*) is located on the former rail reserve on the eastern side of Flores Road in the suburb of Wonthella. Planted parallel to the road and situated between Fourth and Fifth Streets, the trees have been planted along a north-south axis adjacent to the old rail alignment.

Conservation of the place is highly recommended. Any proposed change should not unduly impact on the heritage values of the place and should retain significant fabric wherever feasible.

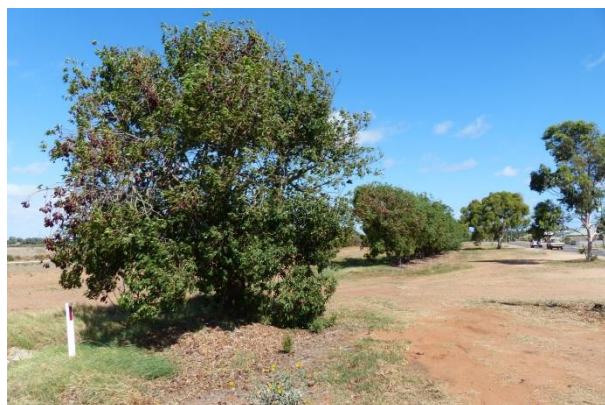
Stand of trees looking south.
