# WONTHELLA SKATEPARK

**DRAFT** SKATEPARK ASSESSMENT REPORT  
MARCH 2012

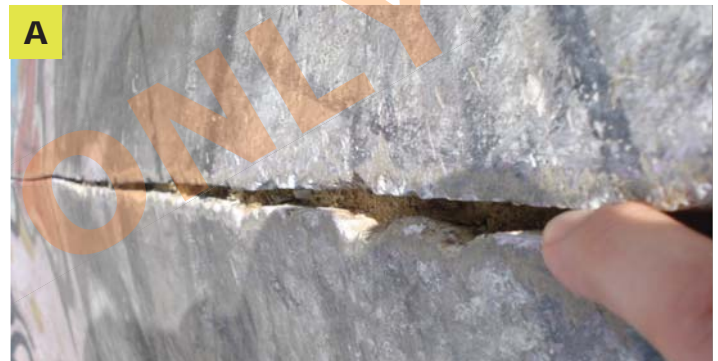
The BANK (A) has large cracks in the surface from an obstacle that was removed

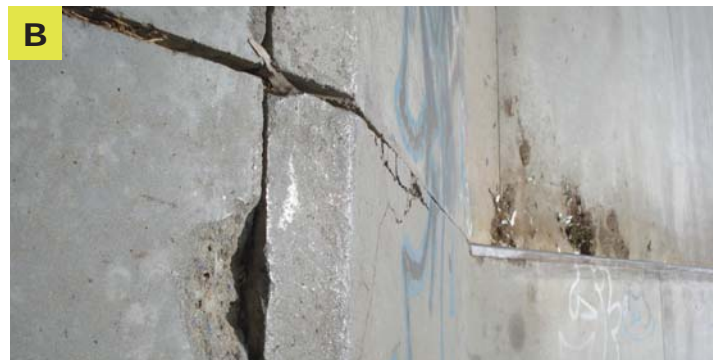
There are cracks and erosion on the skateable surface (B) between transition pieces.

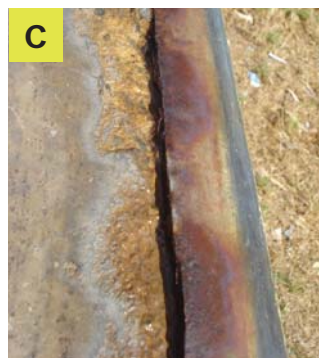
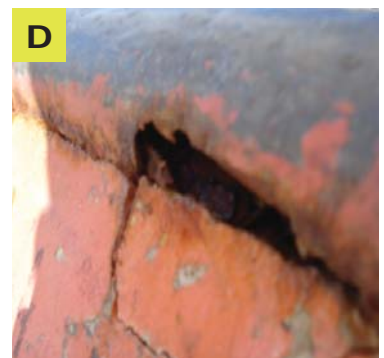
The tolerance of the coping on the FUNBOX LEDGE (C) QUARTER PIPE (D) is incorrect due to damage, has holes and rust and the surrounding concrete is heavily eroded. As a result, it cannot be used safely by users.

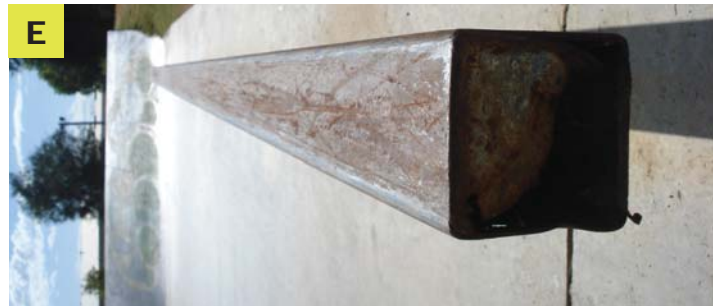
The GRIND LEDGE (E) has holes and sharp edges exposed on the ends. This is a significant risk to the intended users.

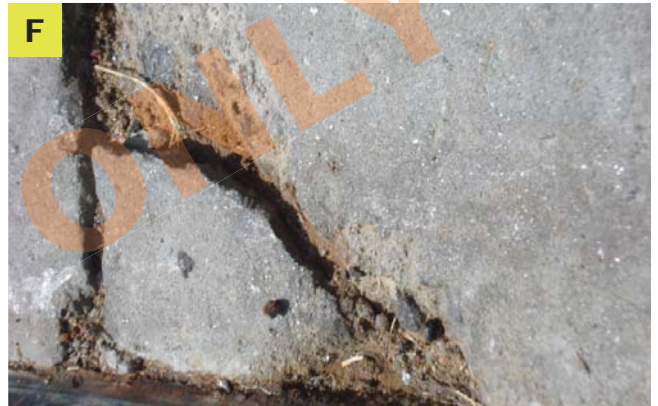
The platform edge of the coping (F) has deteriorated and shows structural concrete failure, causing a significant tripping hazard for skateboard & scooter wheels. This also increases the potential of debris covering on the skatepark surface.

NUMBERED	UNSAFE ITEMS	LOCATION	ACTION REQUIRED	REFERENCE IMAGE	PRIORITY	TIMING
1	CONCRETE EROSION AT PLATFORM BEHIND COPING. WHEEL TRAP	BEHIND QUARTER PIPE COPING EDGE	CLEAN DEBRIS, PATCH HOLES 6-25 MM	(H)	CRITICAL	IMMEDIATE
2	STRUCTURAL FAILURE TO CONCRETE AT PLATFORM BEHIND COPING. TRIPPING & STRUCTURAL HAZARD.	BEHIND QUARTER PIPE COPING EDGE	CUT OUT DAMAGED SECTION AND REPLACE WITH APPROVED GROUT	(F)	CRITICAL	IMMEDIATE
3	LARGE CRACKS AT TOP OF BANKED HIP. TRIPPING AND WHEEL TRAP	PLATFORM EDGE OF BANKED HIP NORTH OF PARK	CLEAN DEBRIS, PATCH HOLES 6-25 MM	(A)&(B)	CRITICAL	IMMEDIATE
4	FINGER TRAP AND SHARP EDGES	ENDS OF GRIND RAILS	FILL HOLES WITH APPROVED GROUT, GRIND SMOOTH	(E)	CRITICAL	IMMEDIATE
5	JAGGED HOLES AND CRACKS TO COPING. HIGH RISK TO USERS	COPING OF QUARTER PIPE NEAR FUNBOX	REMOVE SHARP EDGES FILL HOLES OR REPLACE COPING	(D)	CRITICAL	IMMEDIATE
6	NO SAFETY SIGNAGE	ENTRY PATHS TO SKATEPARK	REPLACE SIGNAGE	(I)	CRITICAL	IMMEDIATE

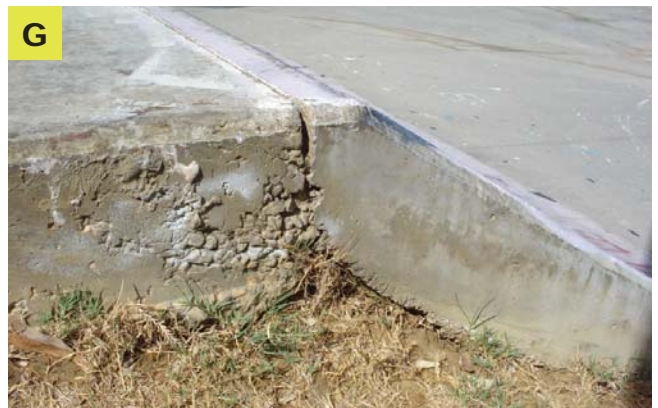
Significant erosion around the grass edge of the skatepark at the BANK (G) shows wear and exposes a coarse edge.

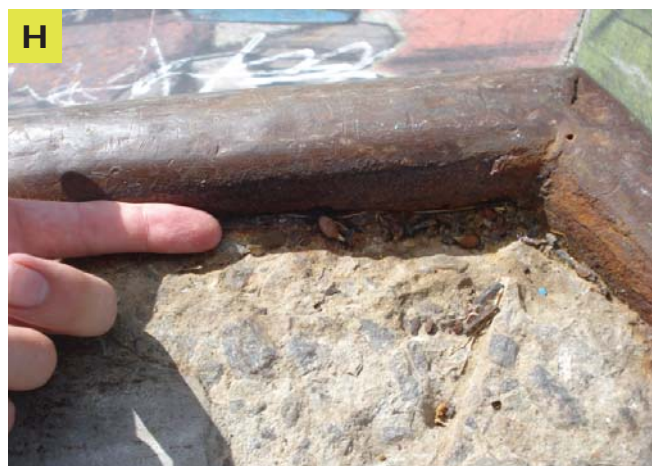
The structural integrity of the QUARTER PIPE (H) coping shows wear in the circular steel edge and in the supporting concrete. This will deteriorate further and needs to be addressed before it exposes any more sharp edges.

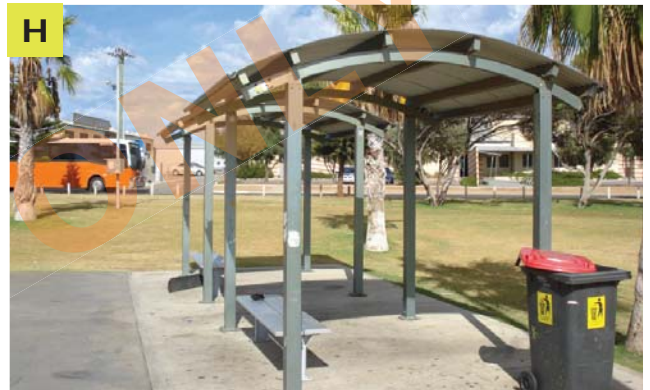
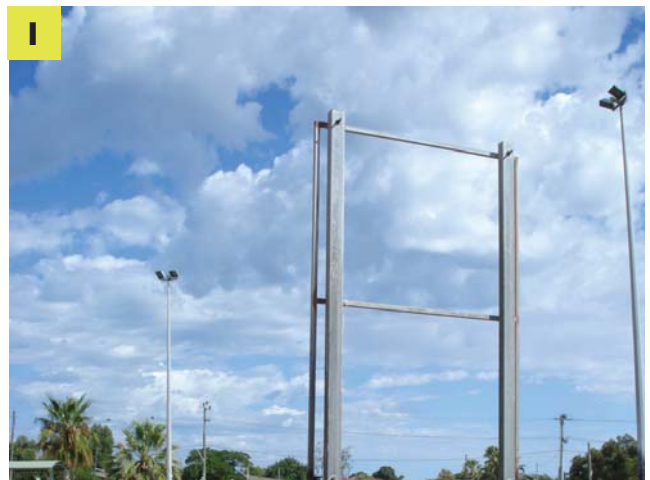
Amenities at the site are rated as fair (45%) but can be improved by adding facilities as shown below:

AMENITY	STATUS
SHADE FOR 8 USERS	ADEQUATE
SEATING FOR 8 USERS	INADEQUATE
BINS FOR 8 USERS	ADEQUATE
WATER FOUNTAIN FOR 8 USERS	INADEQUATE
ACCESS POINTS TO SITE	ADEQUATE
READABLE SIGNAGE	INADEQUATE

Safety signage is critical to inform users of recommended safety equipment to be worn, emergency contact information and to reduce risk to council.
