REMOVAL OF HERITAGE LISTED PLACE – 140 FLORES ROAD, WEBBERTON

REPORT

ATTACHMENT 3

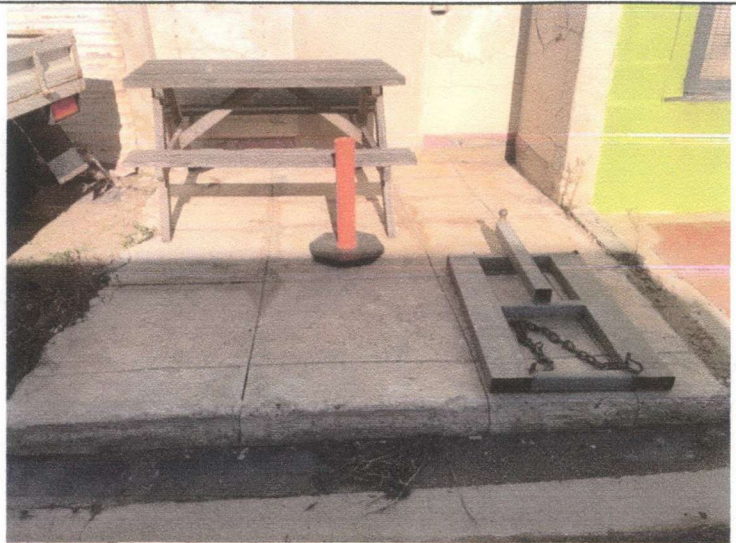
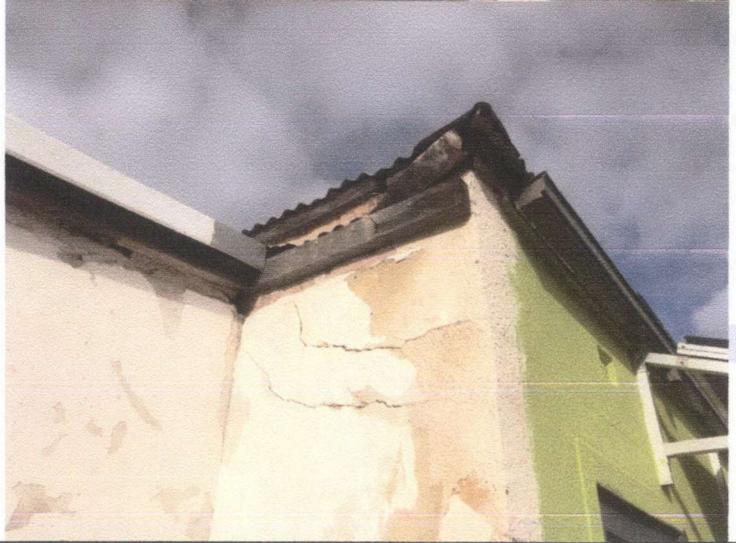
- North side elevation to the rear of the building
- There had previously been a lean-to kitchen which fell down and was not replaced. The old doorway to this lean-to has been filled in
- Extensive cracking to brickwork is present

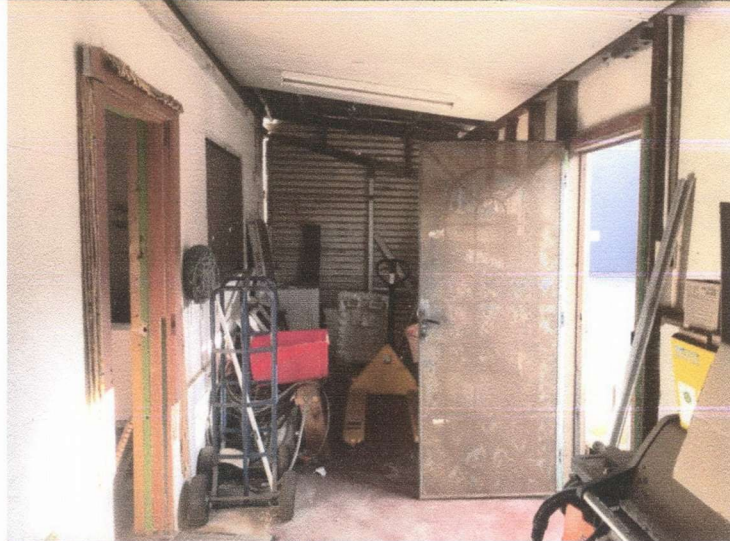
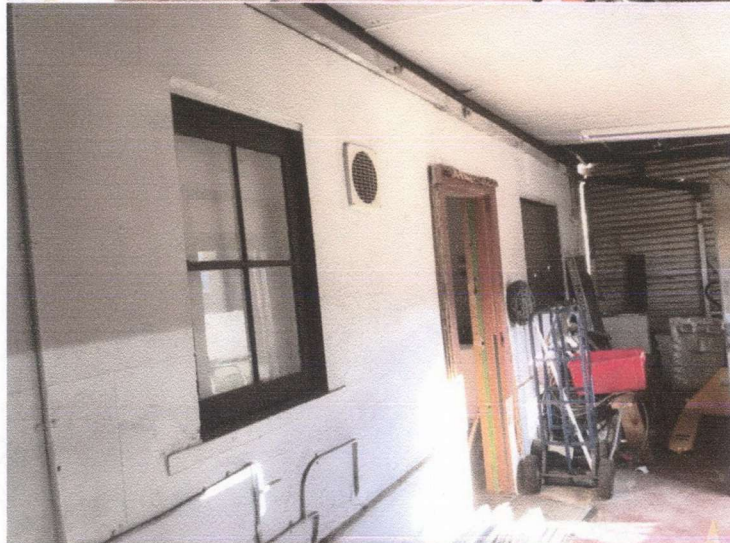
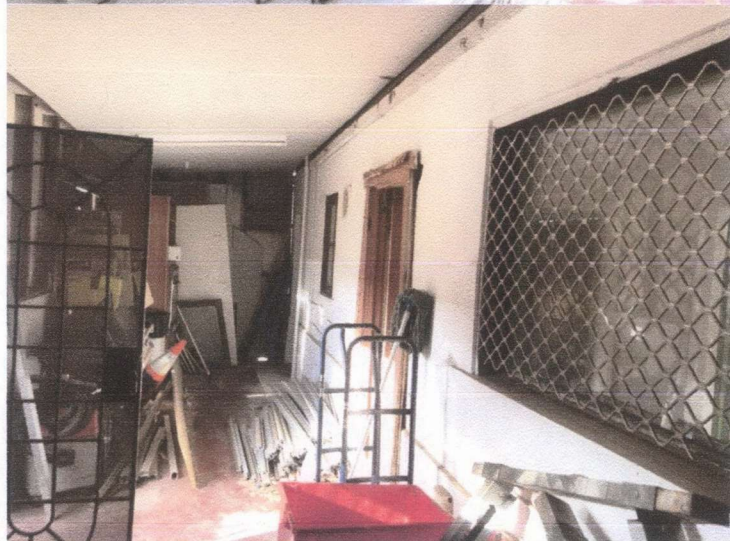
- Asbestos and tin clad rear extension
- Large gaps between panels, around doors and between walls and roof allowing dust, rain and pests into the building.

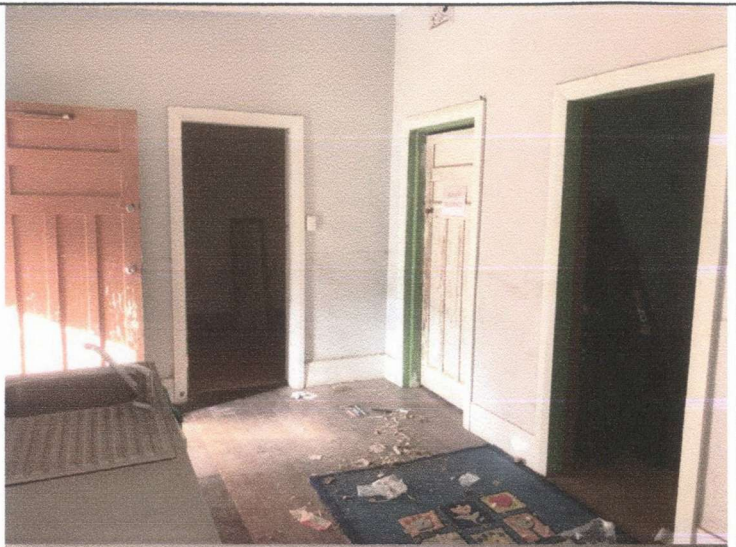
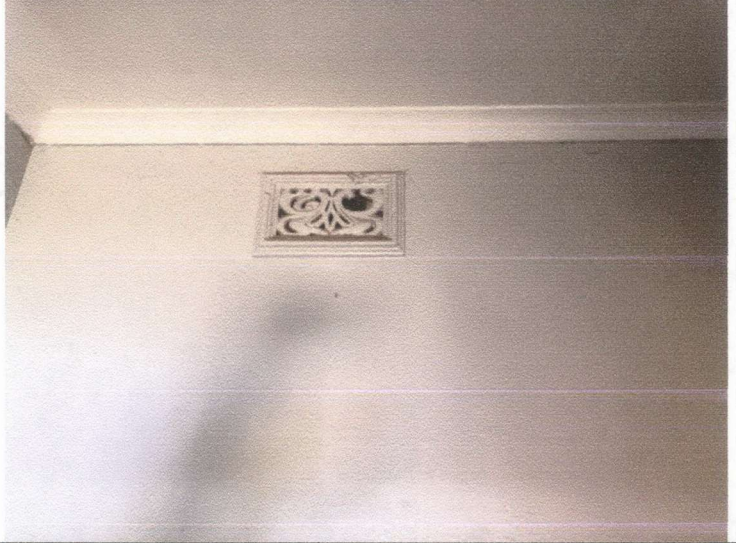
- Damaged brezeway

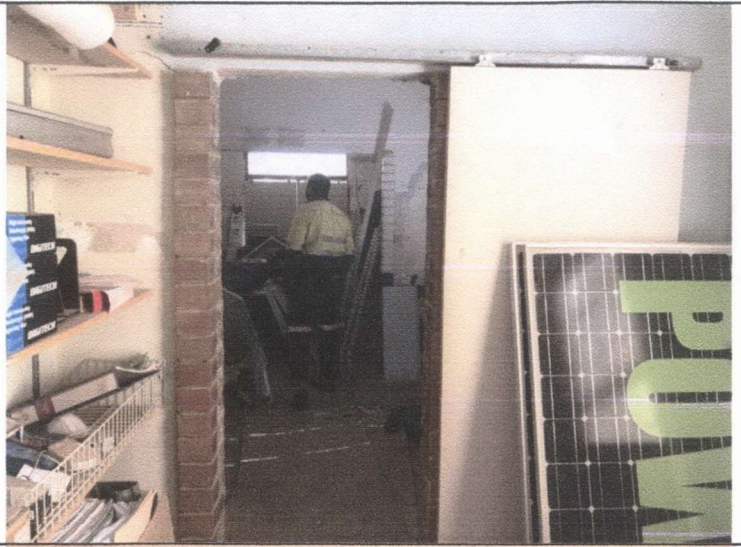
- Ceiling bowing and cracked

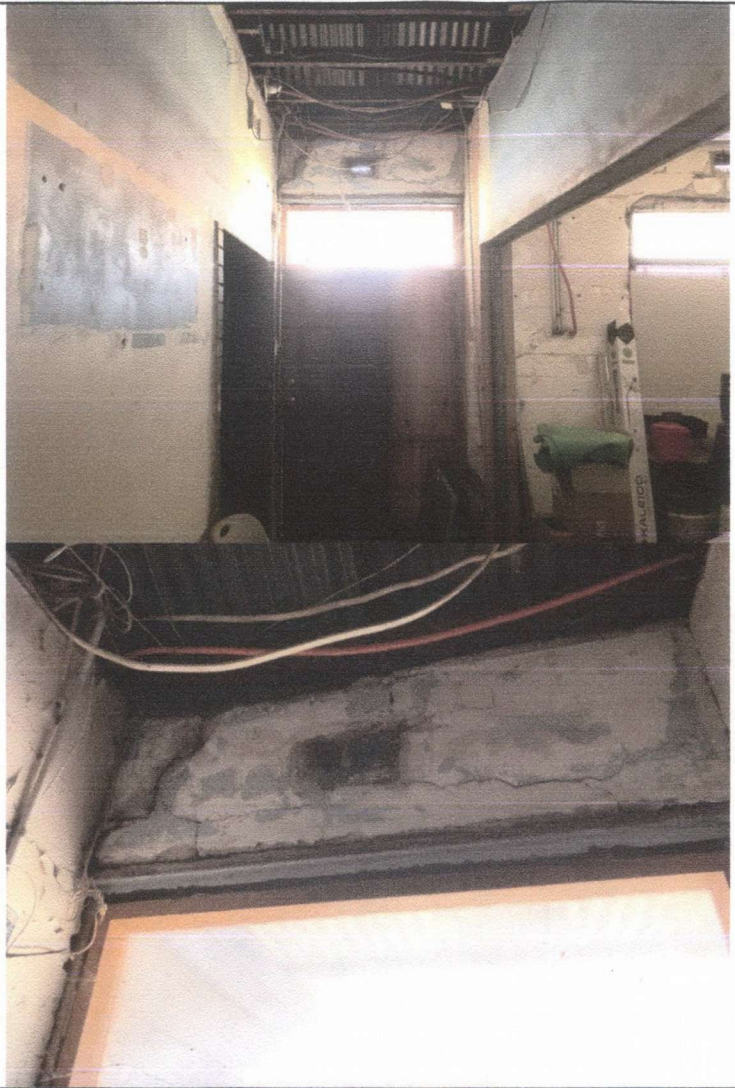
- Internal hallway facing front door
- Missing ceiling
- Extensive deterioration to blockwork above entry

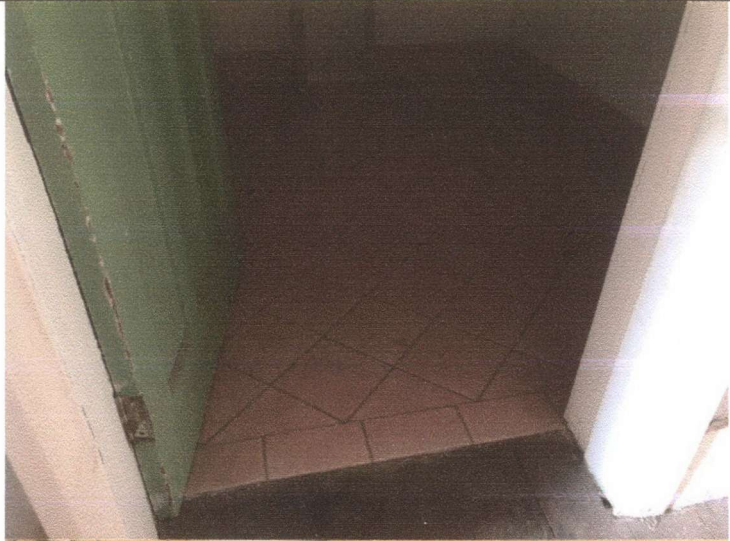
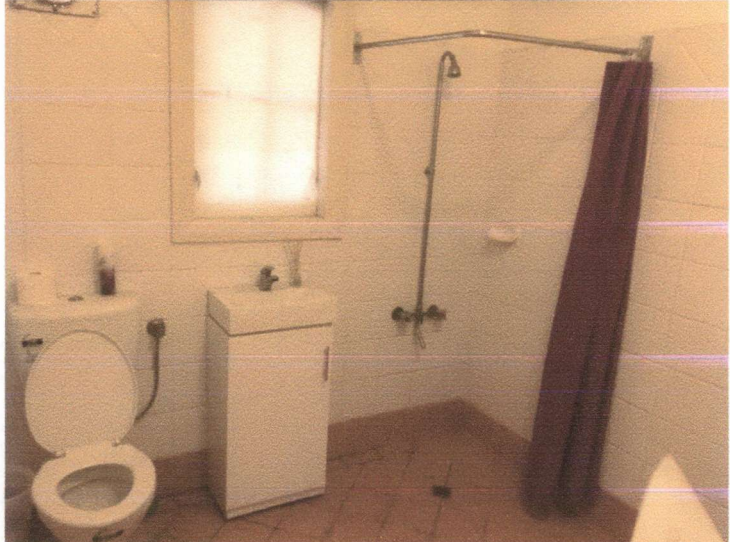
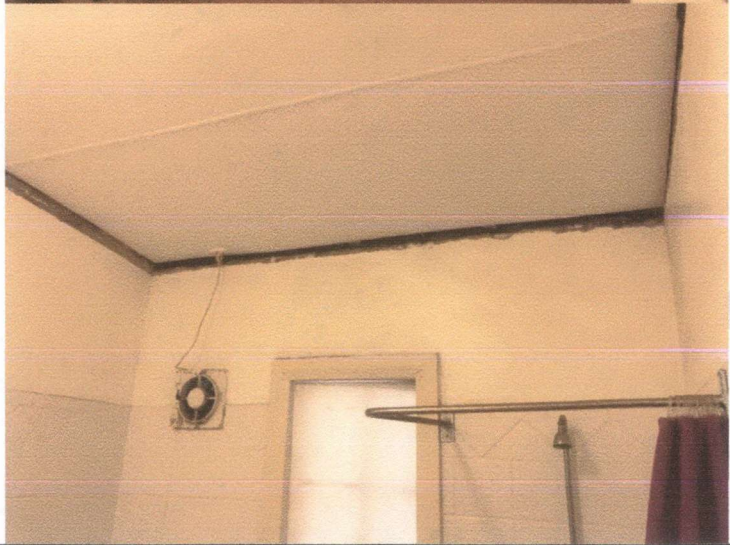
- Internal room
- Modified tiled flooring
